HISTORIC LOVELAND ELKS LODGE (BPOE #1051) BUILDING

HISTORIC STRUCTURE ASSESSMENT PHOTOS

PAGE NUMBER EC-1	HISTORIC STRUCTURE ASSESSMENT HISTORIC BPOE #1051 BUILDING CHS/SHF #2011-HA-012	EXISTING CONDITIONS PHOTOS PREPARED BY: P. Berglund CHECKED BY: R. S. Beardmore, PE

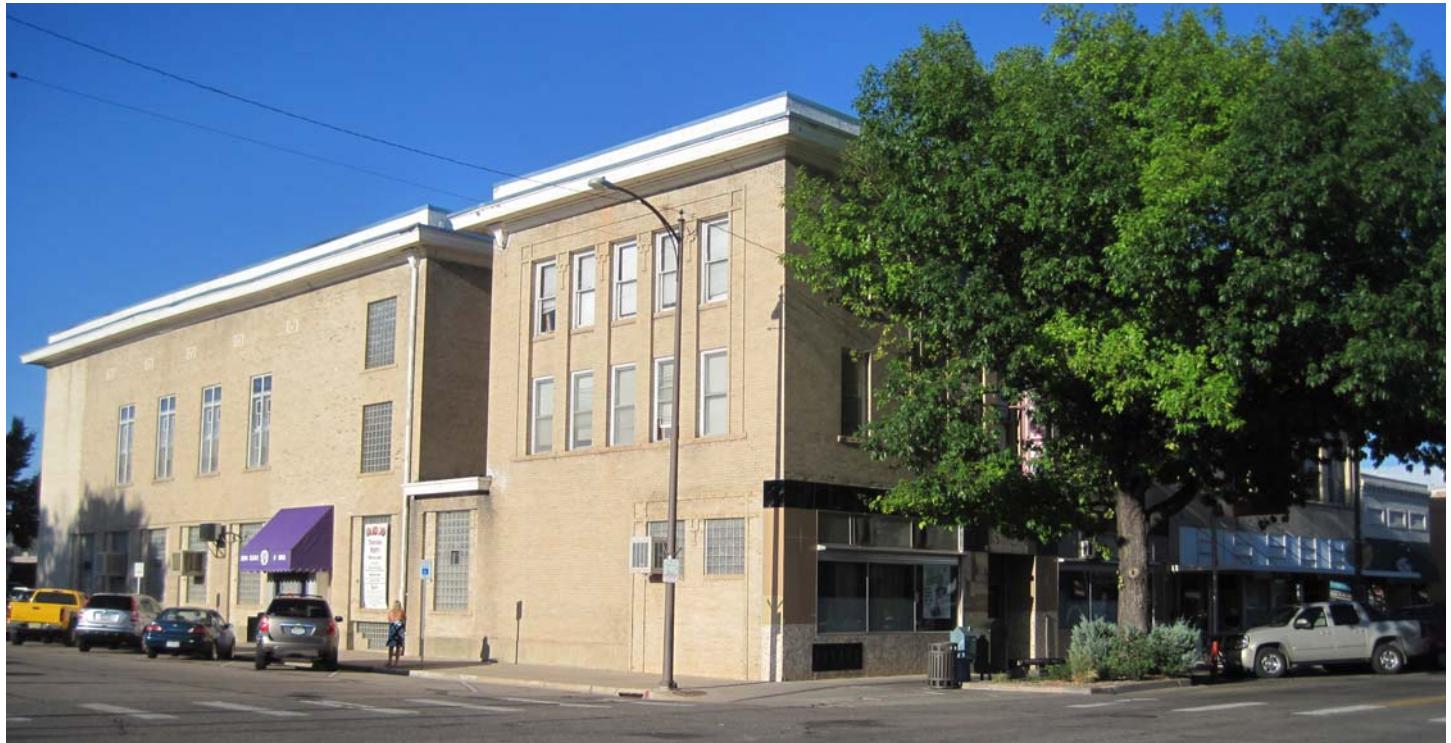
LEL9313 OBLIQUE VIEW OF SOUTHWEST CORNER OF LOVELAND ELKS LODGE BUILDING

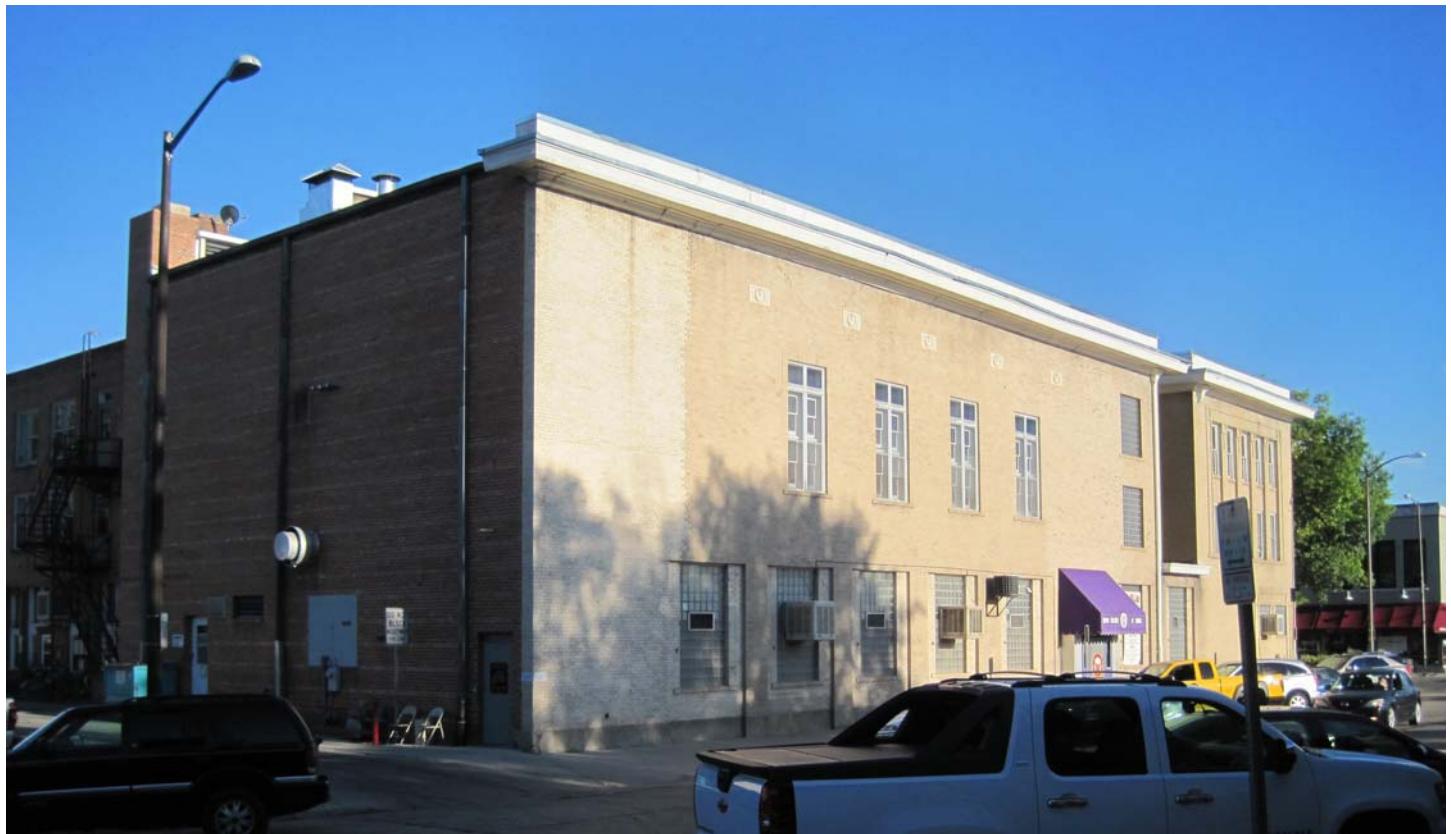
LEL9321 OBLIQUE VIEW OF NORTHWEST CORNER OF LOVELAND ELKS LODGE BUILDING

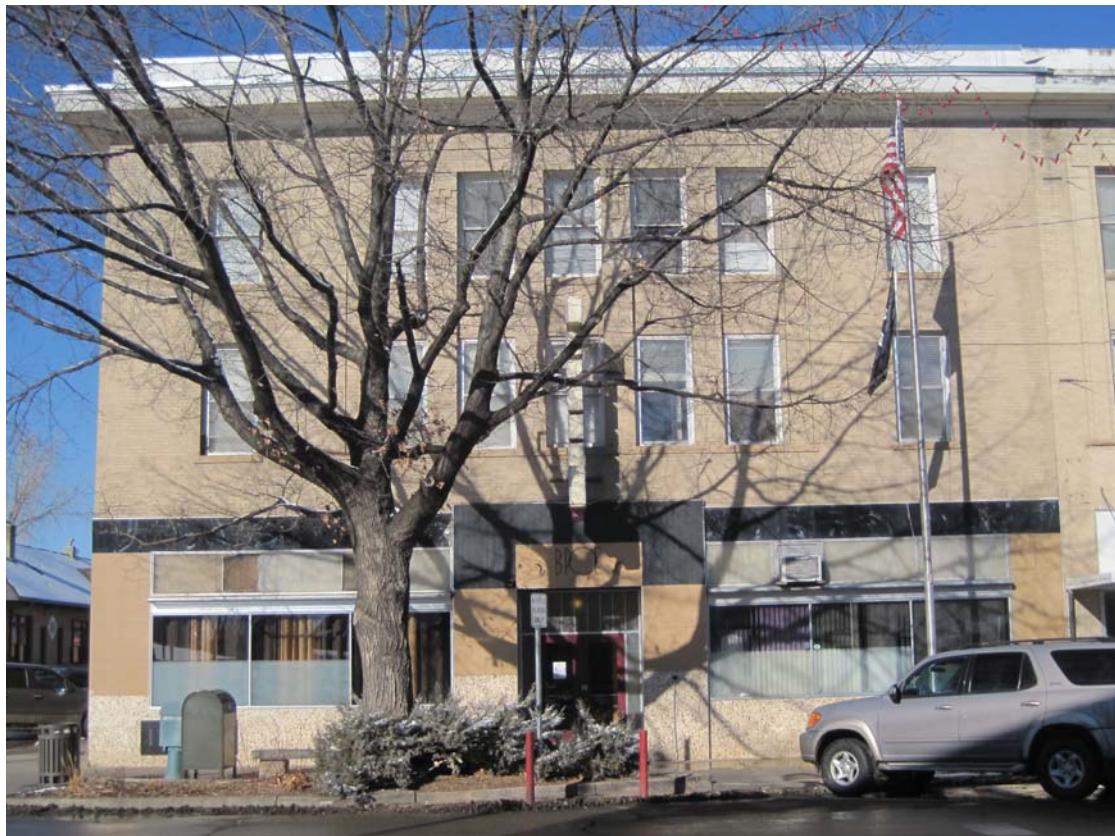
LEL1046 SOUTH (FRONT) ELEVATION

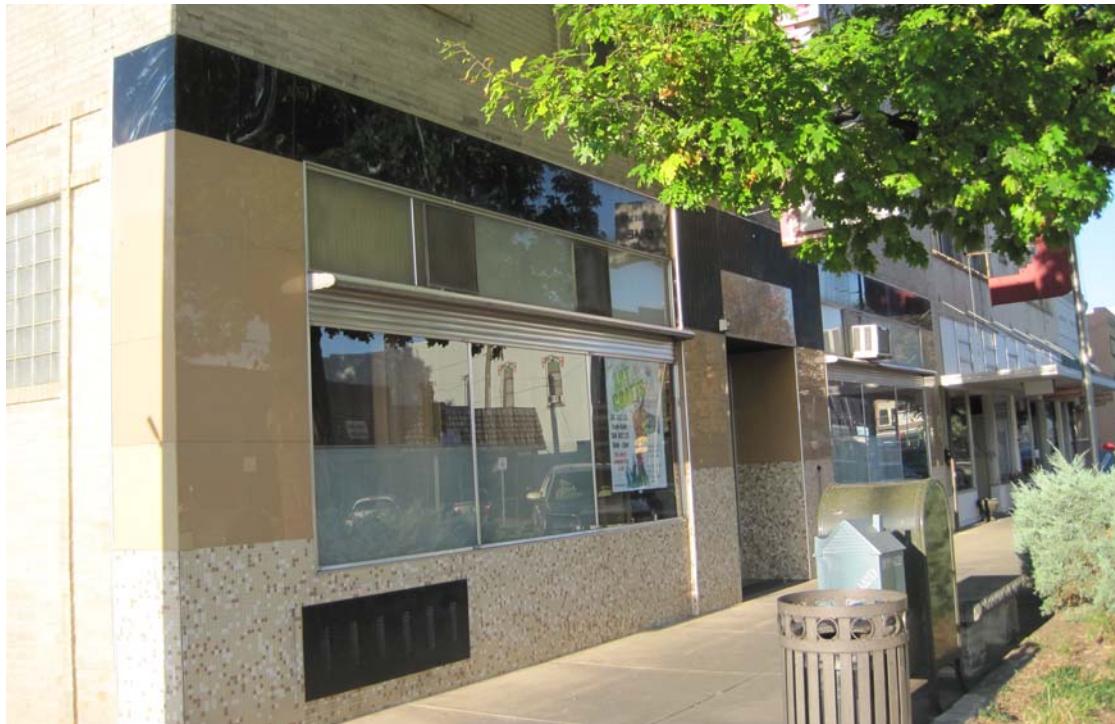
LEL9351 STOREFRONT AS VIEWED FROM SOUTHWEST CORNER

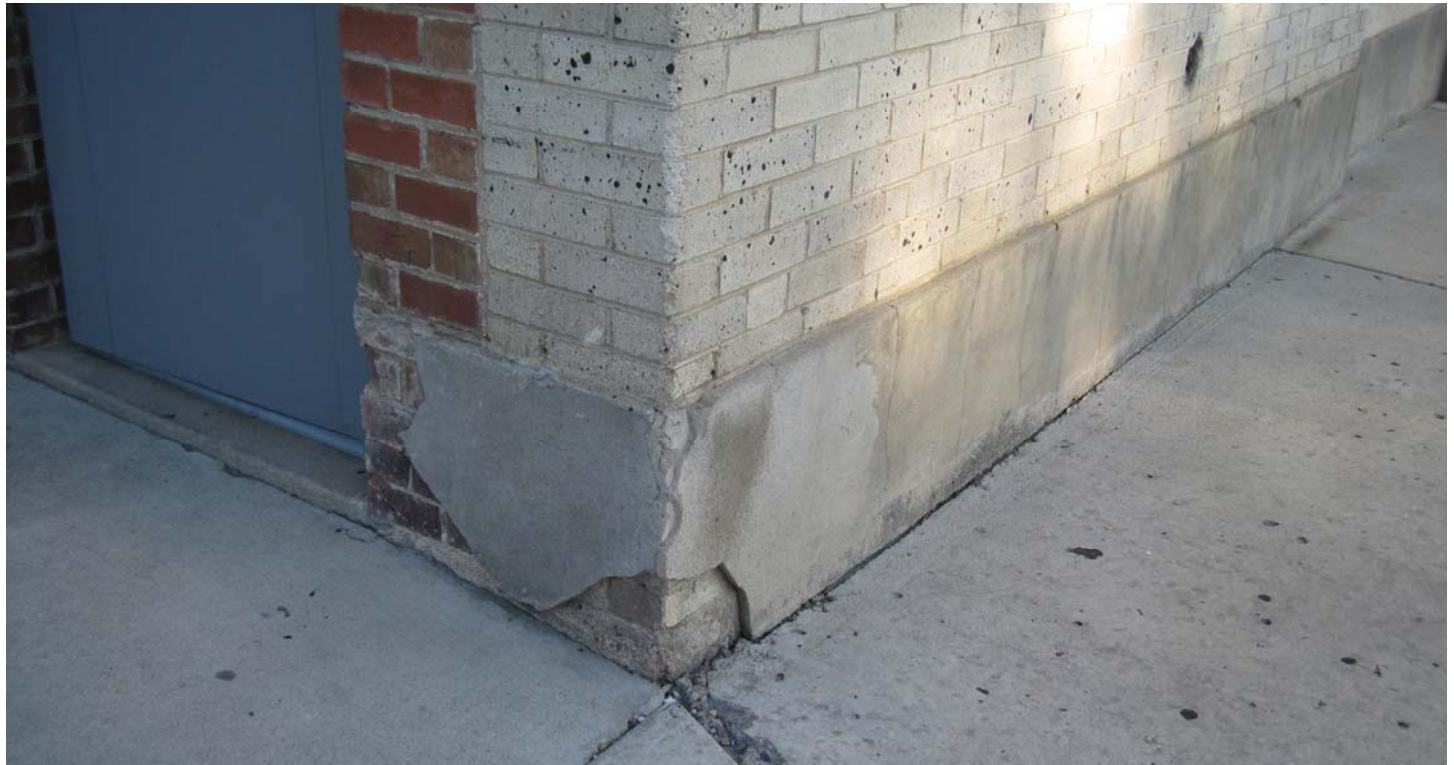
LEL9333 NORTHWEST CORNER VIEW SHOWING CONCRETE PARGING ALONG TOP OF FOUNDATION

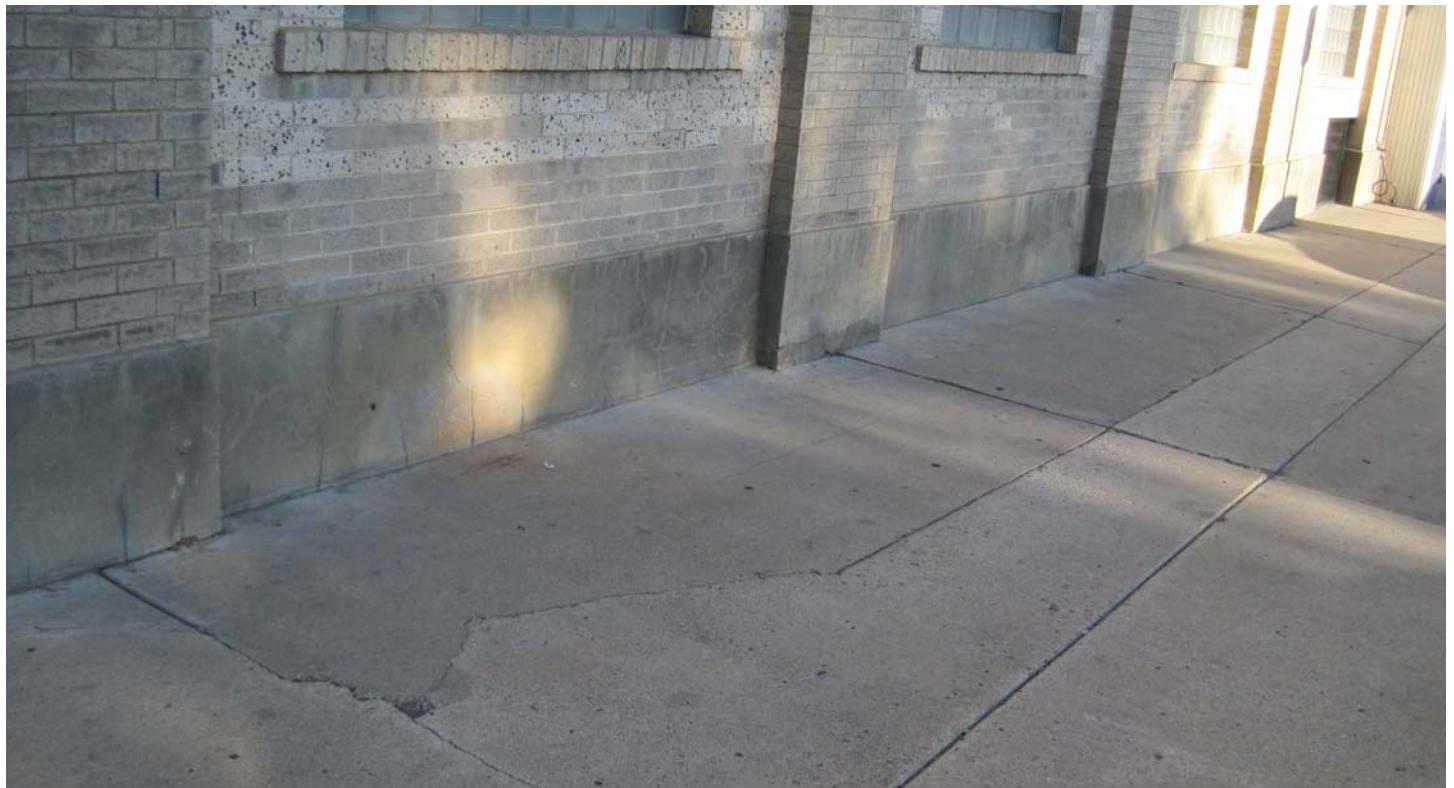
LEL9342 WEST ELEVATION NEAR NORTHWEST CORNER SHOWING CONCRETE INFILL AT LOCATION OF HISTORIC GLASS PAVERS ABOVE VAULTS ADJACENT TO AND PREVIOUSLY OPEN TO FOUNDATION WALL

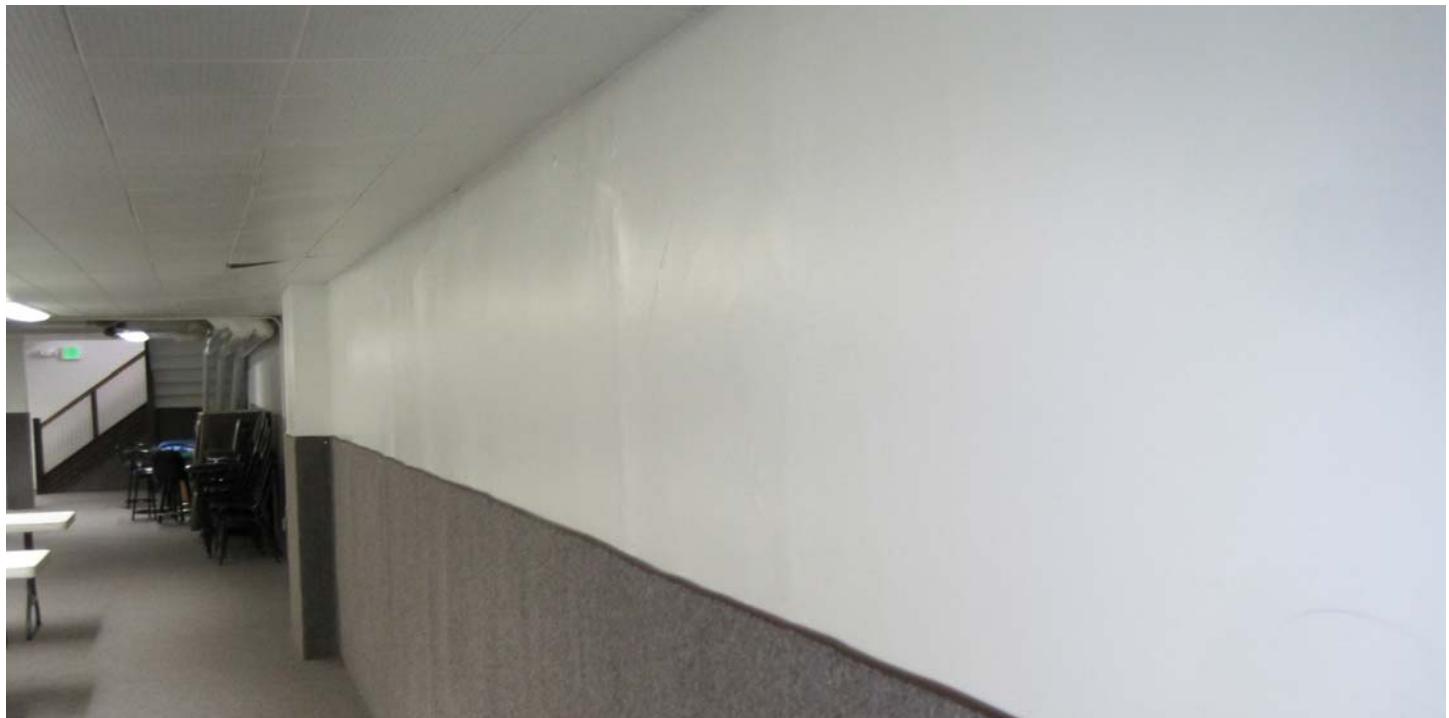
LEL7409 VIEW LOOKING SOUTH ALONG WEST BASEMENT WALL SHOWING GHOSTING OF ARCHED OPENINGS

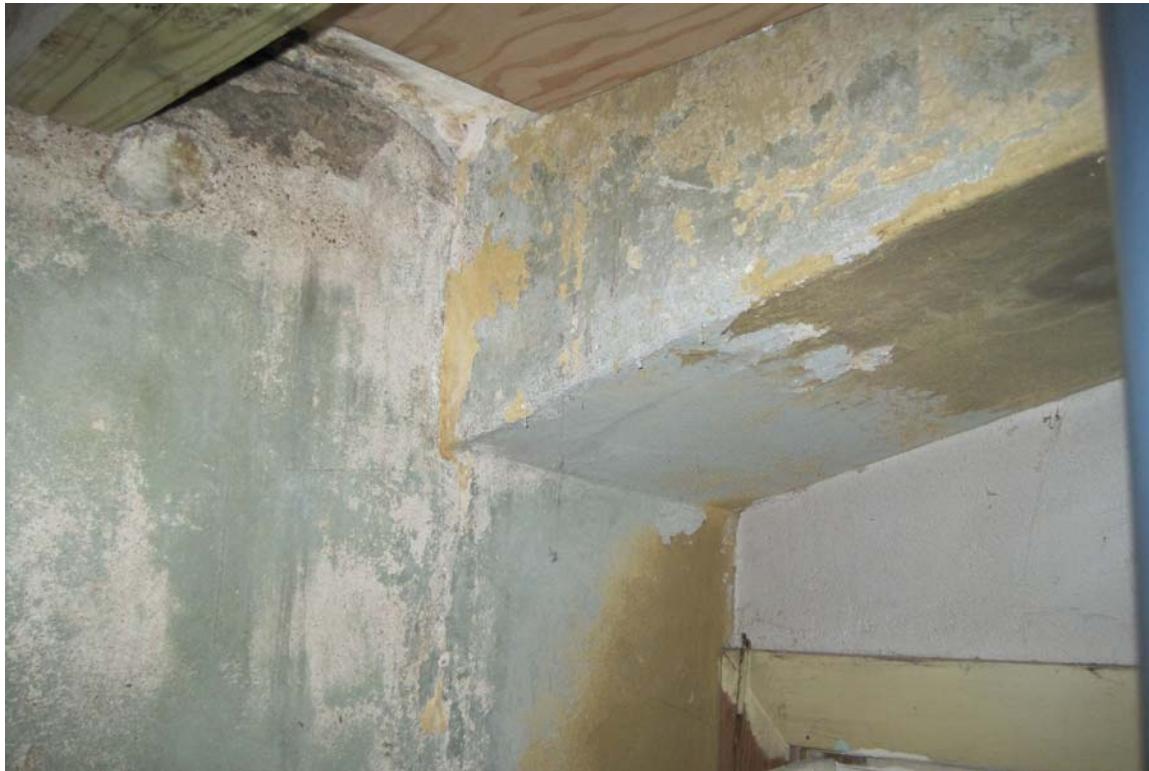
LEL7424 CLOSER VIEW AT NORTH END OF HISTORIC ARCH, CONCRETE, AND BRACING AT SUB-SIDEWALK VAULT

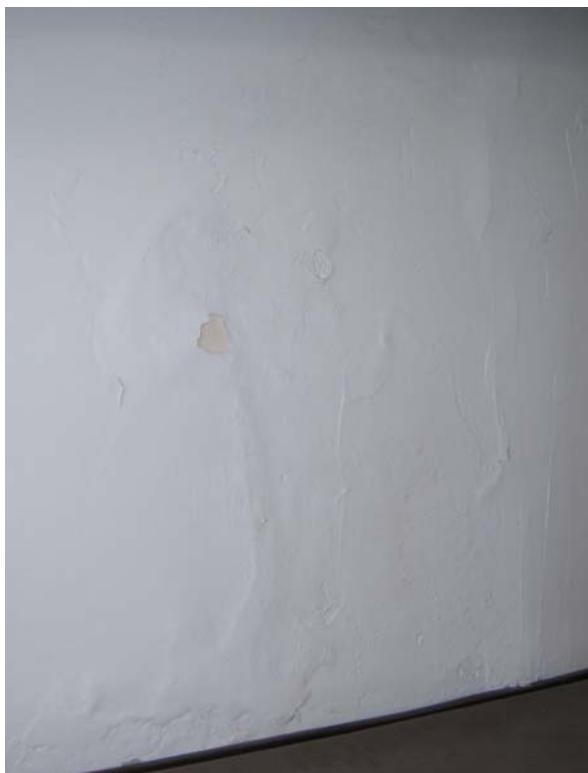
LEL7417 PATCHED SPALLED CONCRETE AT WEST FOUNDATION WALL

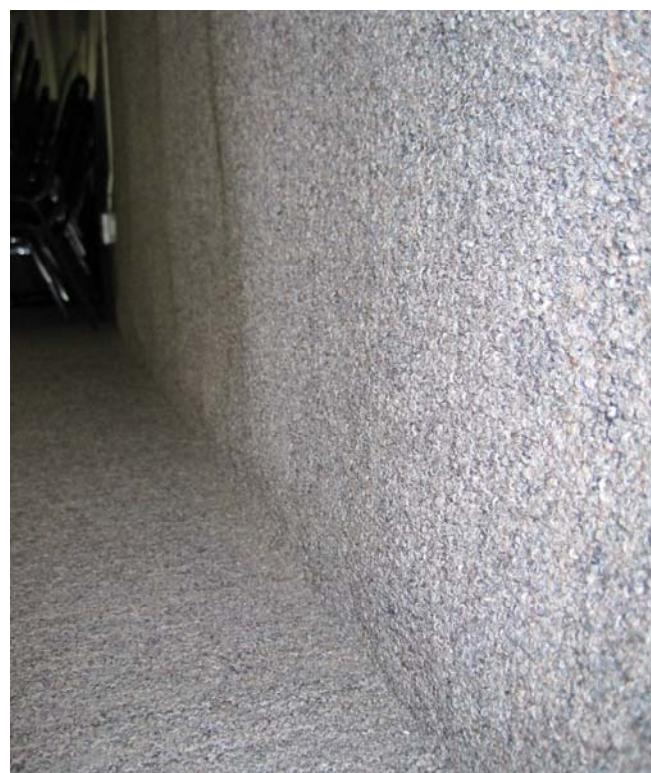
LEL7528 BULGING CARPET WAINSCOT INDICATING SPALLING BEHIND

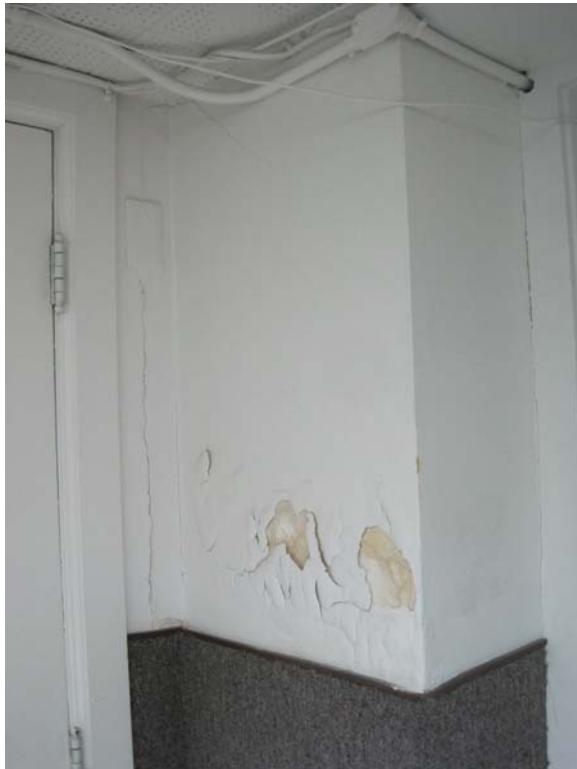
LEL7538 BUBBLED PAINT ON FOUNDATION WALL SOUTH OF ELEVATOR DOOR

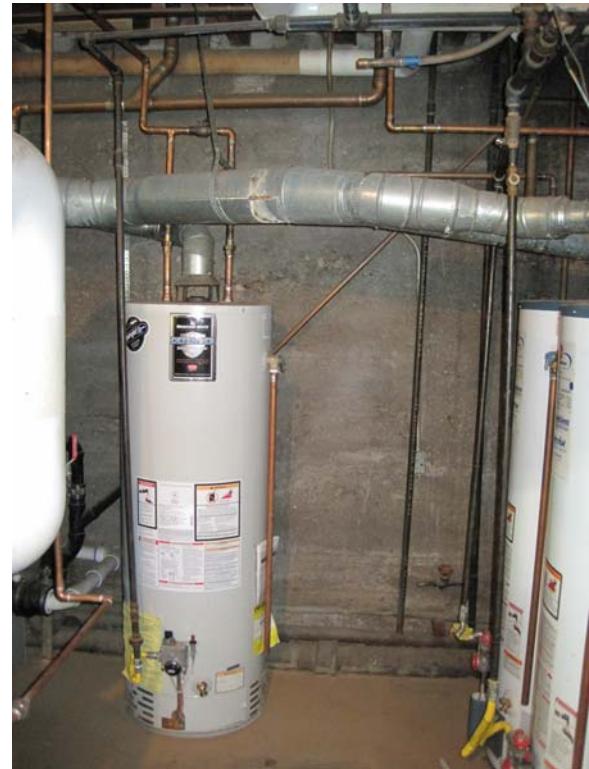
LEL7343 EAST CONCRETE FOUNDATION WALL IN BOILER ROOM

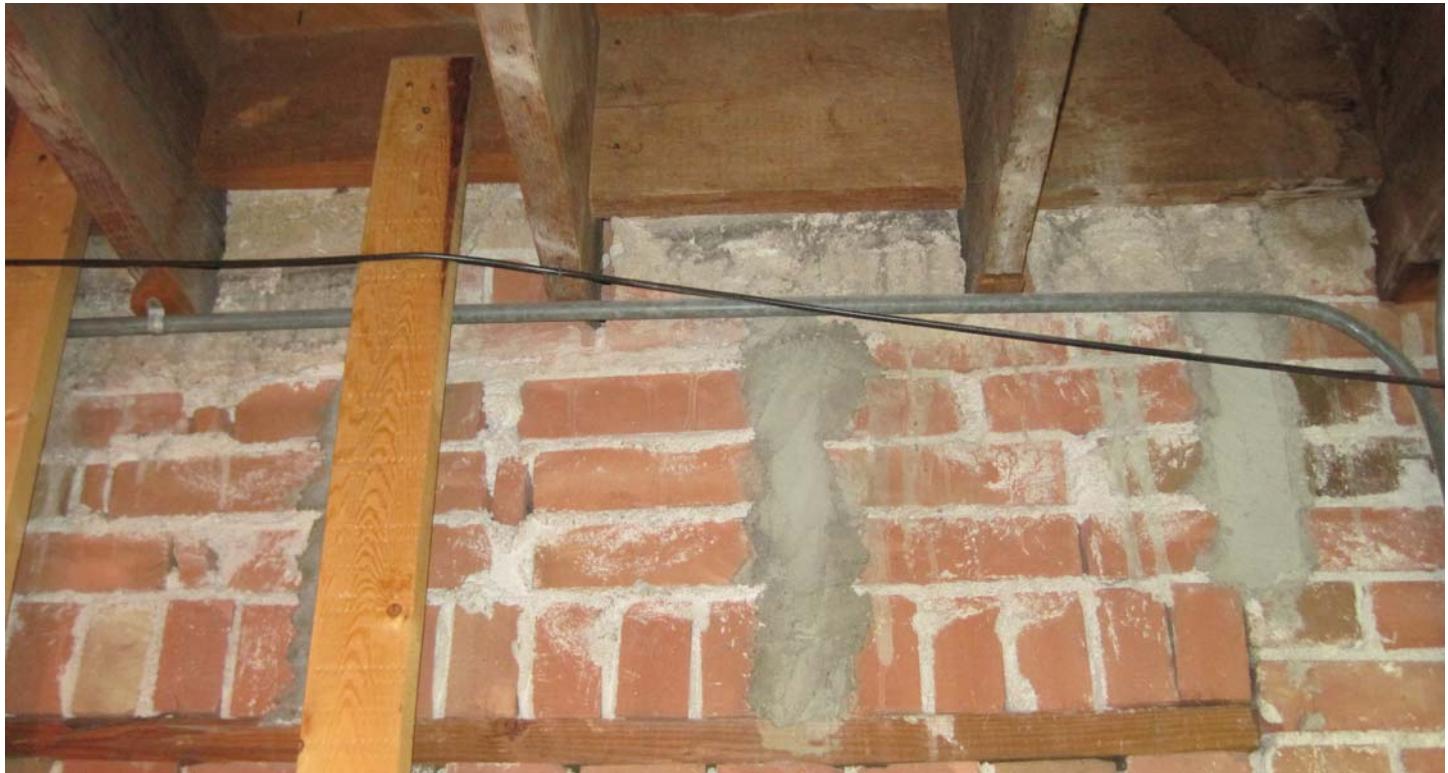
LEL7464 BRICK FOUNDATION WALL IN FAN ROOM SHOWING RETROFITTED FLOOR JOIST CONFIGURATION

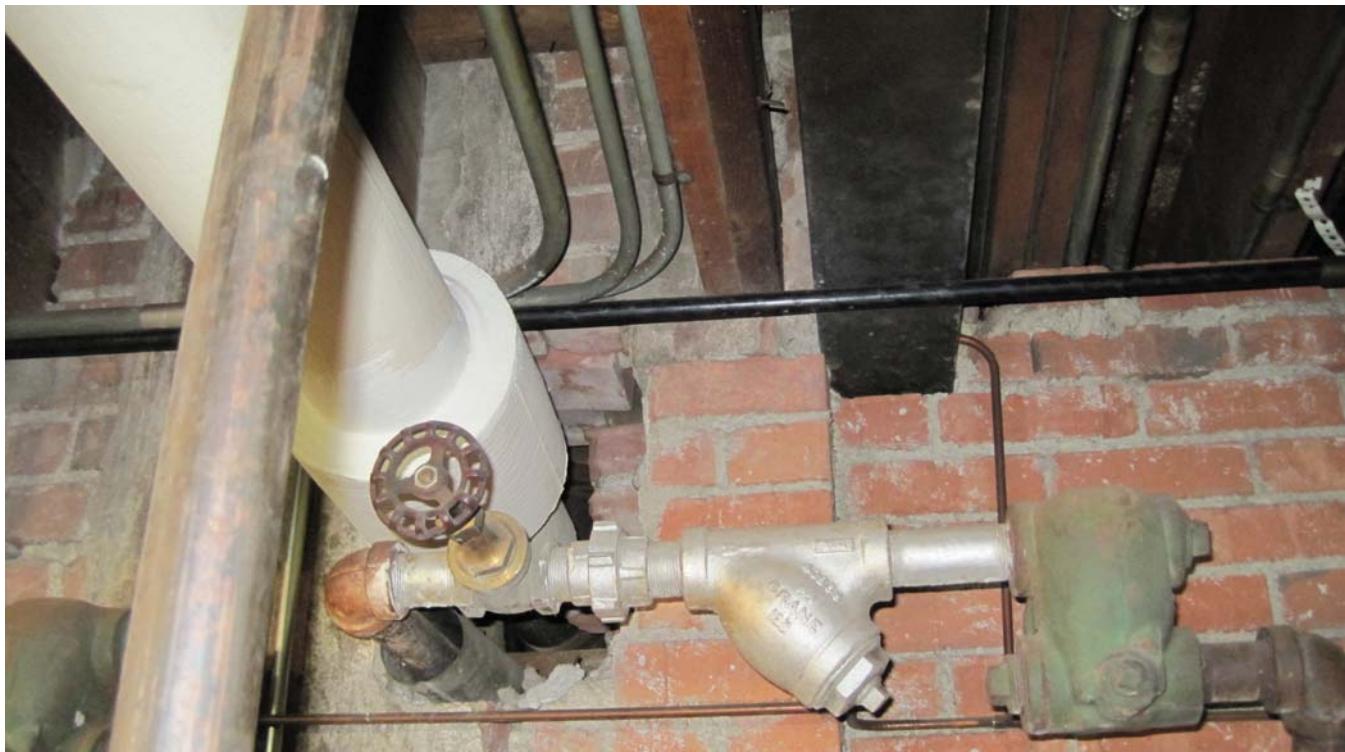
LEL7354 STRUCTURAL SYSTEMS OF STEEL BEAM, WOOD FLOOR JOISTS, AND SUPPORTING MULTI-WYTHE BRICK MASONRY AT EAST WALL IN BASEMENT BOILER ROOM

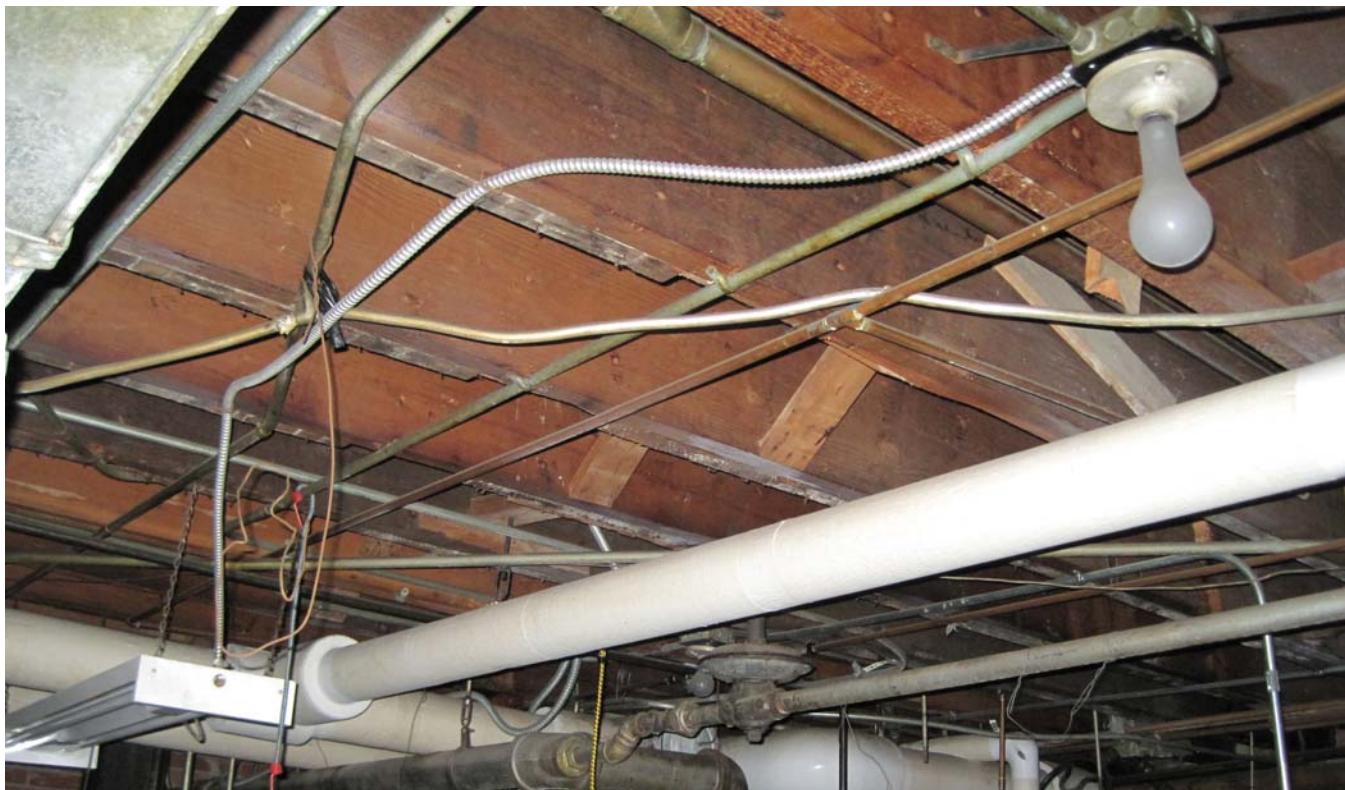
LEL7364 FLOOR JOISTS AND BRACING IN BASEMENT BOILER ROOM

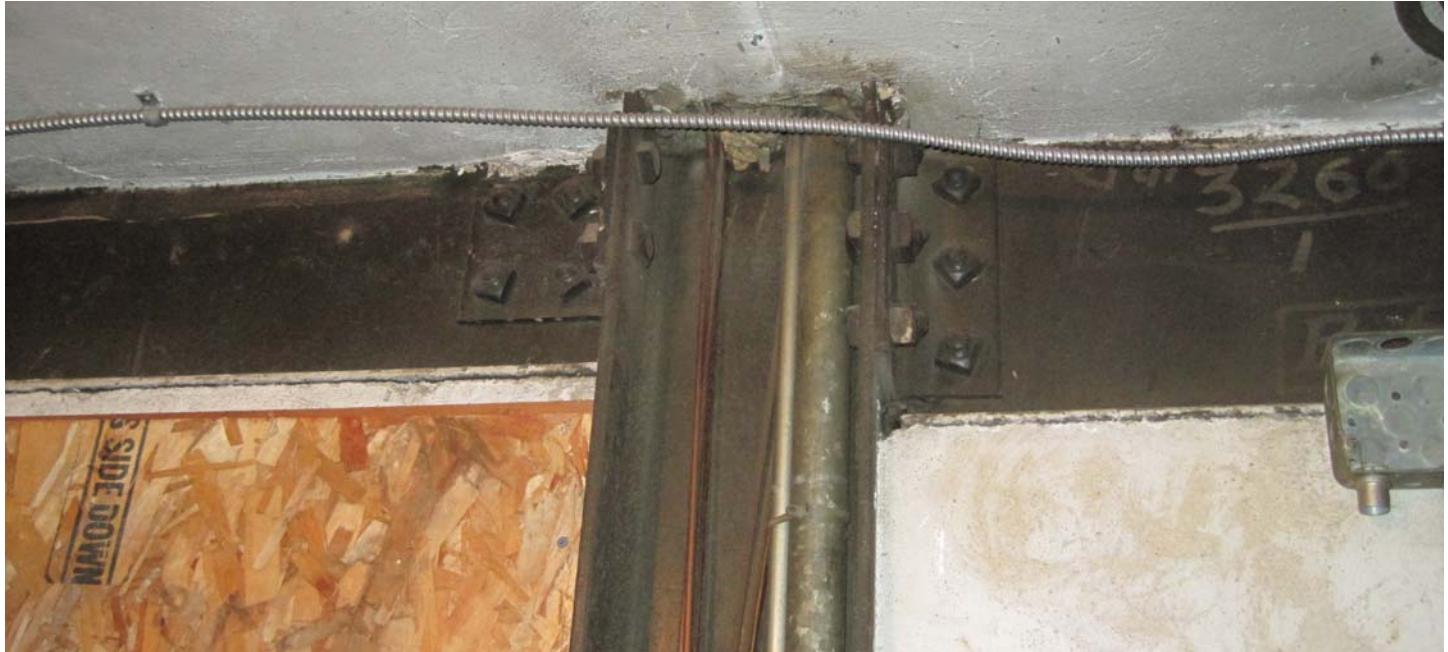
LEL1024 STEEL COLUMN AND BEAMS AT SOUTH WALL OF NORTH MECHANICAL ROOM

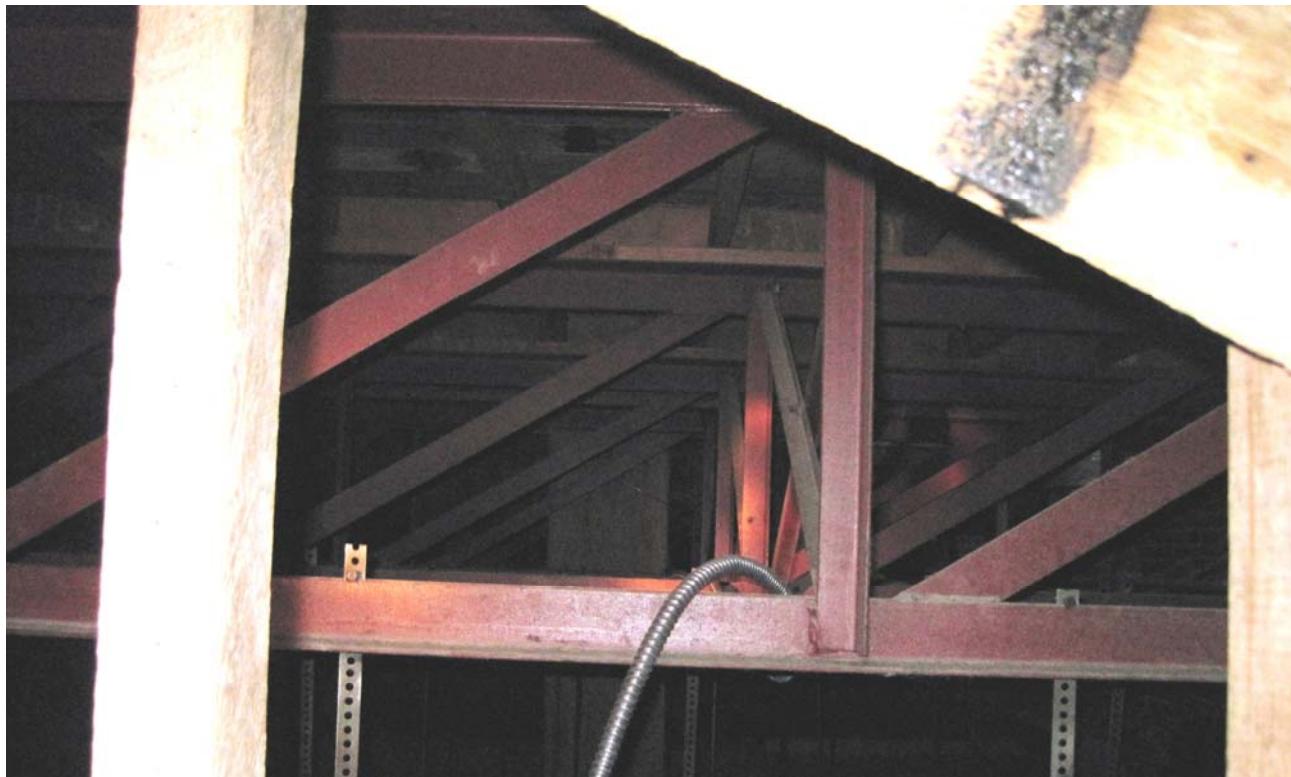
LEL7748 STEEL TRUSSES, WOOD FRAMING, AND STEEL SUPPORT STRAPS ABOVE LODGE ROOM

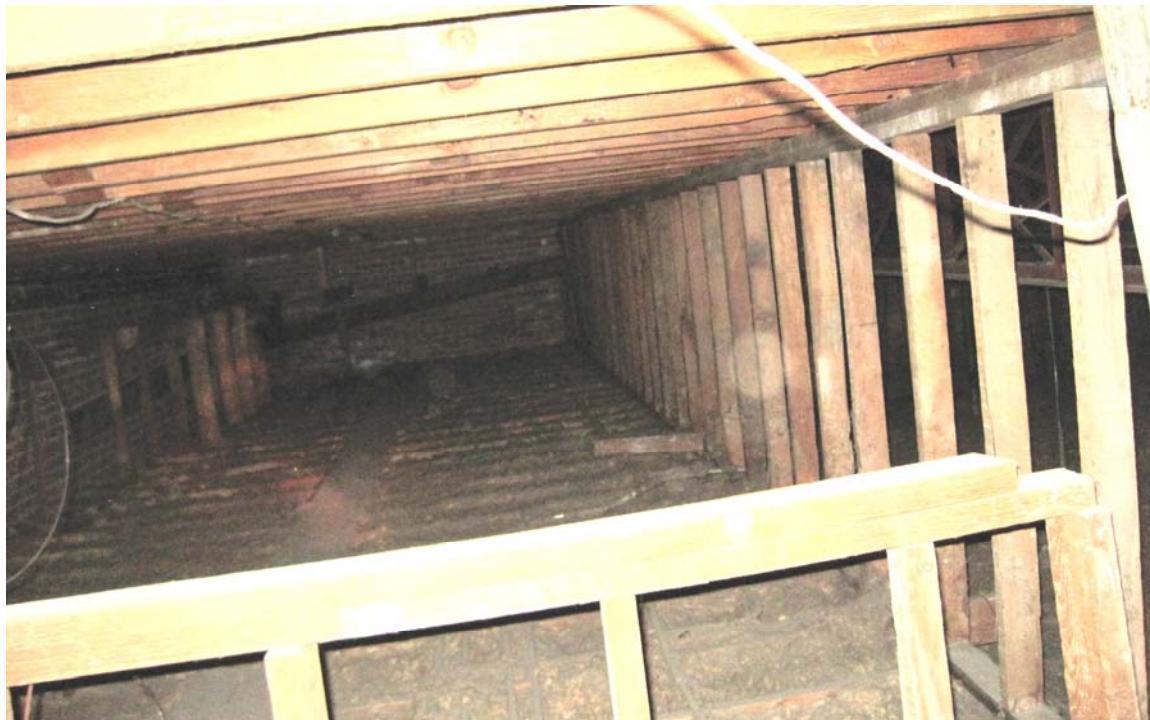
LEL7751 SOUTH ROOF FRAMING WITH EAST WALL AT LEFT, CAMERA FACING SOUTH

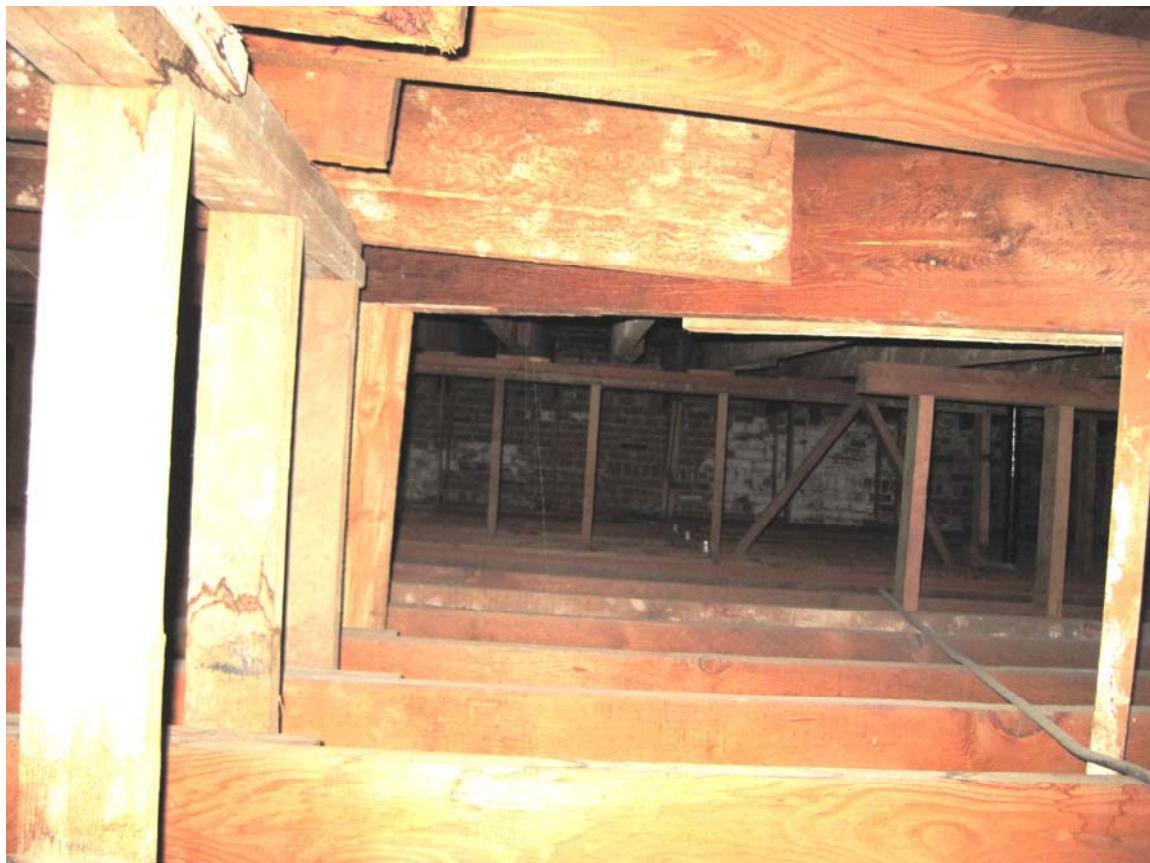
LEL7819 ROOF FRAMING AT WESTERN END OF SOUTH ROOF NEAR LIGHT WELL, CAMERA FACING SOUTH
This project was partially funded by a State Historical Fund Grant from the Colorado Historical Society.

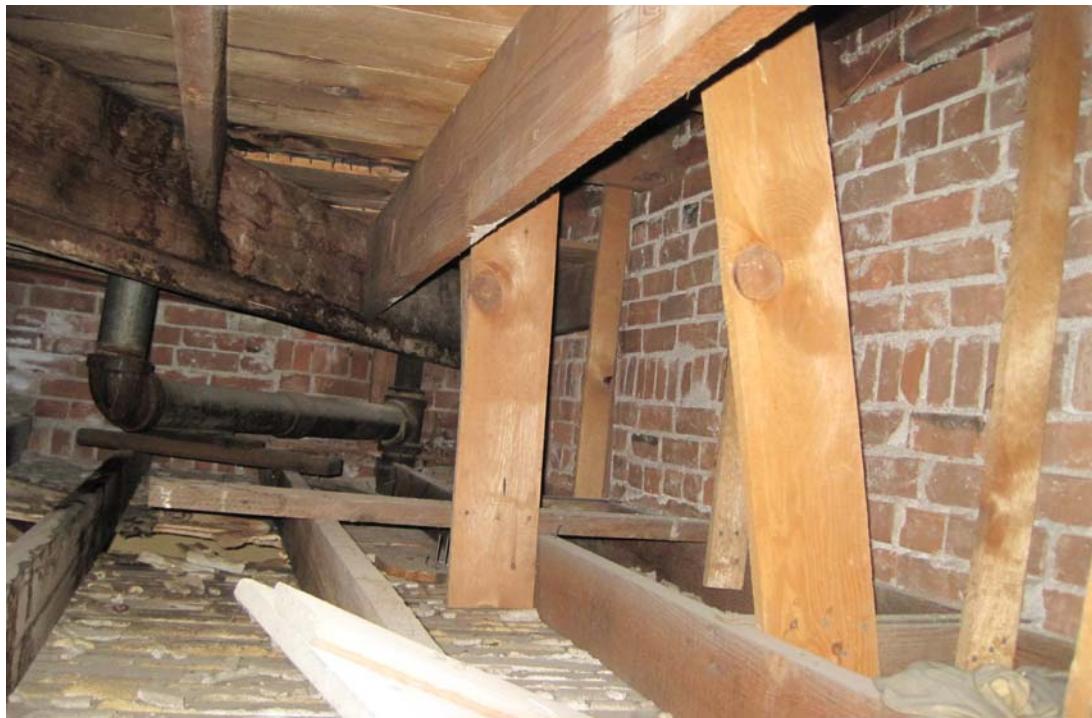
LEL7821 ROOF FRAMING, INTERNAL ROOF DRAIN, AND CEILING FRAMING SOUTH OF LIGHT WELL AT SOUTH ROOF NEAR WEST WALL, CAMERA FACING WEST

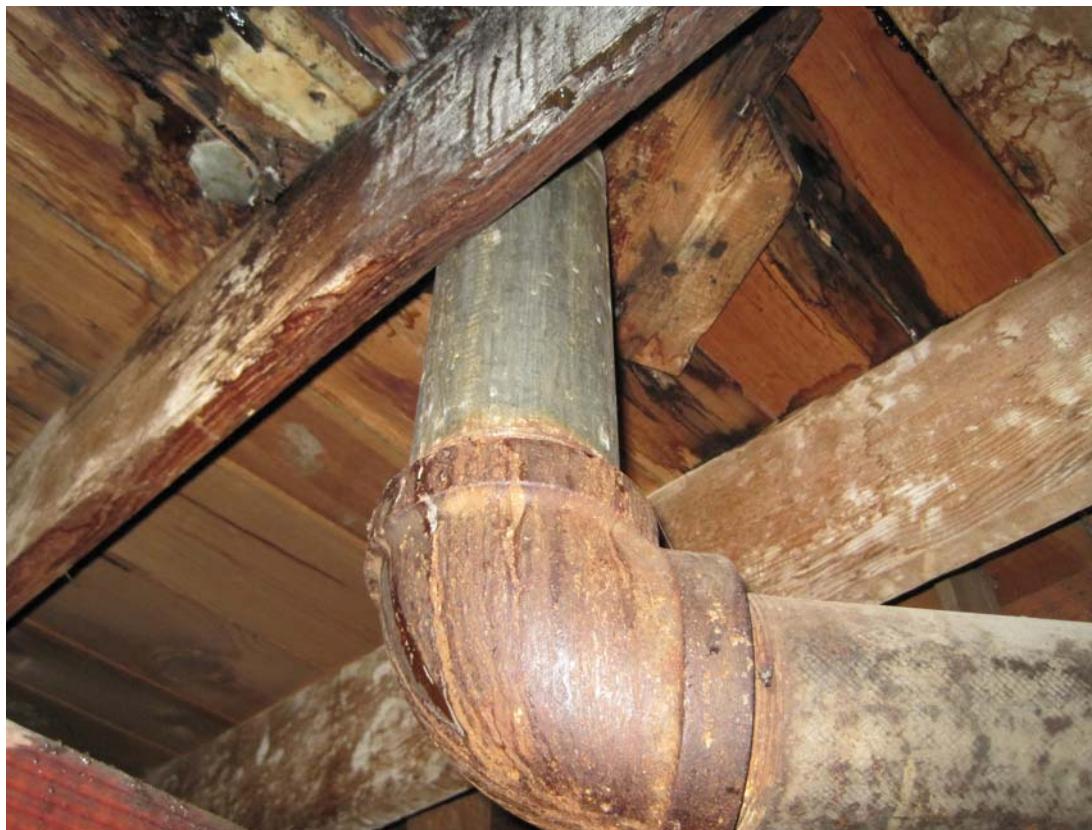
LEL7798 WATER DAMAGE AND INTERNAL ROOF DRAIN NEAR WEST END OF SOUTH ROOF, SOUTH OF LIGHT WELL

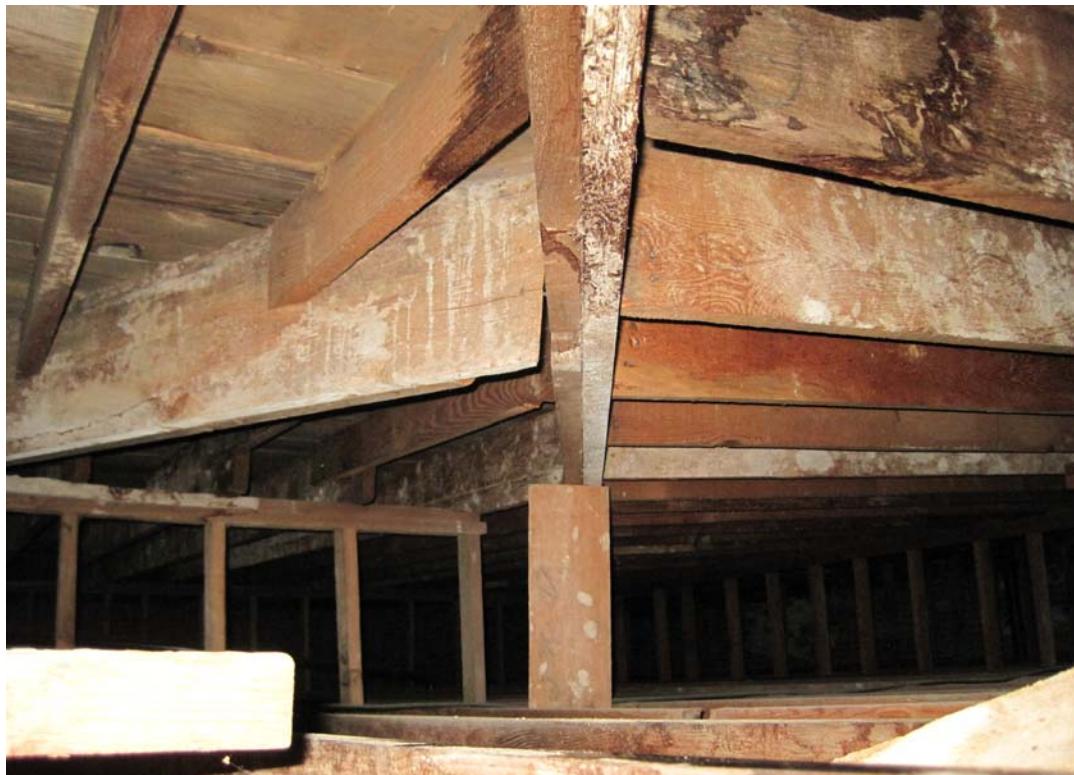
LEL7800 VALLEY BEAM AND ROOF FRAMING OF SOUTH ROOF NEAR LIGHT WELL, CAMERA FACING SOUTHEAST

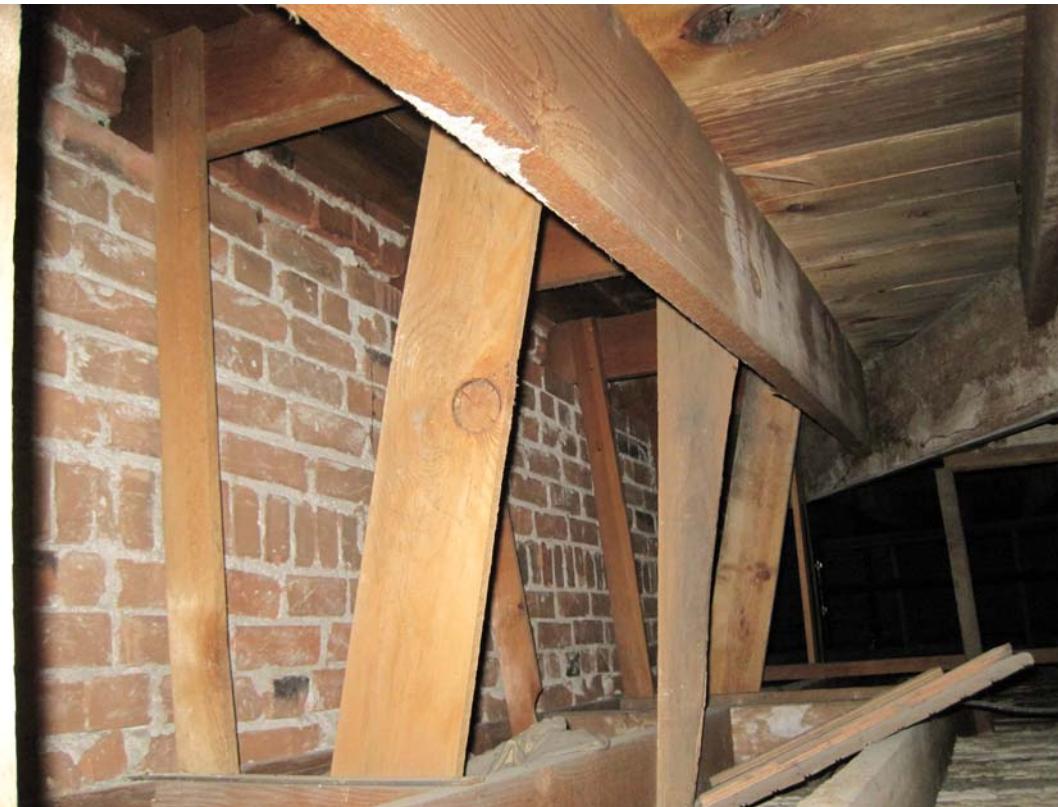
LEL7801 CANTILEVERED CORNICE SUPPORT FRAMING FOR NORTH LIGHT WELL CORNICE ON SOUTH ROOF
This project was partially funded by a State Historical Fund Grant from the Colorado Historical Society.

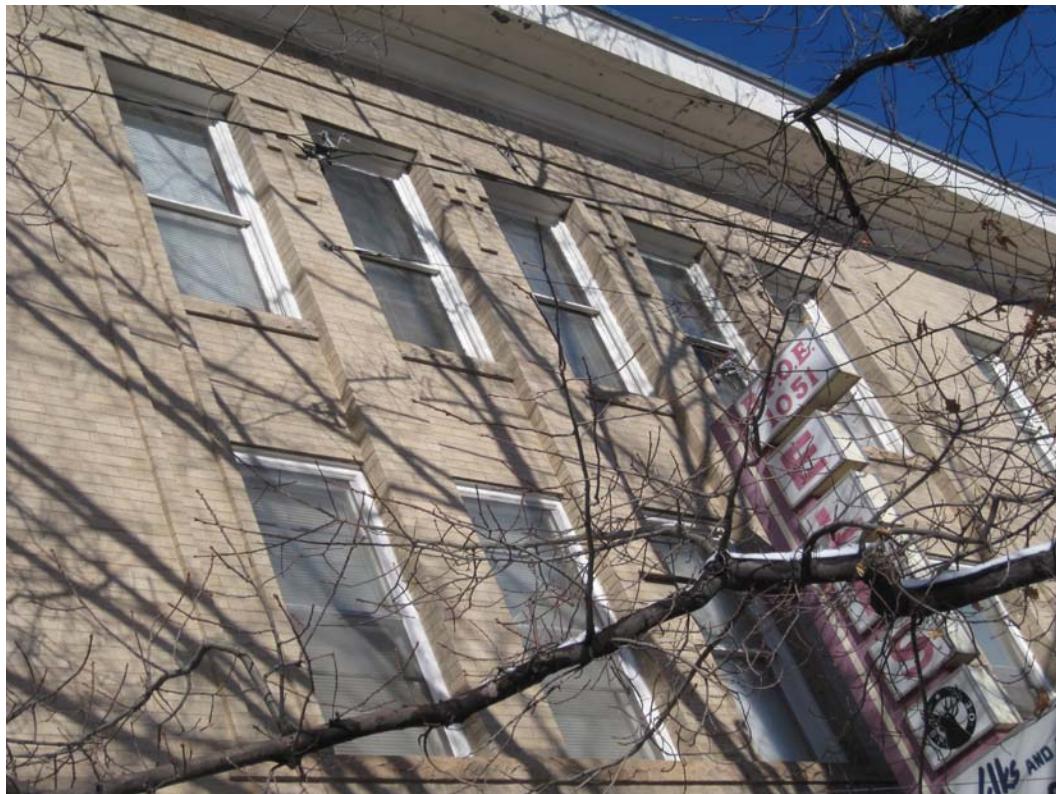
LEL1050 CENTER BANK OF SECOND AND THIRD FLOOR WINDOWS ON UPPER ORIGINAL SOUTH ELEVATION

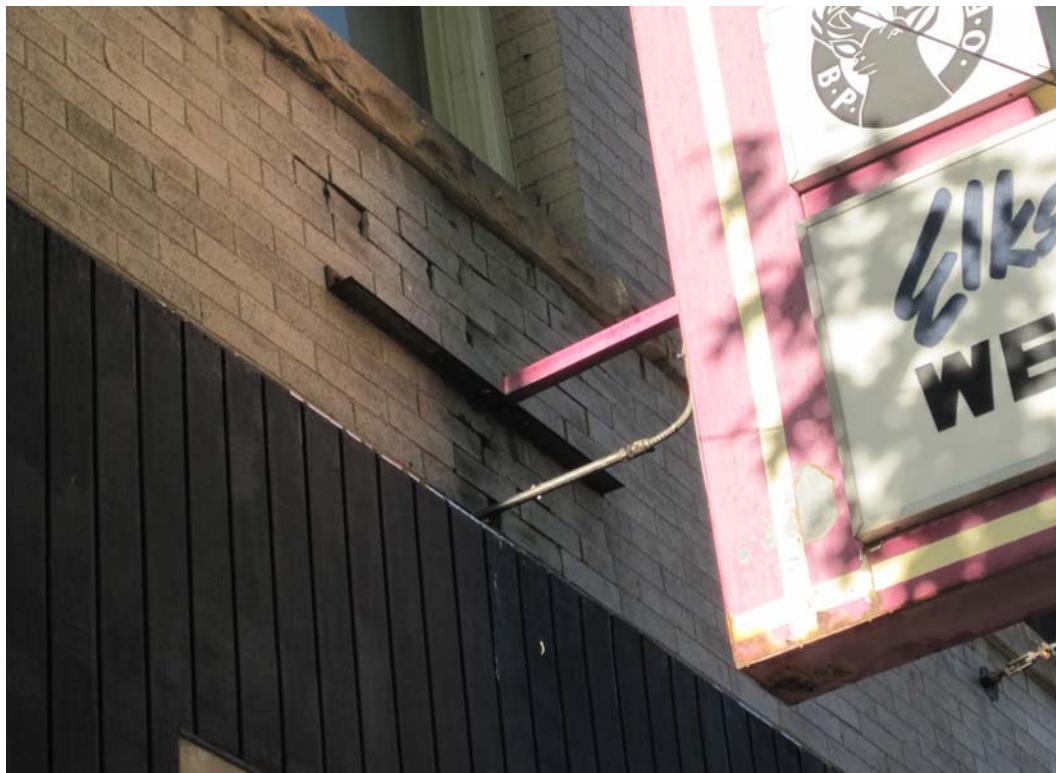
LEL9354 BRICK DAMAGE FROM PRIOR SIGN ATTACHMENT ON SOUTH ELEVATION ABOVE STOREFRONT

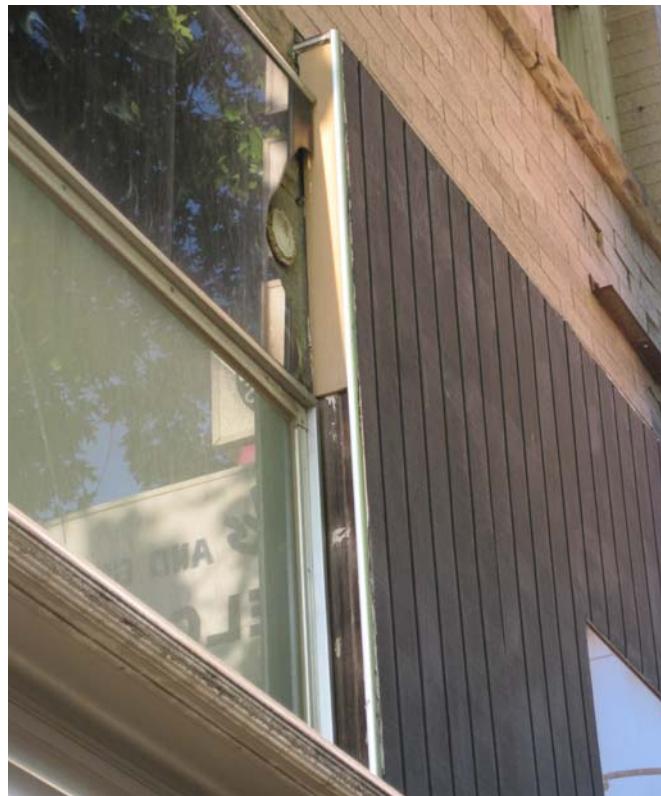
LEL9358 CLOSER VIEW OF CONDITION AT WEST EDGE OF SOUTH ENTRY FURRING
