HISTORIC LOVELAND ELKS LODGE (BPOE #1051) BUILDING

HISTORIC STRUCTURE ASSESSMENT PHOTOS

PAGE NUMBER EC-1	HISTORIC STRUCTURE ASSESSMENT HISTORIC BPOE #1051 BUILDING CHS/SHF #2011-HA-012	EXISTING CONDITIONS PHOTOS PREPARED BY: P. Berglund CHECKED BY: R. S. Beardmore, PE

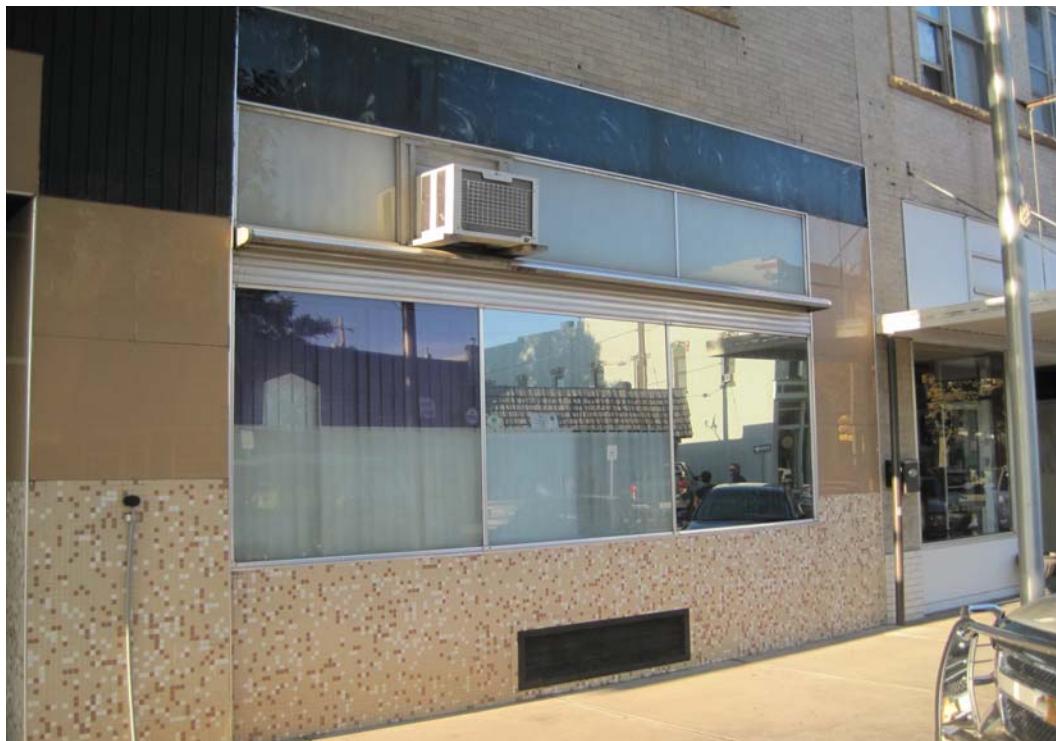
LEL9353 STOREFRONT FINISHES APPLIED TO EAST END OF SOUTH ELEVATION

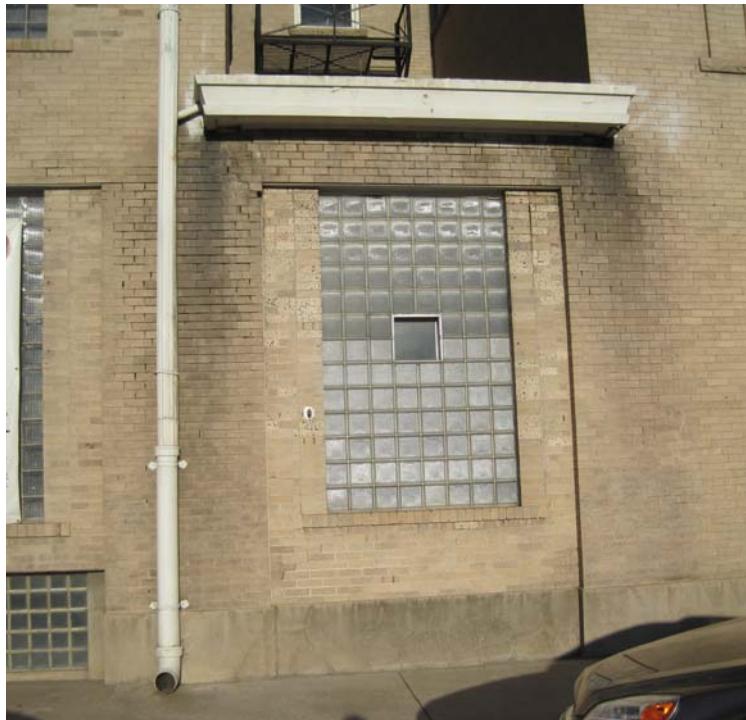
LEL9343 MASONRY DAMAGE FROM OVERFLOW AT EDGES OF FIRST FLOOR ROOF BELOW LIGHT WELL

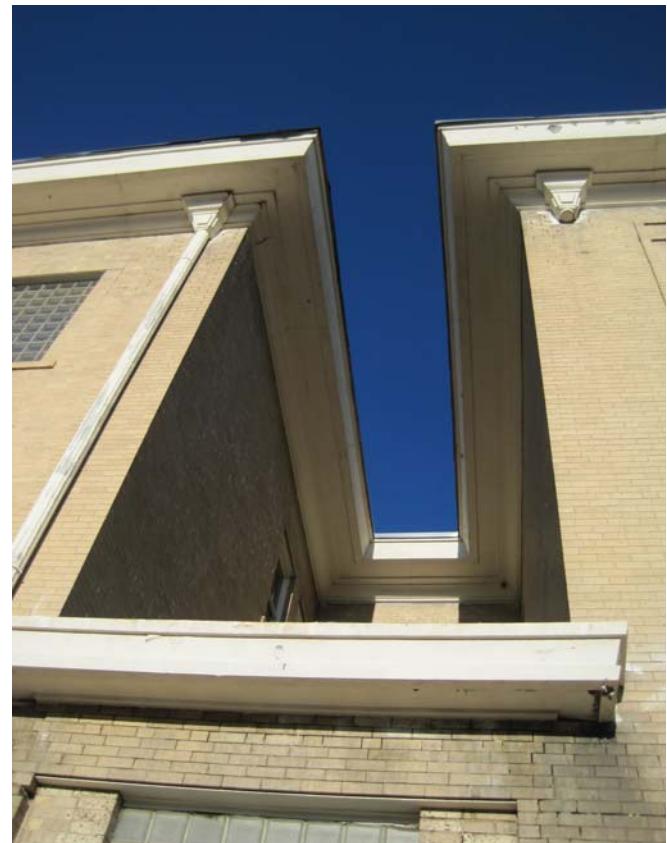
LEL9346 LIGHT WELL SHEET METAL CORNICE

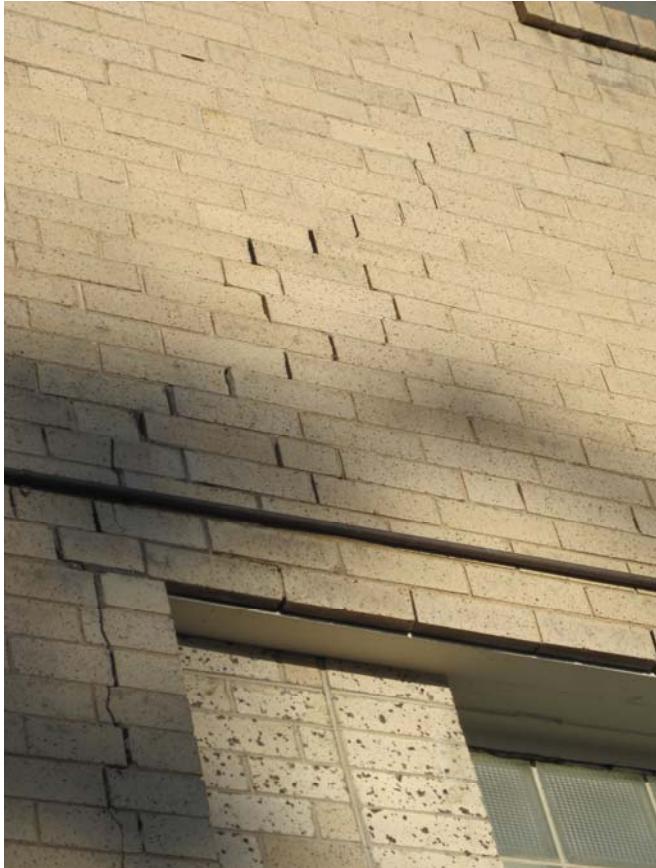
LEL9340 IN-PLANE CORBEL PATTERN CRACKING ABOVE NORTH END OF FOURTH WINDOW FROM THE NORTH ON THE WEST ELEVATION

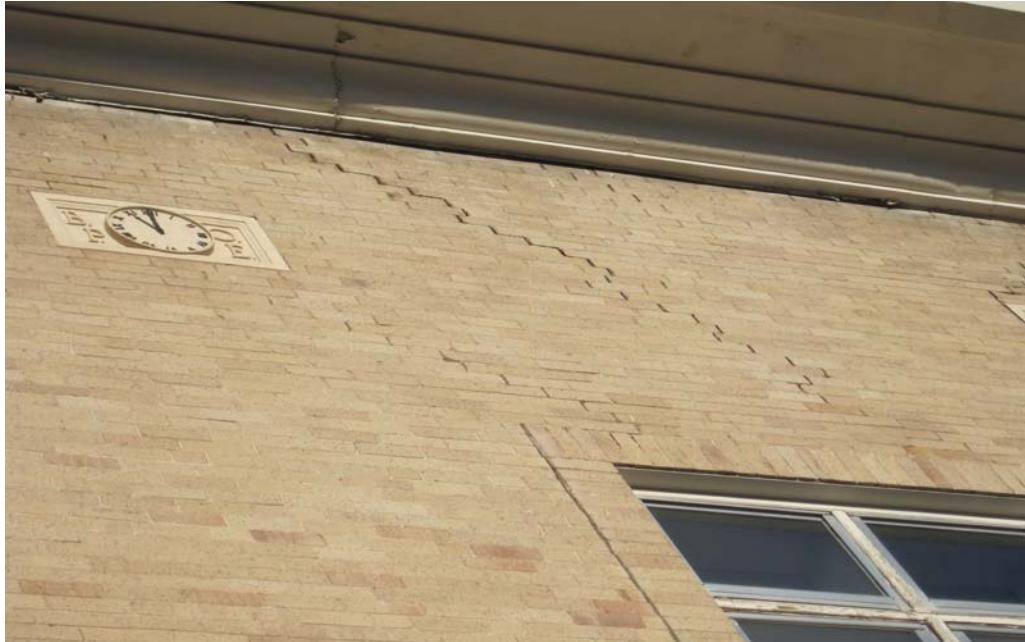
LEL9335 IN-PLANE CORBEL PATTERN CRACKING ABOVE NORTH END OF NORTH WINDOW ON WEST ELEVATION

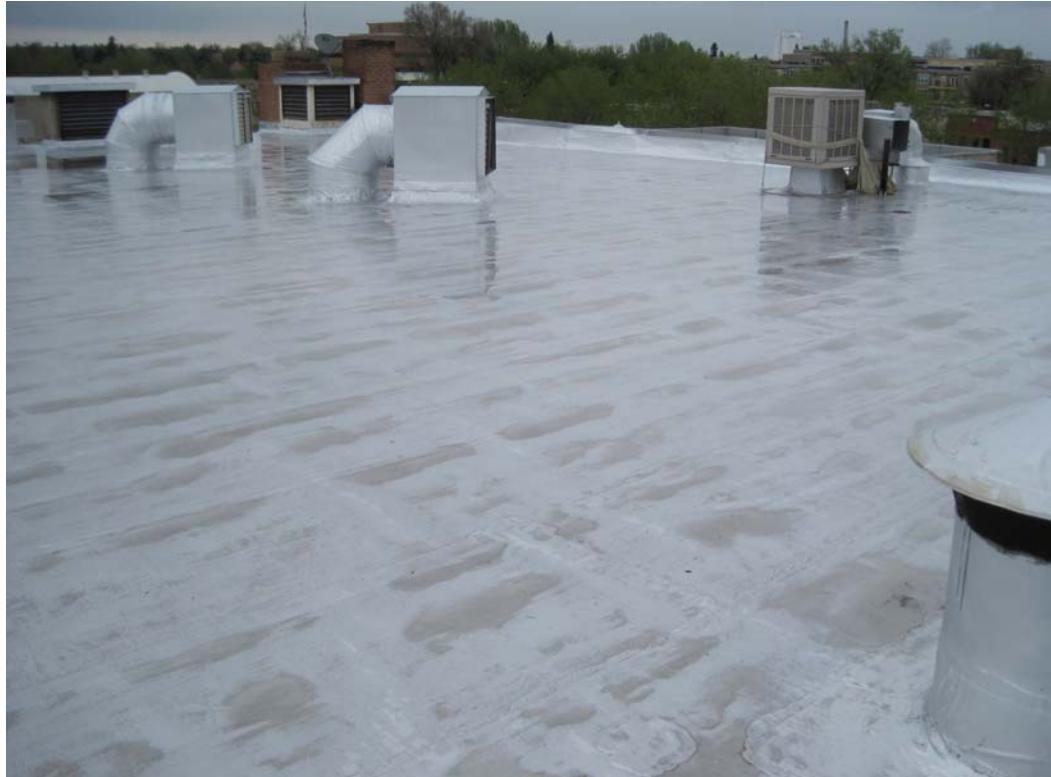
LEL7718 OVERVIEW PHOTO OF NORTH ROOF, FROM SOUTHWEST CORNER CAMERA FACING NORTHEAST

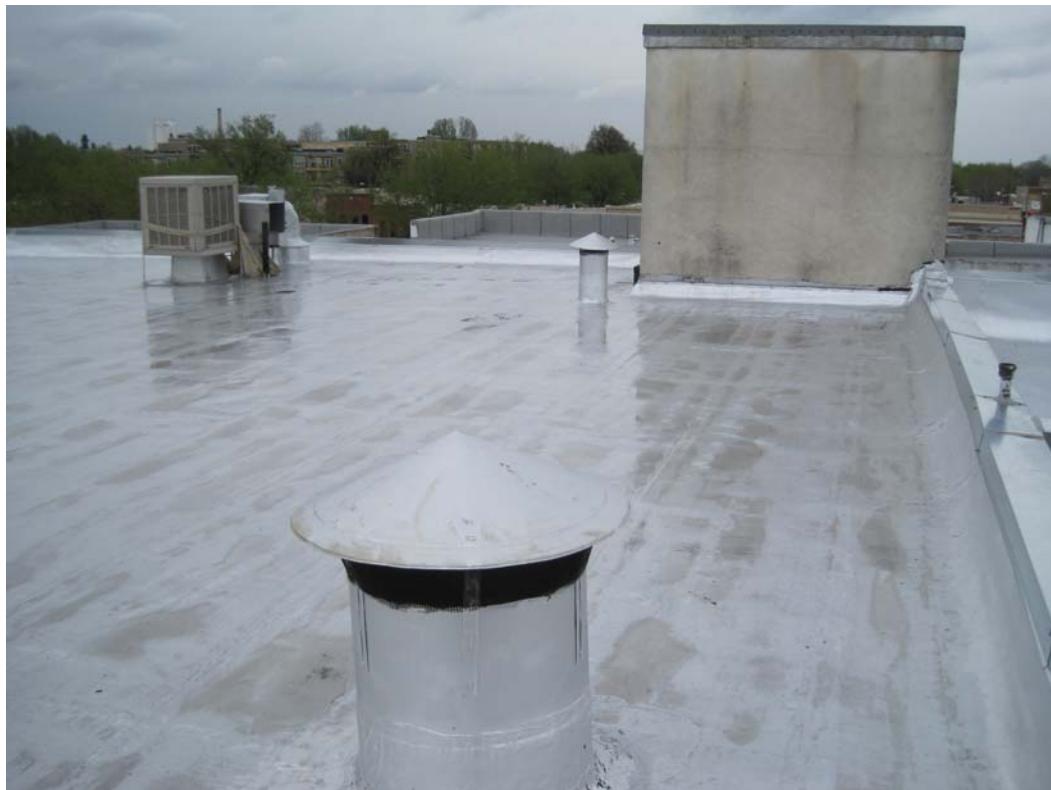
LEL7719 SOUTH END OF NORTH ROOF WITH ELEVATOR ENCLOSURE AT RIGHT, CAMERA FACING EAST

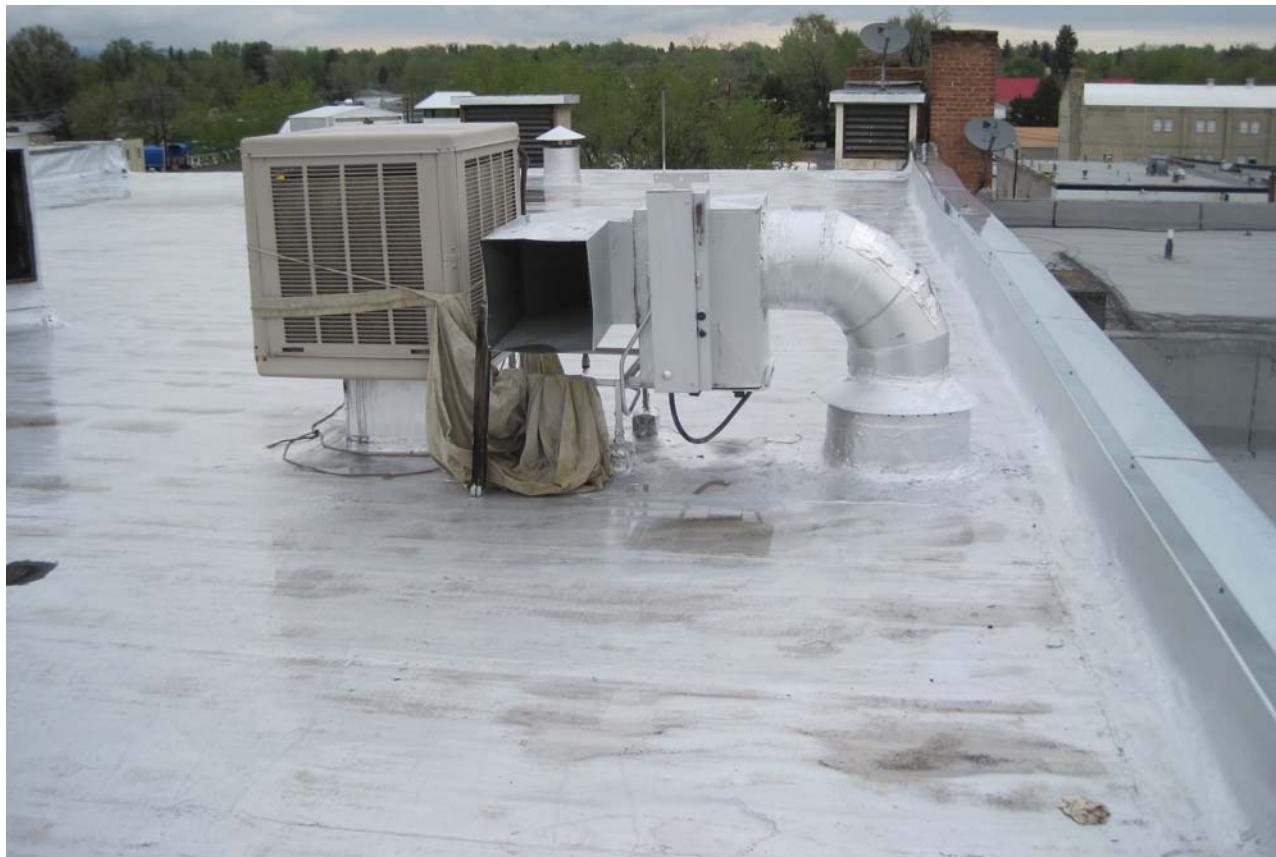
LEL7699 VIEW OF EAST EDGE OF NORTH ROOF, CHIMNEY AND VENT CHASE AT RIGHT SIDE BACKGROUND, CAMERA FACING NORTH

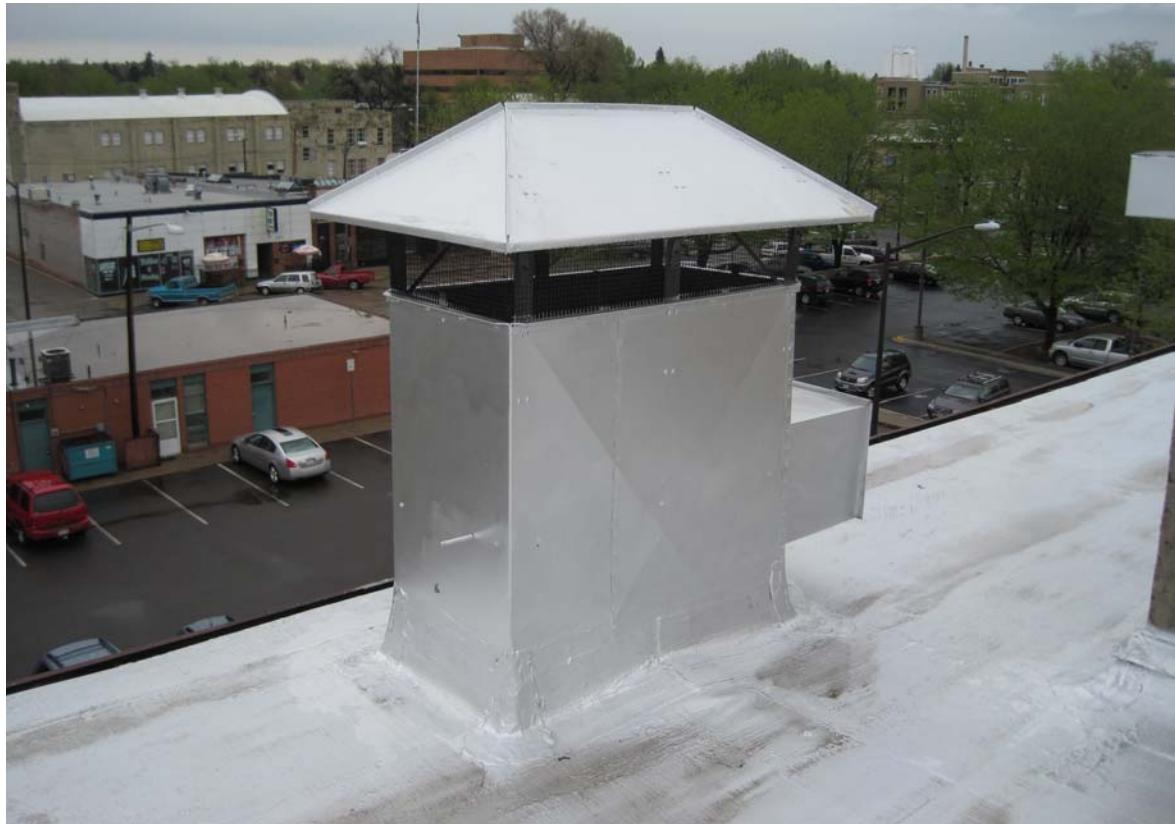
LEL7732 VENTILATION CHASE AT CENTRAL NORTH END OF ROOF

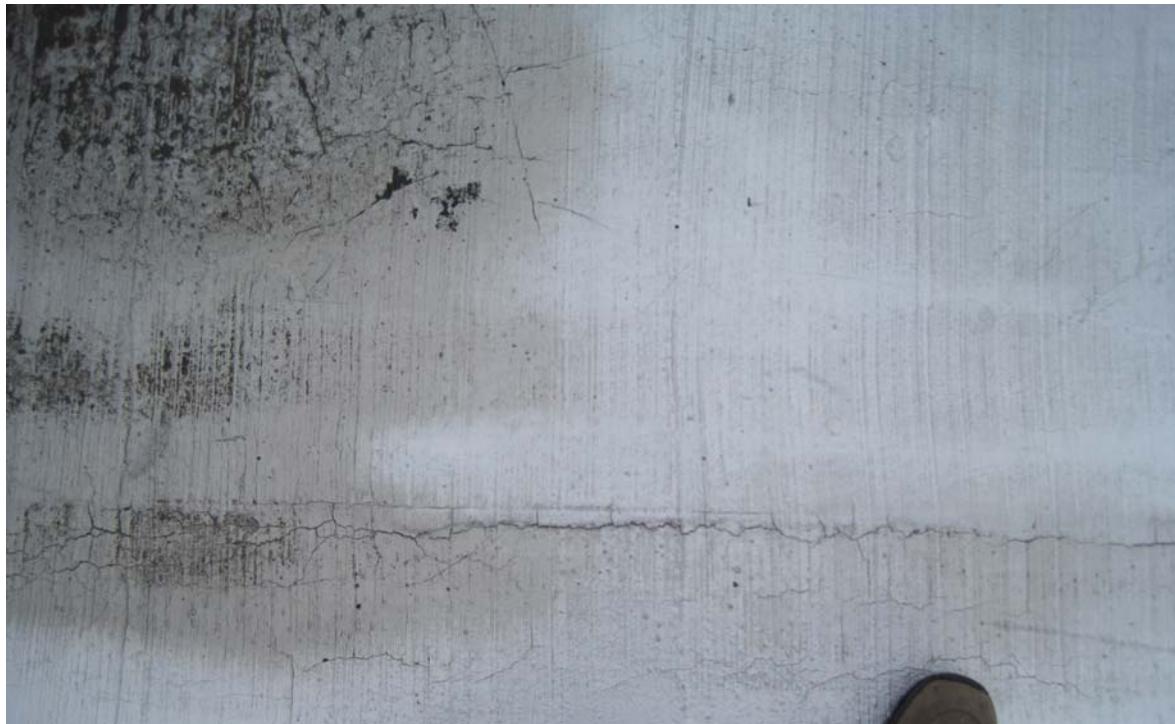
LEL7733 CONDITION OF ROOFING OF NORTH ROOF

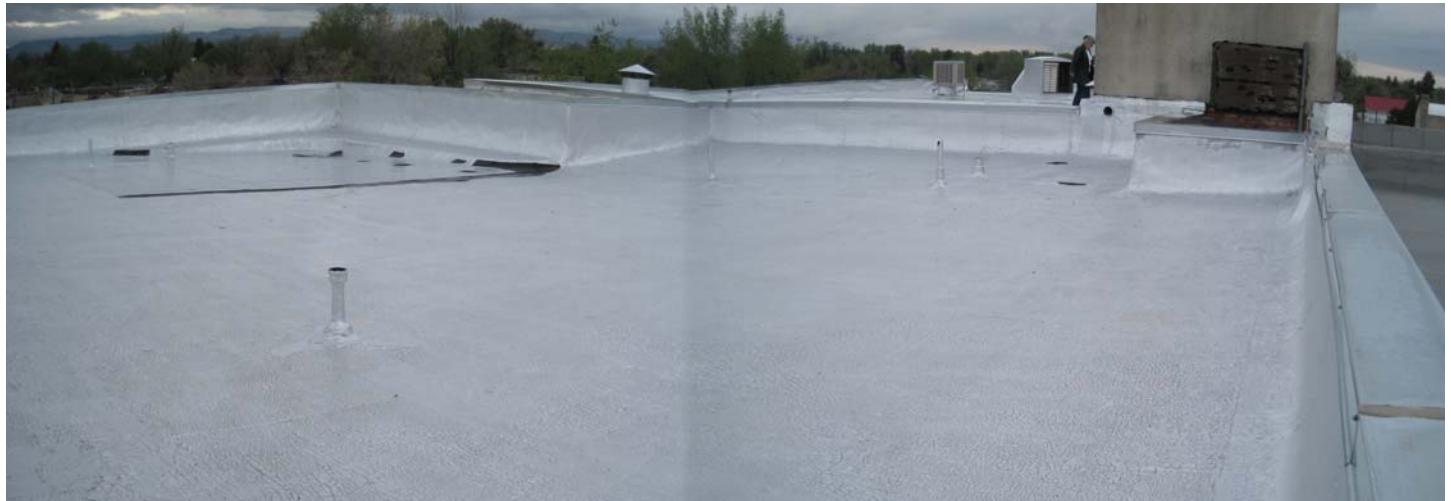
LEL7704 PANORAMA OF NORTH END OF SOUTH ROOF

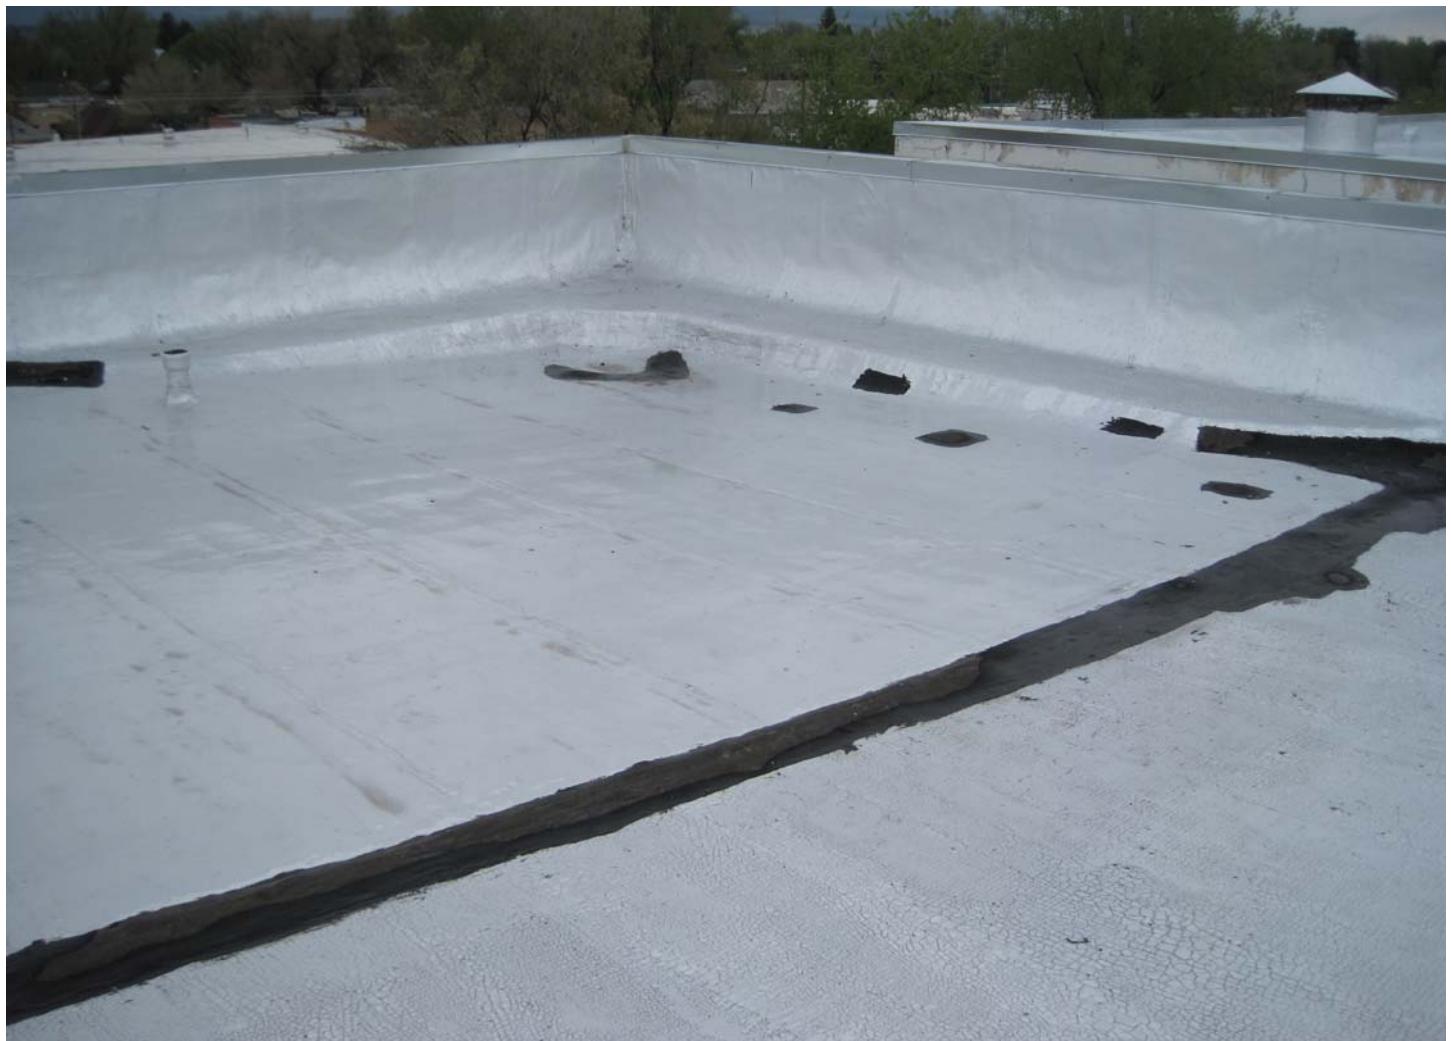
LEL7705 AREA OF PONDING, INTERIOR DRAIN, AND ROOF LEAKS (NOTE MULTIPLE PATCHES) AT NORTHWEST CORNER OF SOUTH ROOF, SOUTH OF LIGHT WELL

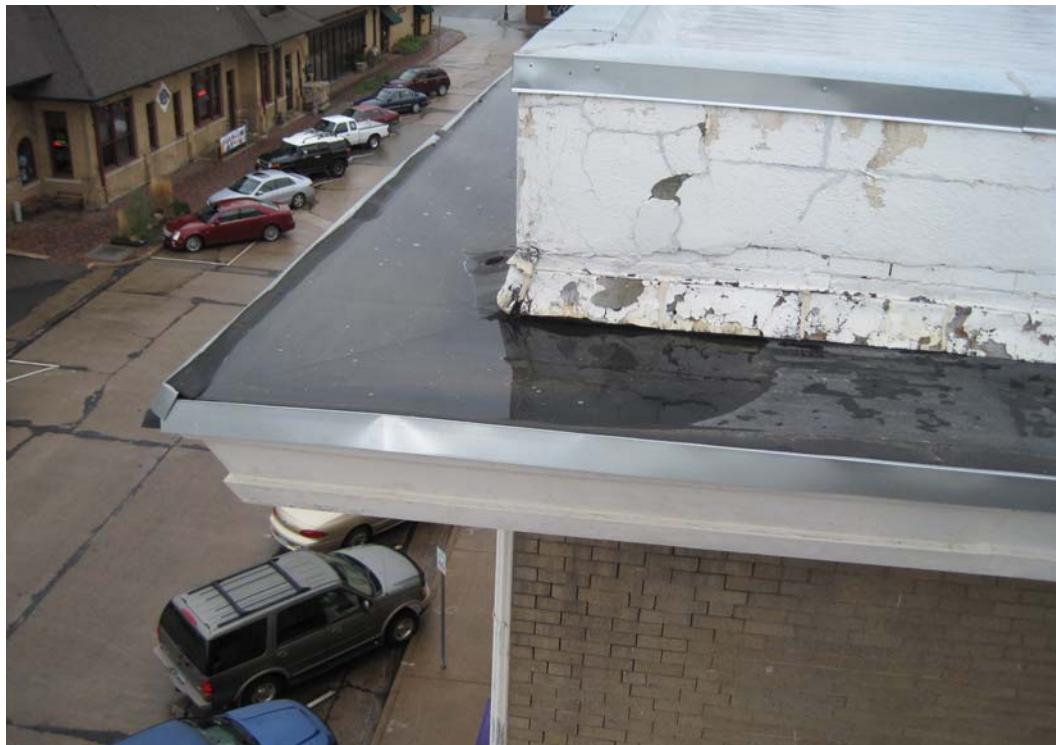
LEL7707 SOUTHWEST CORNER OF NORTH ROOF AT LIGHT WELL SHOWING SHEET METAL PARAPET CAP, PARAPET, MEMBRANE COVERED INTEGRAL GUTTER, SHEET METAL CORNICE, AND BRICK MASONRY

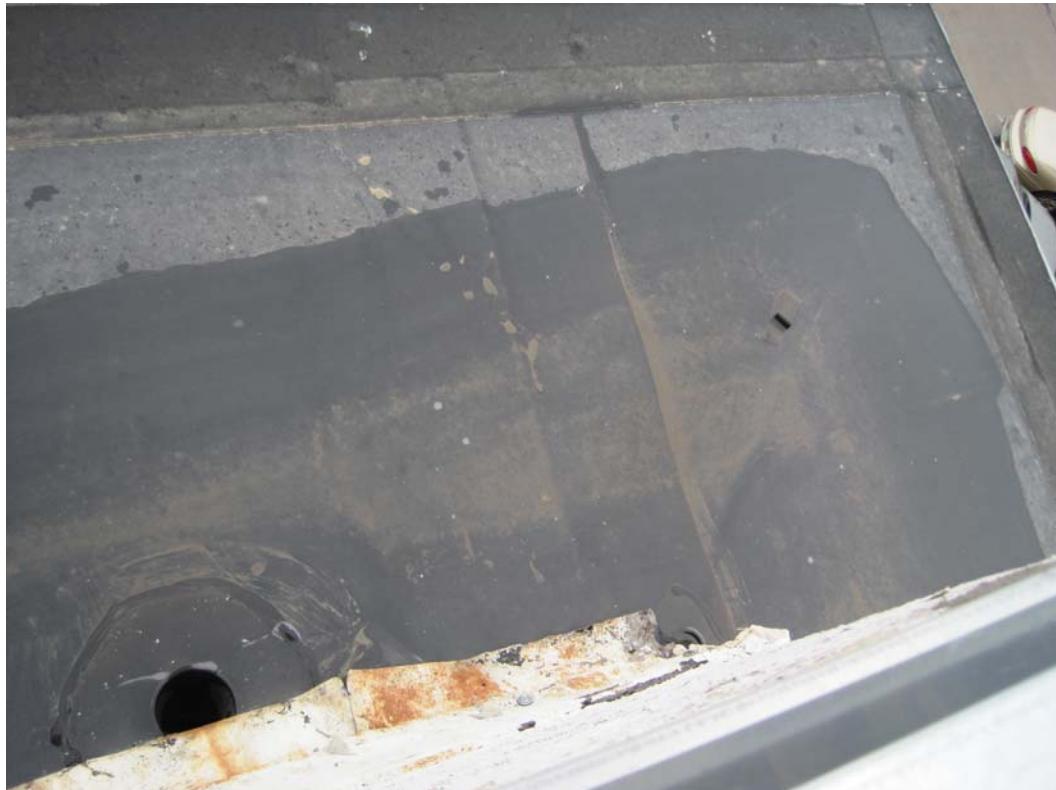
LEL7706 MEMBRANE COVERED INTEGRAL GUTTER AT WEST SIDE OF NORTHWEST CORNER OF SOUTH ROOF

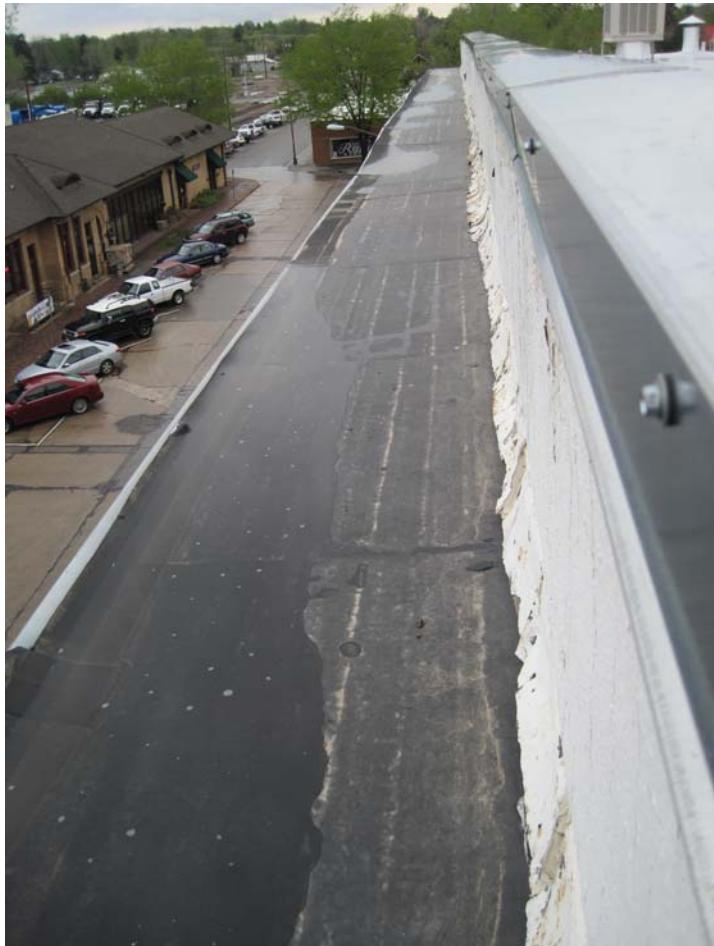
LEL7715 COVERED INTEGRAL GUTTER OF SHEET METAL CORNICE ON WEST ELEVATION

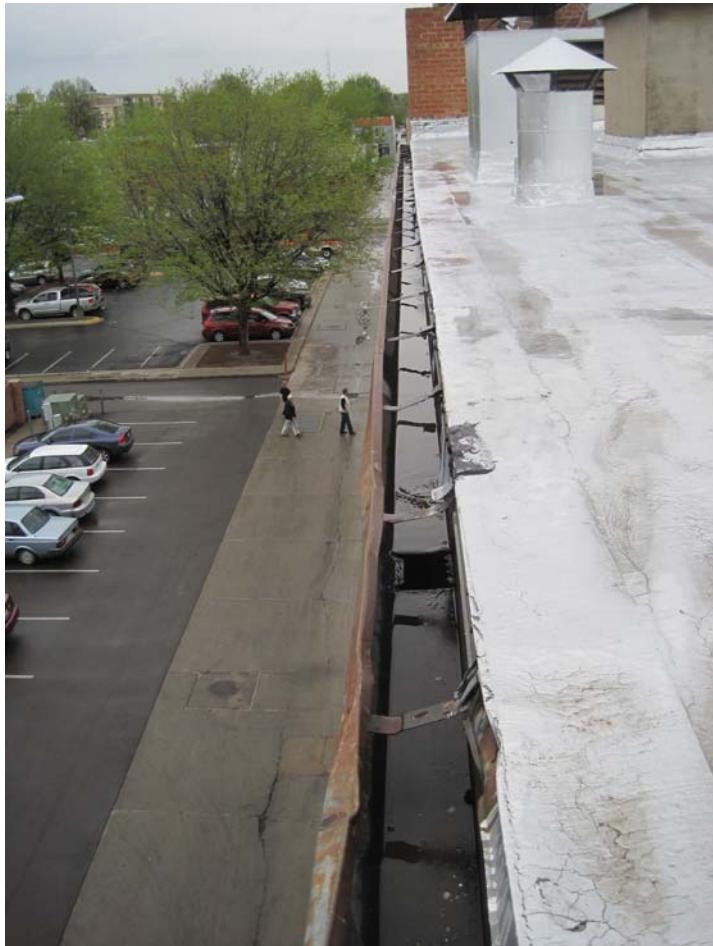
LEL7726 BOX GUTTER AT NORTH EDGE OF NORTH ROOF

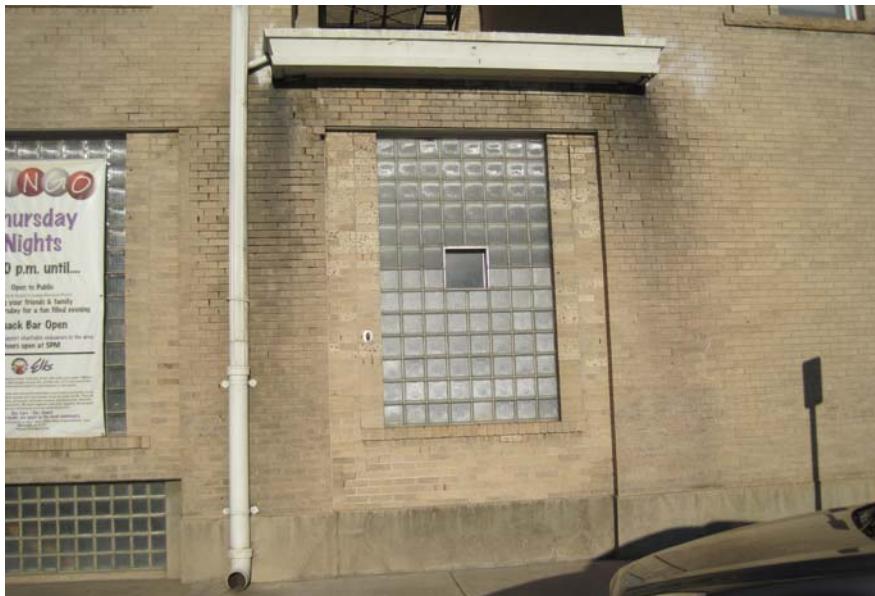
LEL9343 CORNICE WITH INTEGRAL GUTTER ON ROOF BELOW LIGHT WELL (NOTE EROSION AND BRICK STAINING)

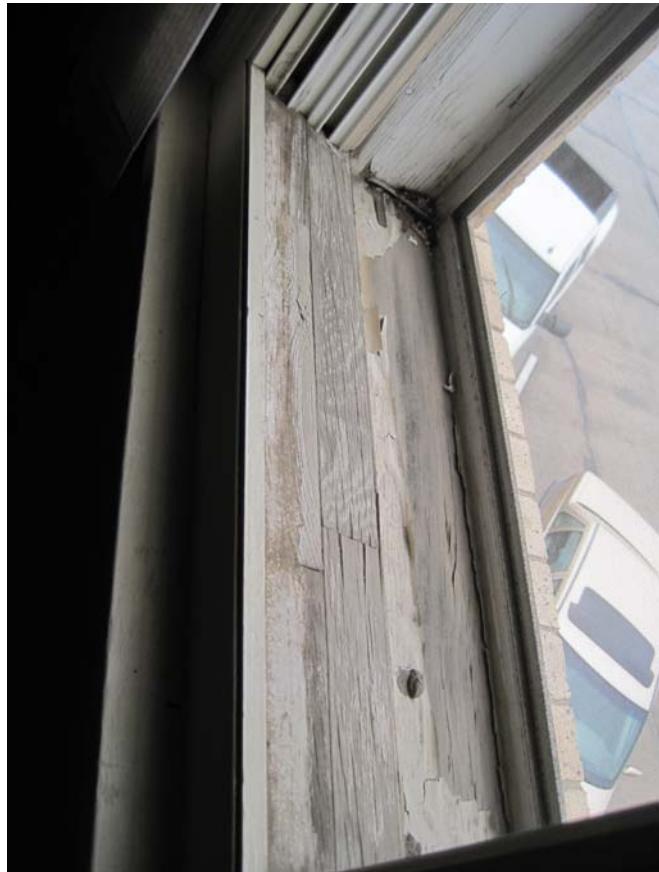
LEL7612 SILL CONDITION OF LODGE ROOM WINDOW

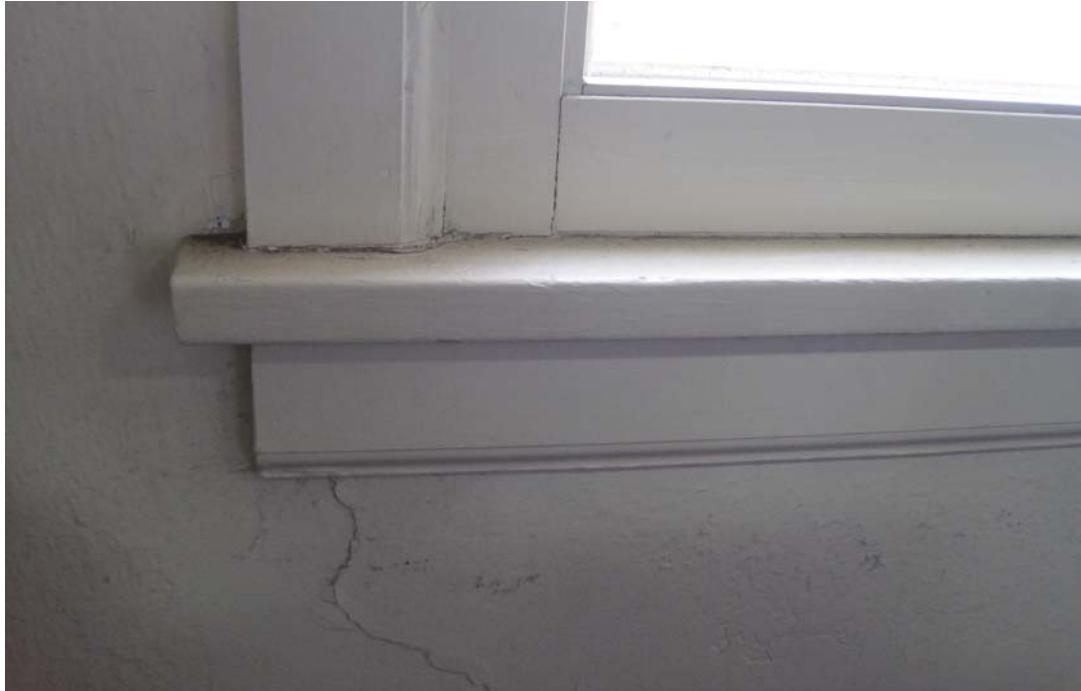
LEL7614 INTERIOR TRIM OF LODGE ROOM WINDOW

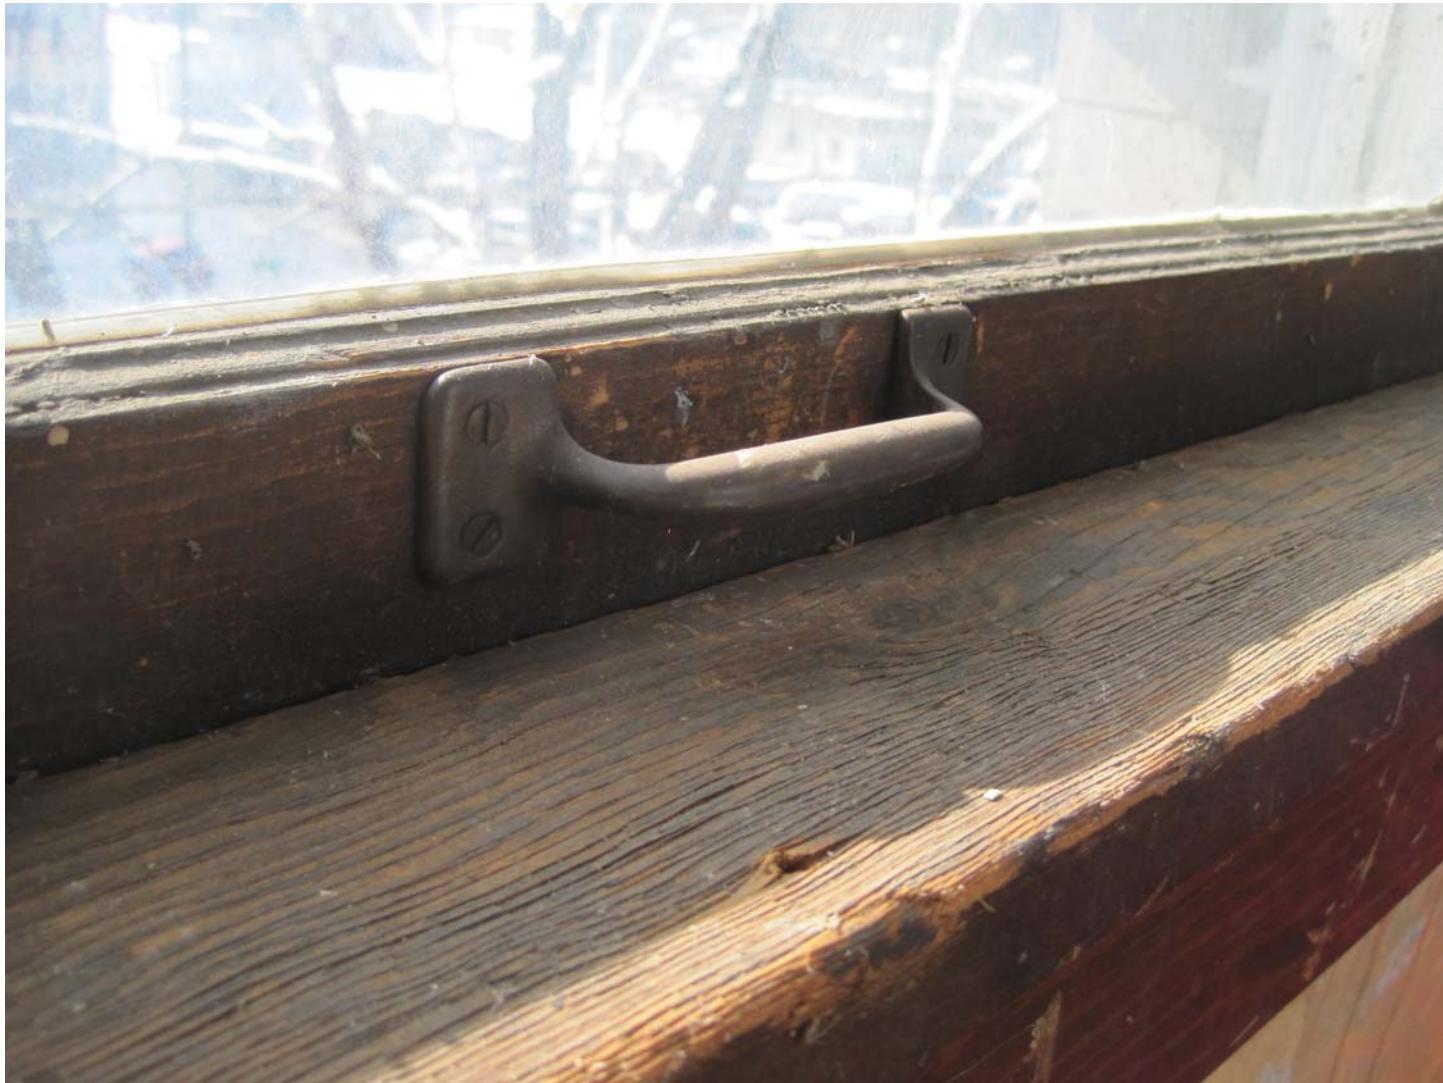
LEL0995 SASH PULL ON ORIGINAL SOUTH WINDOW, AND ADJACENT ORIGINAL FINISHES CONDITION

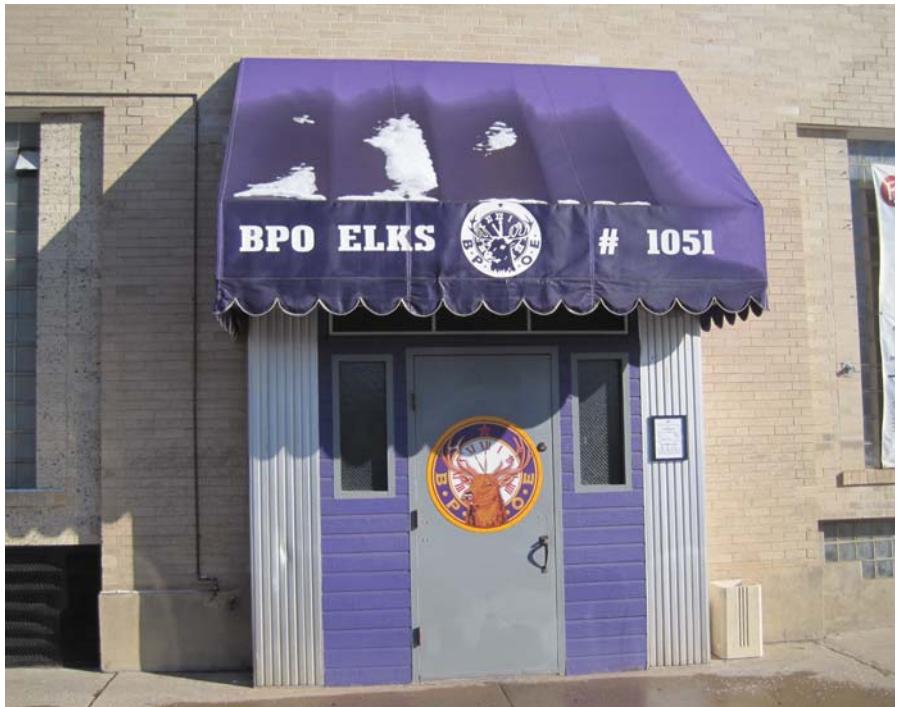
LEL1059 WEST ENTRANCE DOOR WITH HISTORIC ALUMINUM TRIM

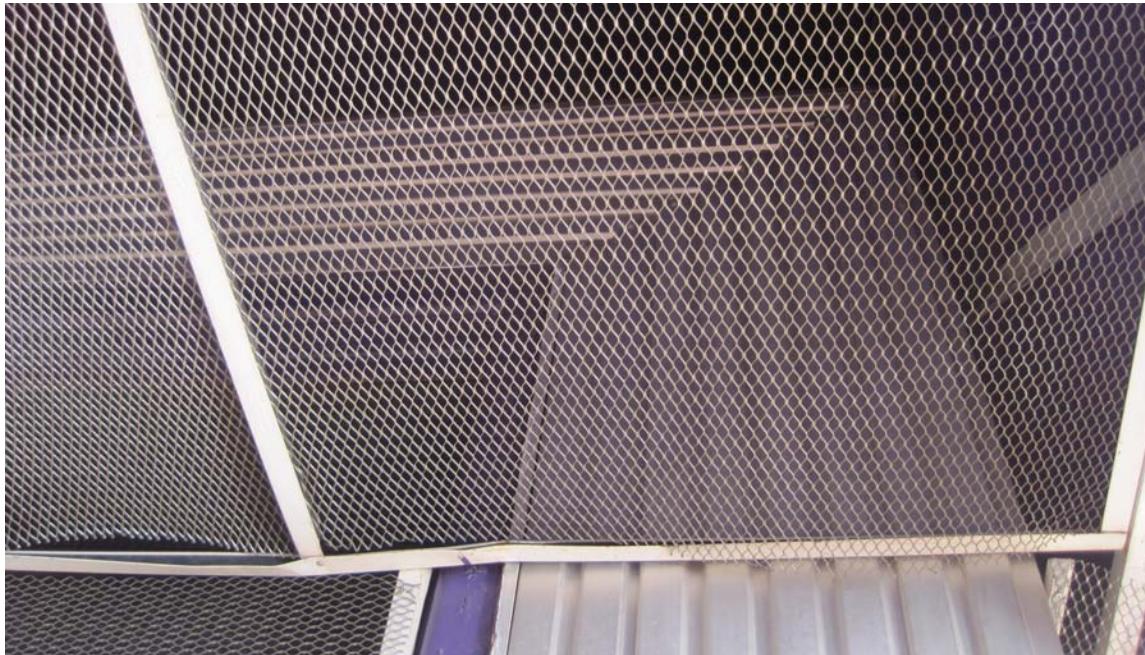
LEL1061 VIEW OF MILL FINISH ALUMINUM TRIM OF WEST DOOR EXTENDING INTO SCREENED AWNING SPACE

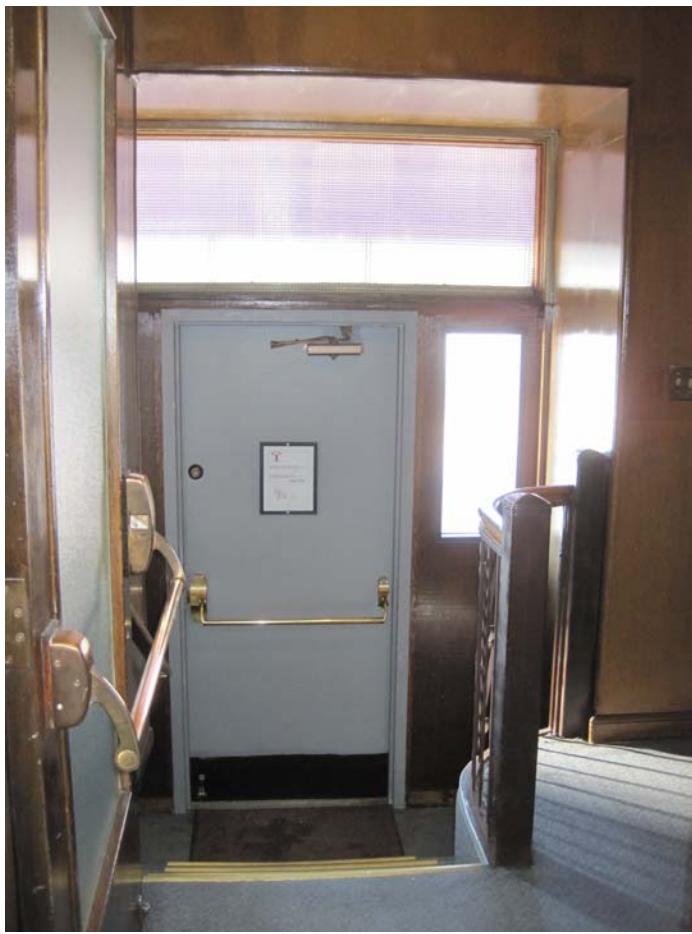
LEL1039 INTERIOR OF WEST EXTERIOR DOOR

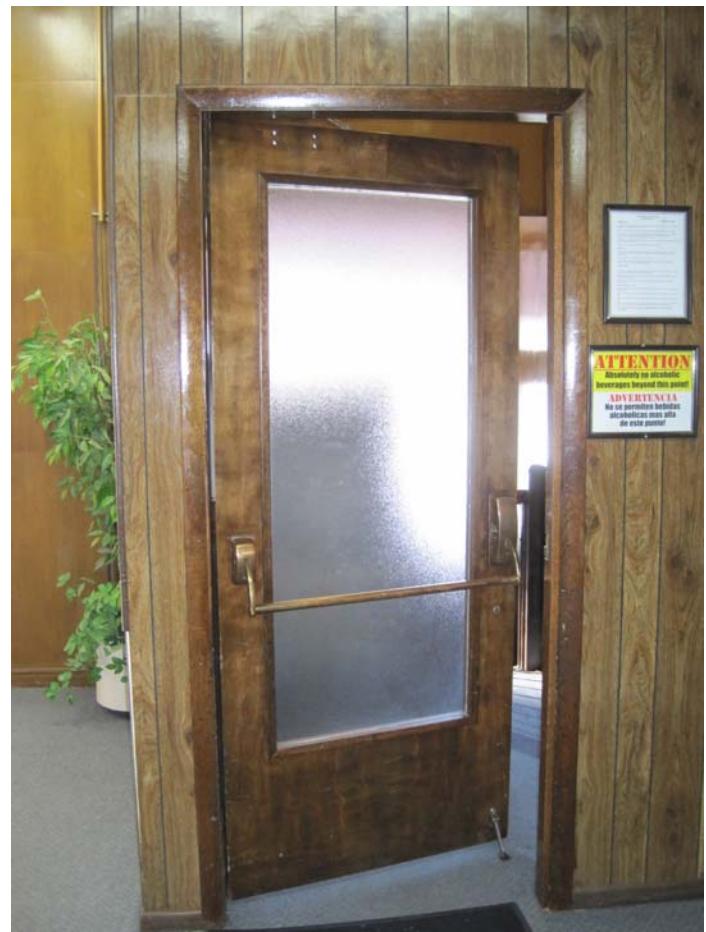
LEL1040 WEST VESTIBULE DOOR

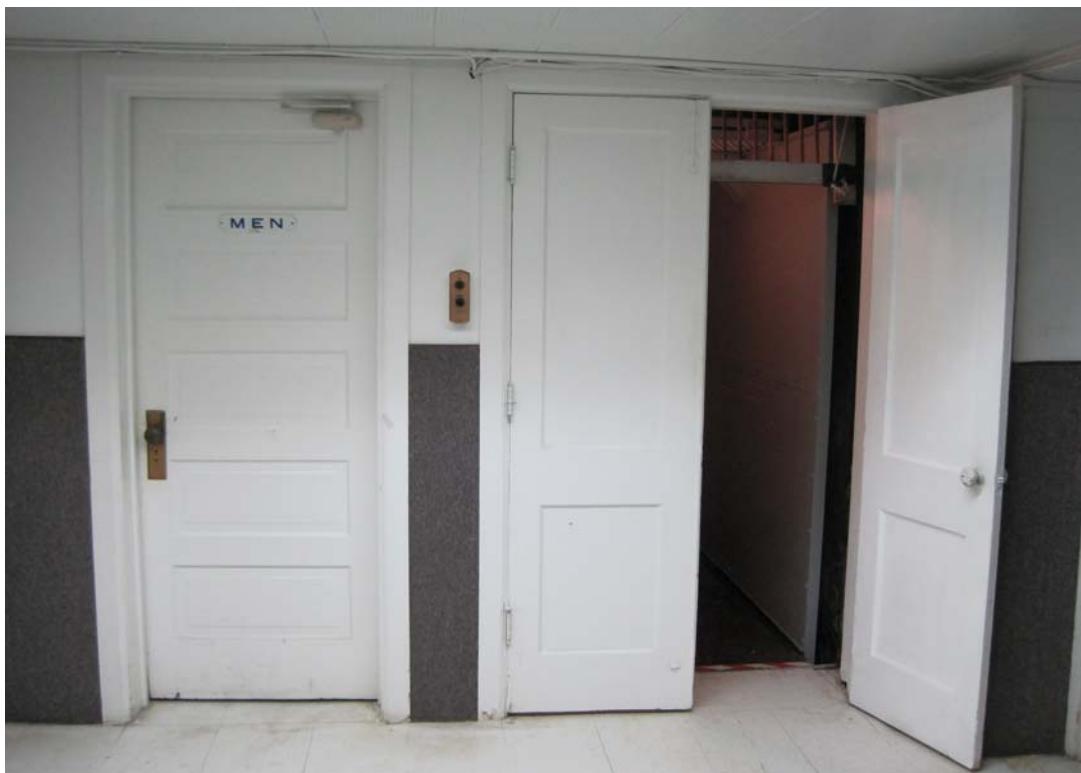
LEL7291 TYPICAL BASEMENT INTERIOR FIVE PANEL DOOR TO MEN'S ROOM (AT LEFT) AND DOORS AT ELEVATOR

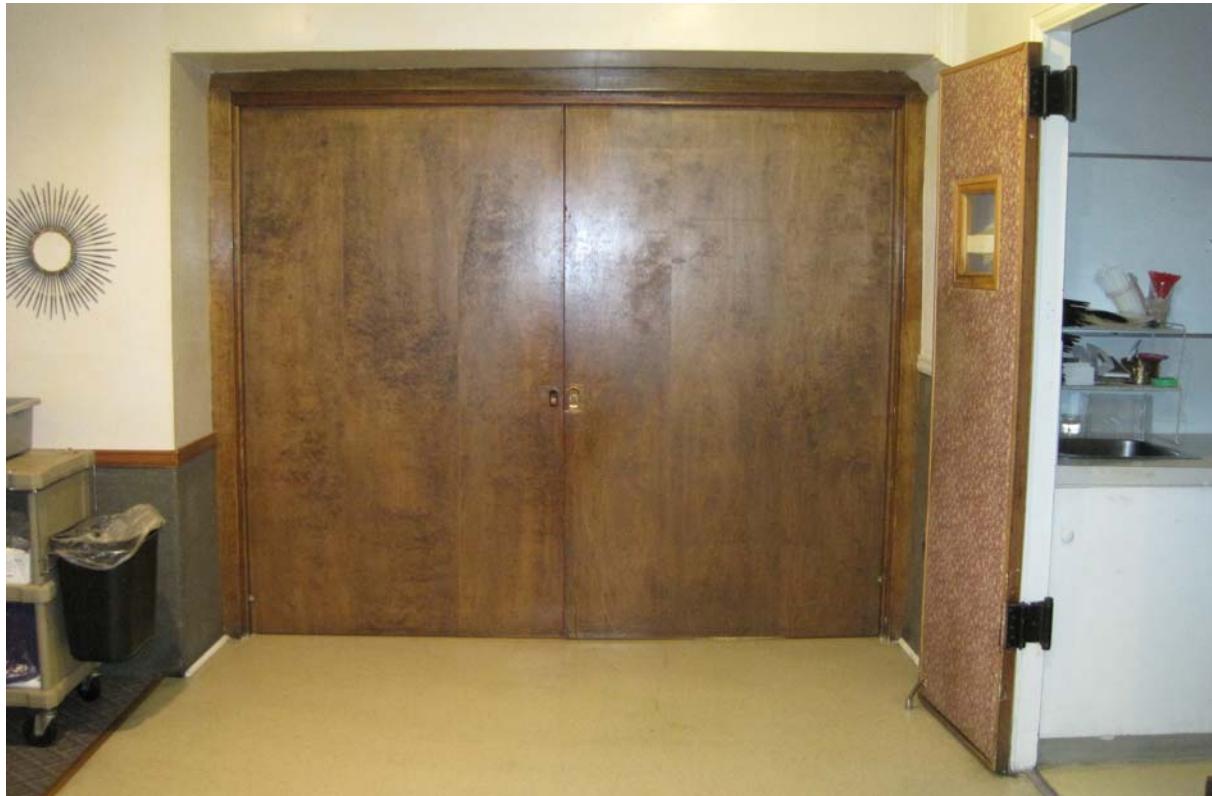
LEL8817 FIRST FLOOR HISTORIC POCKET DOORS BETWEEN RANGE ROOM AND CLUB ROOM

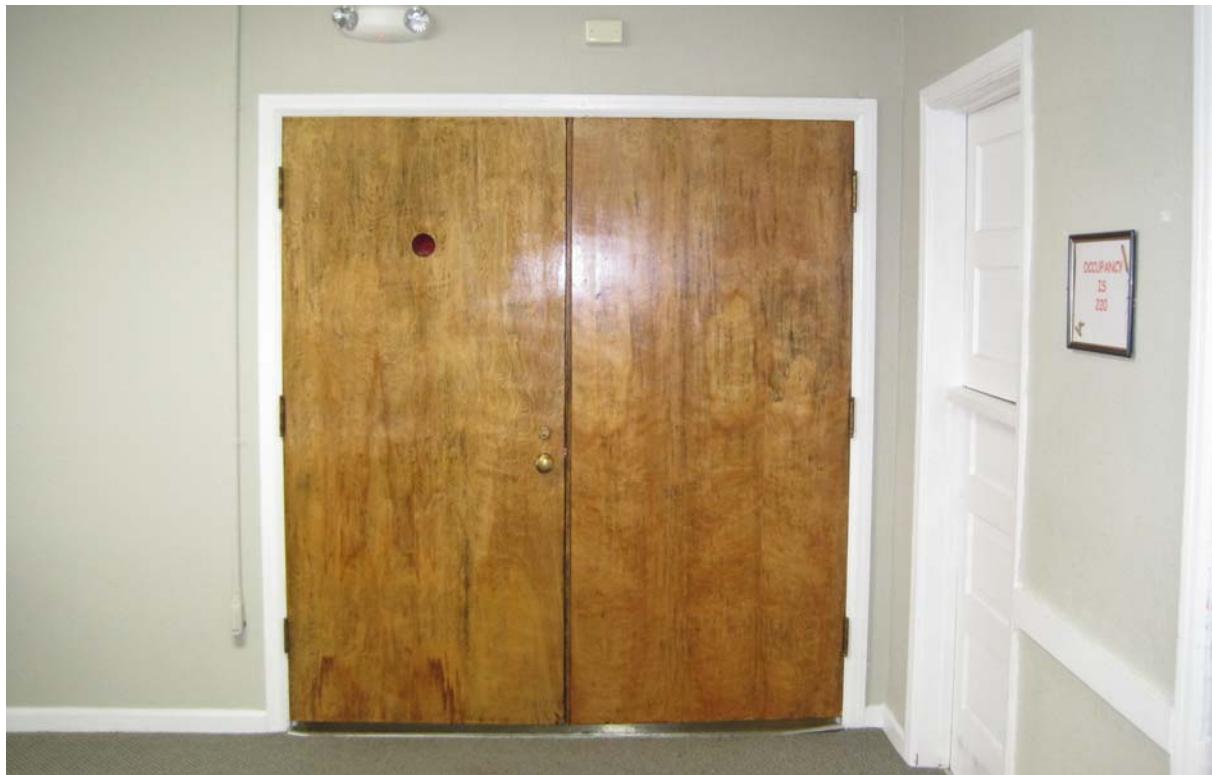
LEL7546 SECOND FLOOR DOORS TO LODGE ROOM AND "DUTCH" DOOR TO STORAGE ROOM AT RIGHT

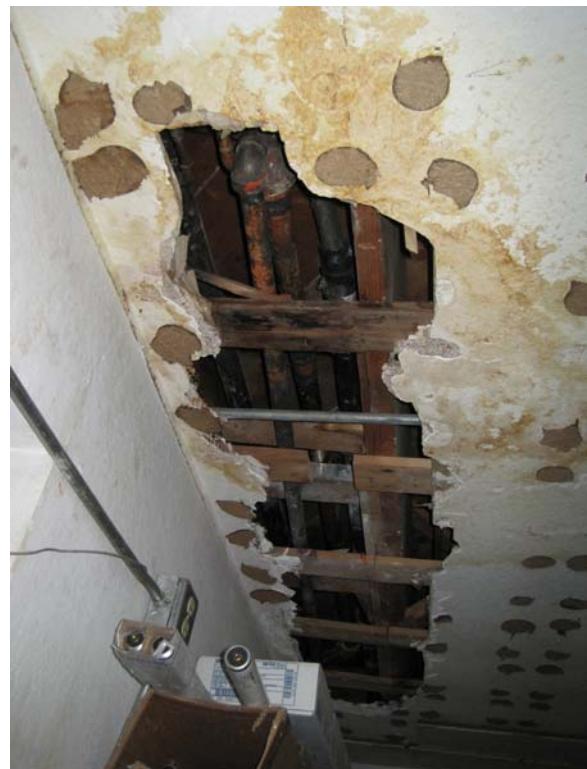
LEL7483 DAMAGED CEILING PLASTER IN
LARGE STORAGE ROOM

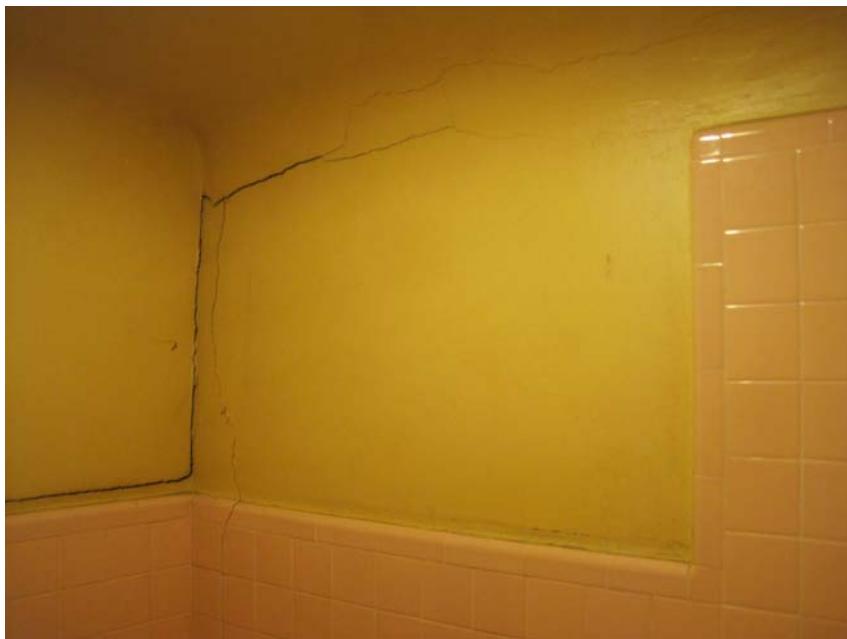
LEL7520 DRAMATIC PLASTER AND TILE FRACTURES AT NORTHEAST CORNER OF SHOWER STALL LOCATED AT SOUTH END OF BASEMENT MEN'S RESTROOM
