HISTORIC LOVELAND ELKS LODGE (BPOE #1051) BUILDING

HISTORIC STRUCTURE ASSESSMENT PHOTOS

PAGE NUMBER EC-1	HISTORIC STRUCTURE ASSESSMENT HISTORIC BPOE #1051 BUILDING CHS/SHF #2011-HA-012	EXISTING CONDITIONS PHOTOS PREPARED BY: P. Berglund CHECKED BY: R. S. Beardmore, PE

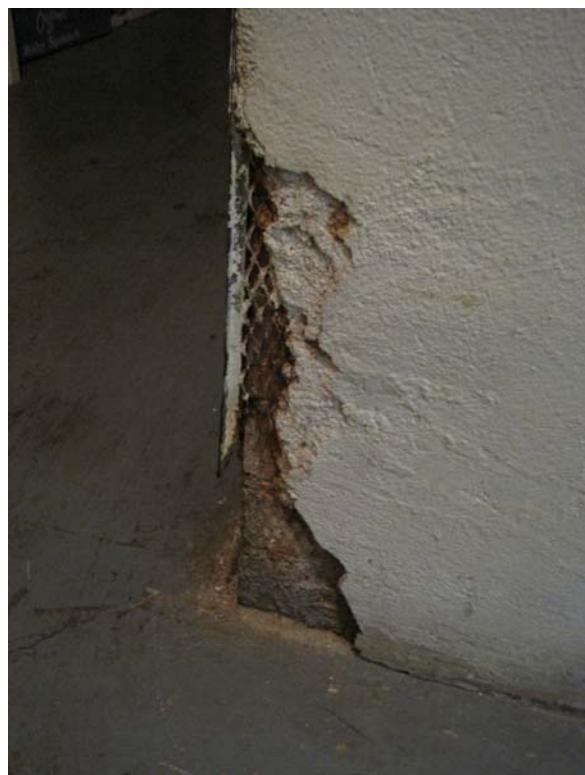
LEL7526 DAMAGE AT BASE OF NORTH STORAGE ROOM WALL EXPOSING METAL LATH BENEATH PLASTER

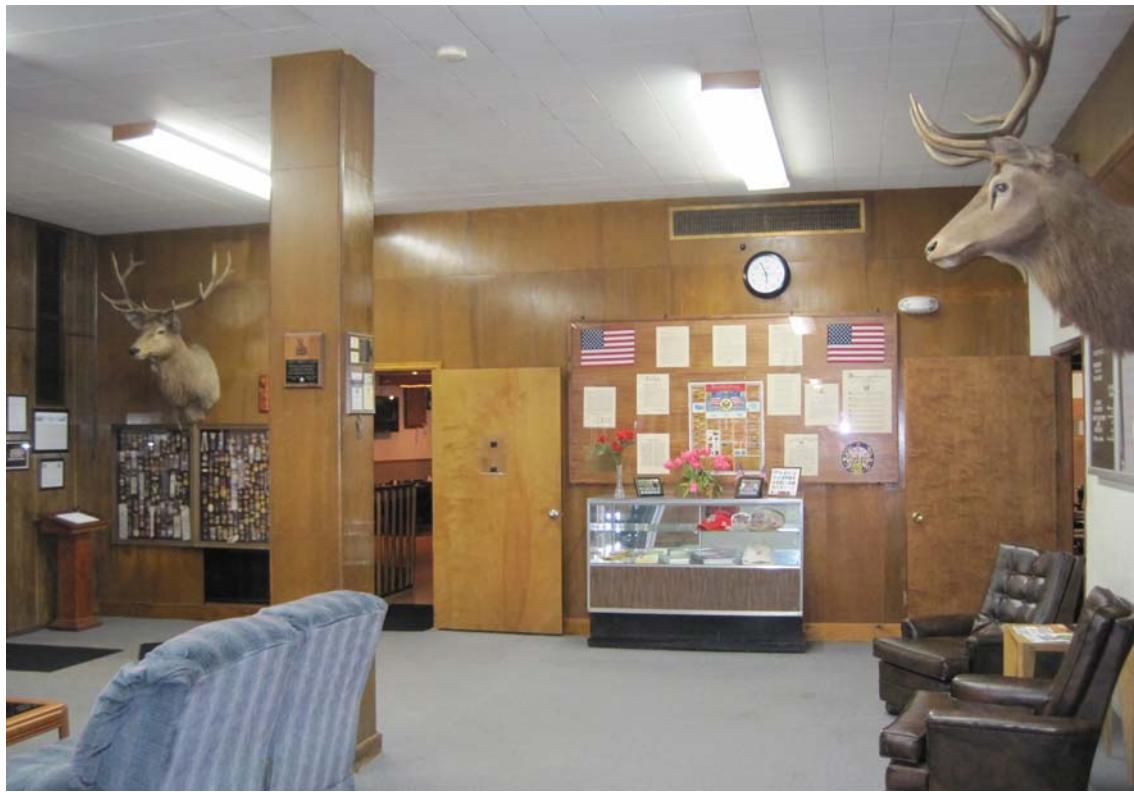
LEL7833 FIRST FLOOR LOBBY, CAMERA FACING NORTH (DOOR TO CLUB ROOM AT CENTER LEFT, RANGE ROOM DOOR AT RIGHT)

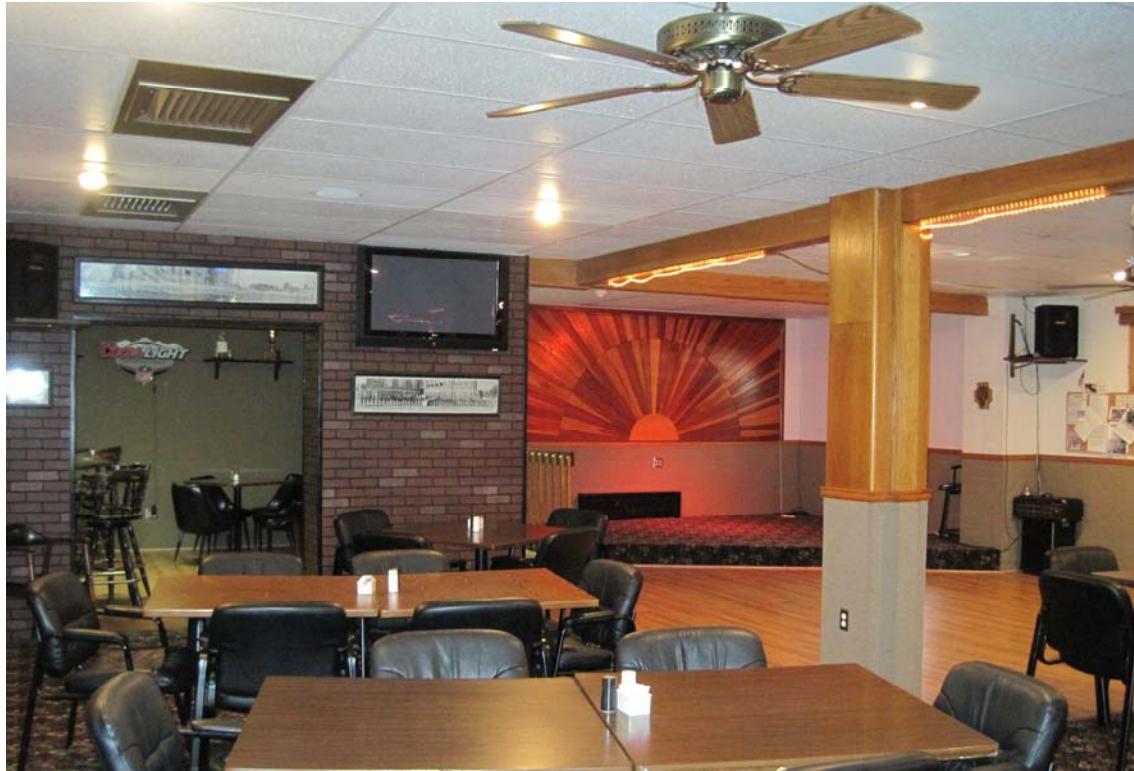
LEL8776 FIRST FLOOR CLUB ROOM, CAMERA FACING SOUTH

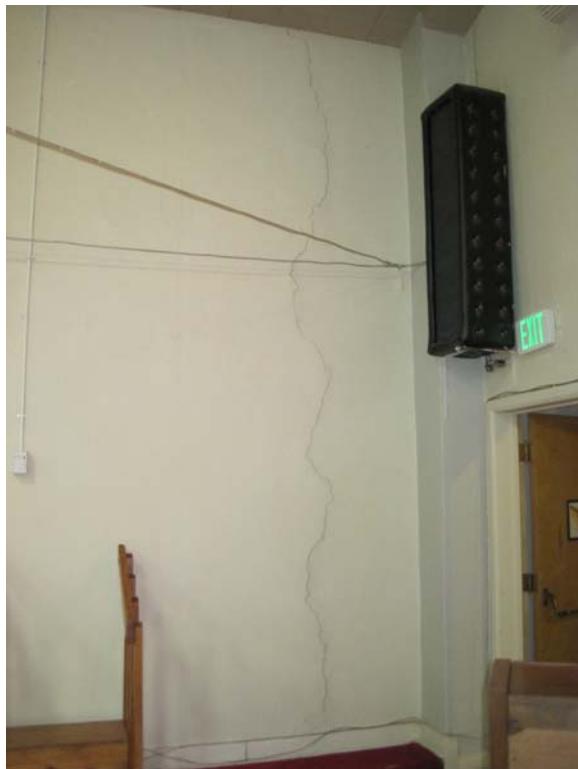
LEL7596 PLASTER FRACTURE ON WEST WALL OF LODGE ROOM THAT COINCIDES WITH BRICK MASONRY GAP SHOWN IN PHOTO #LEL9336

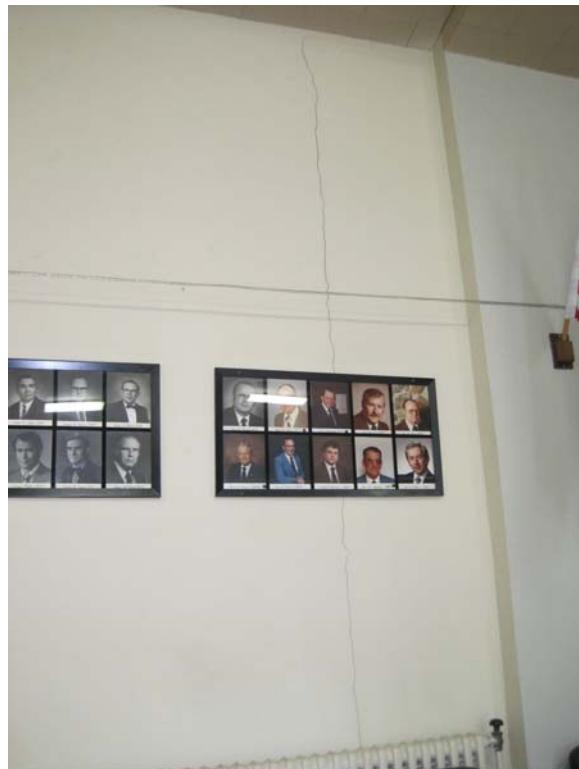
LEL7606 PLASTER FRACTURE ON EAST WALL OF LODGE ROOM, POSSIBLY LOCATED AT HISTORIC LIGHT WELL LOCATION

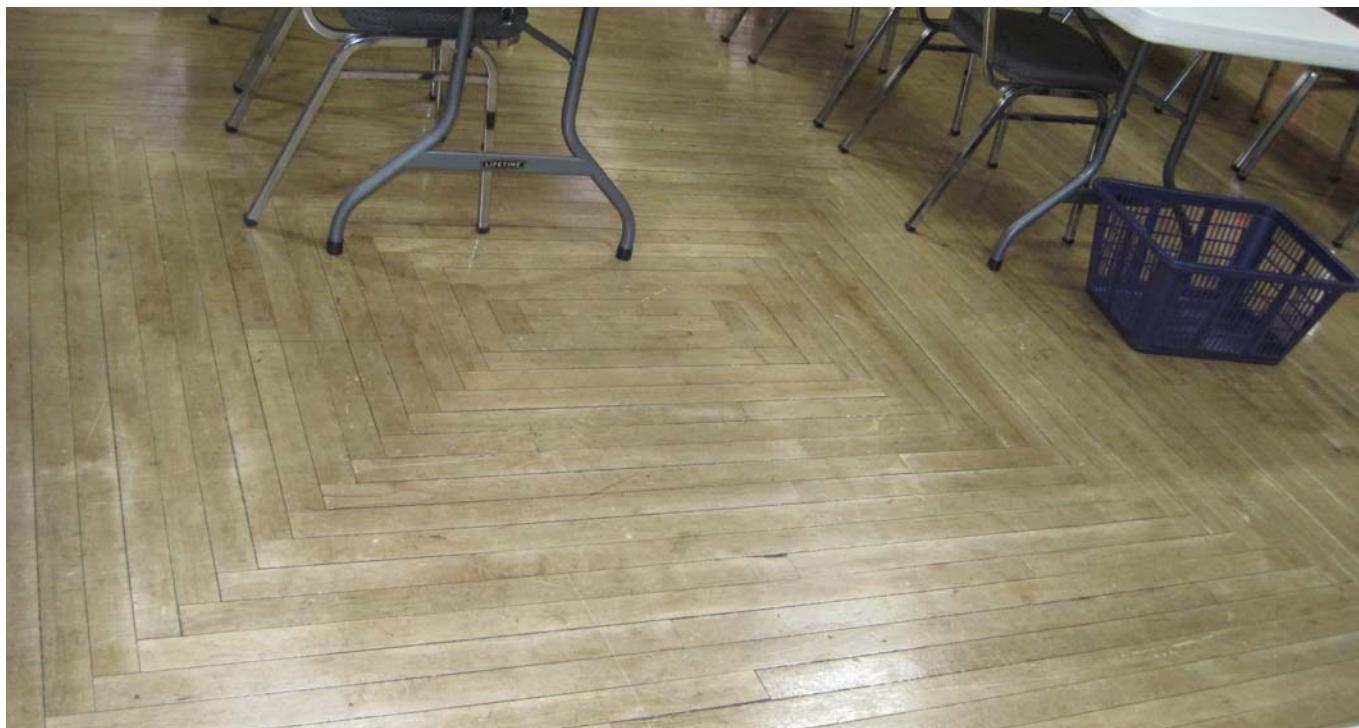
LEL7554 CENTER OF WOOD FLOORING IN LODGE ROOM

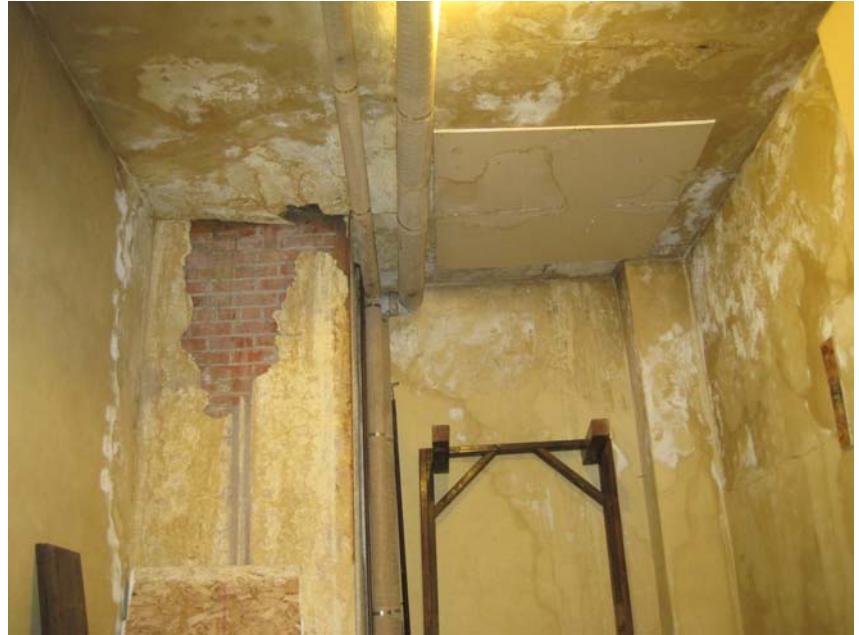
LEL7565 PLASTER FINISHES IN DRESSING ROOM (DAMAGED BY LEAKING OF COOLING UNIT IN MECHANICAL ROOM ABOVE)

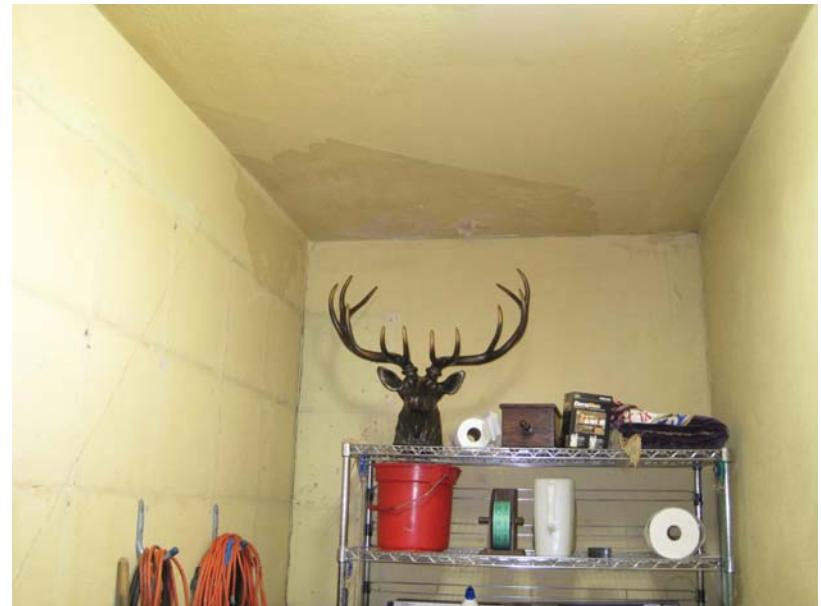
LEL7617 CLOSER VIEW OF STORAGE ROOM WATER DAMAGE
AND ADJACENT FINISHES

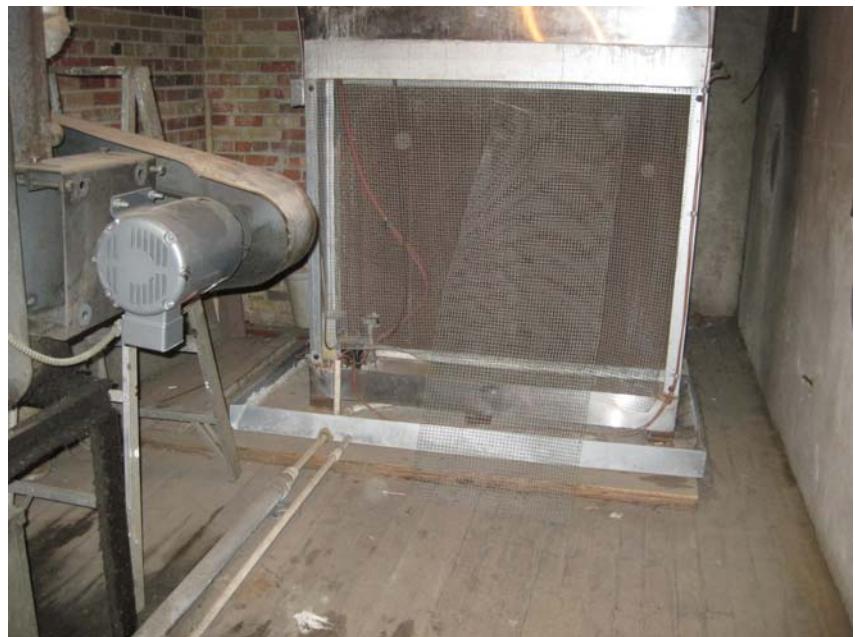
LEL1026 CLOSER VIEW OF BASE OF COOLING UNIT, AT LOCATION OF NORTHEAST CORNER LEAKS ABOVE DRESSING ROOM

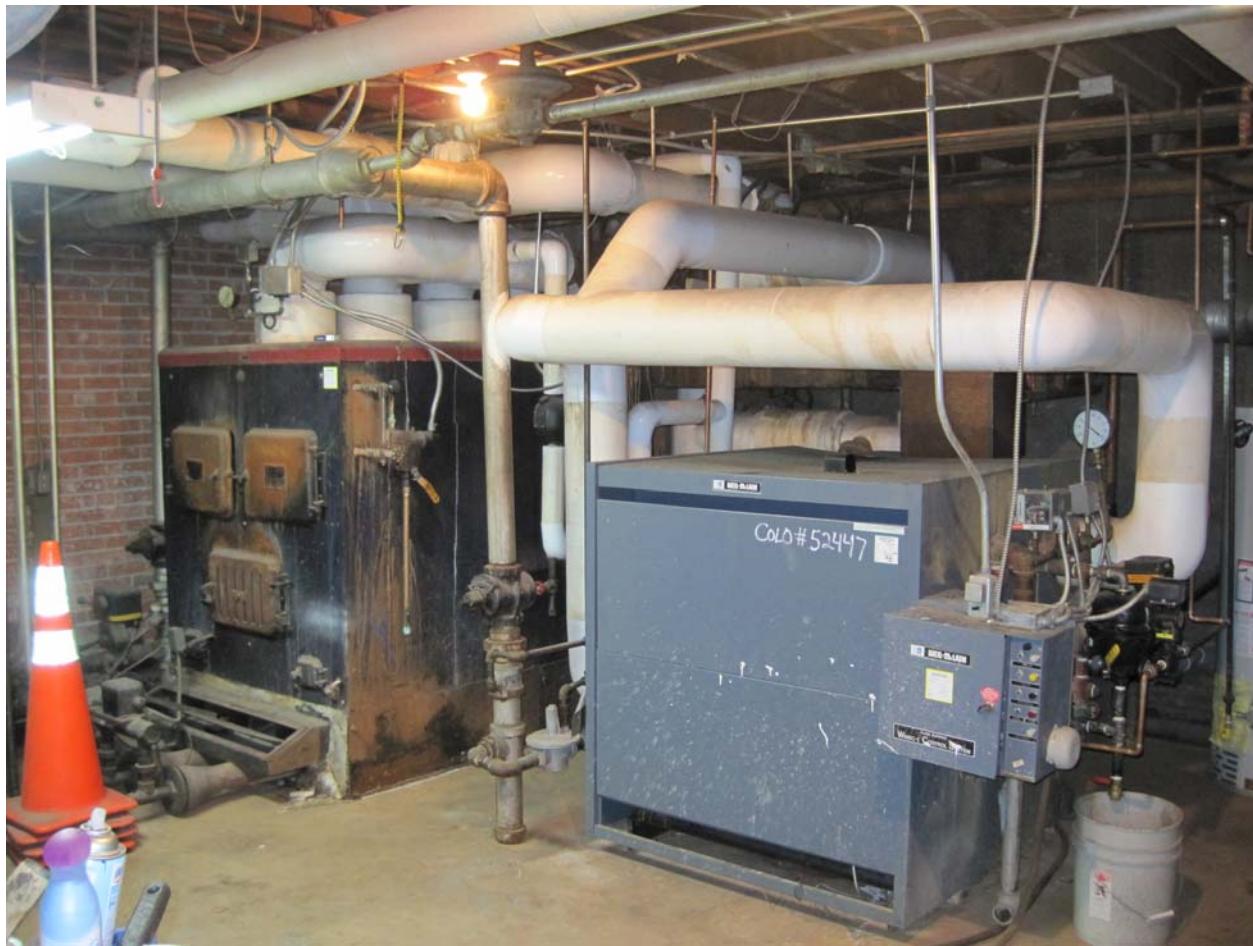
LEL7335 BASEMENT BOILER ROOM

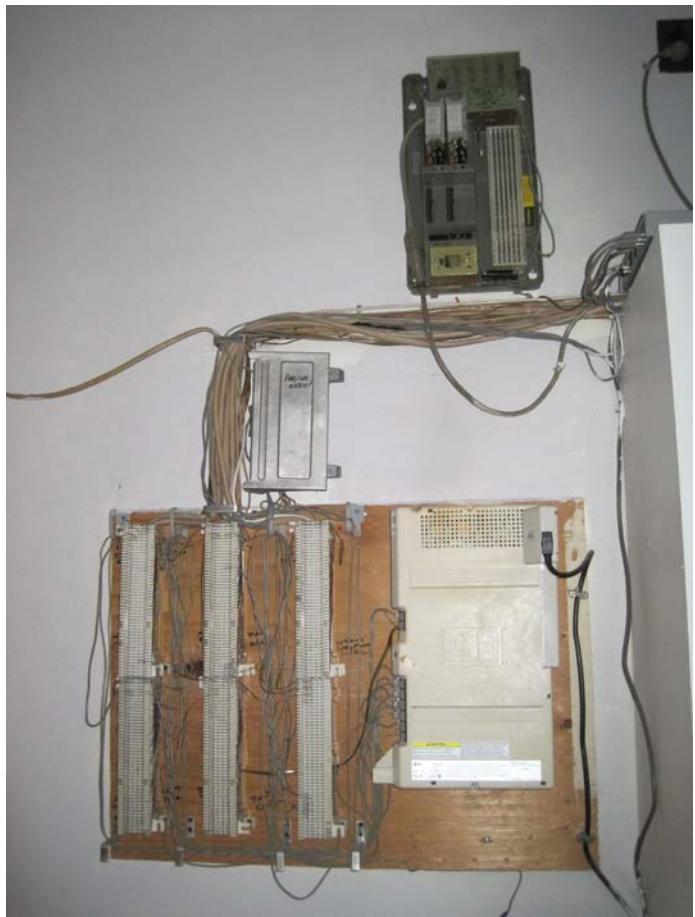
LEL7831 COMMUNICATIONS WIRING NEAR FIRST FLOOR ELEVATOR

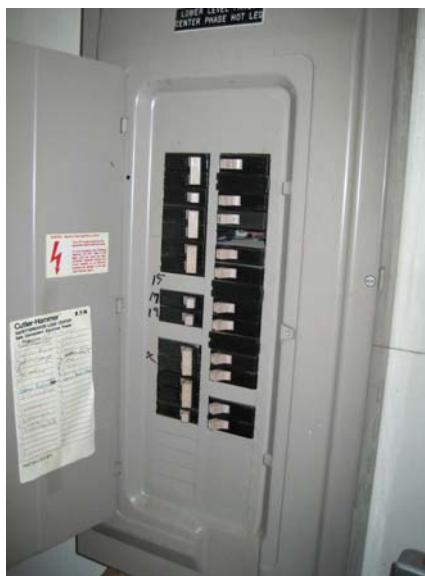
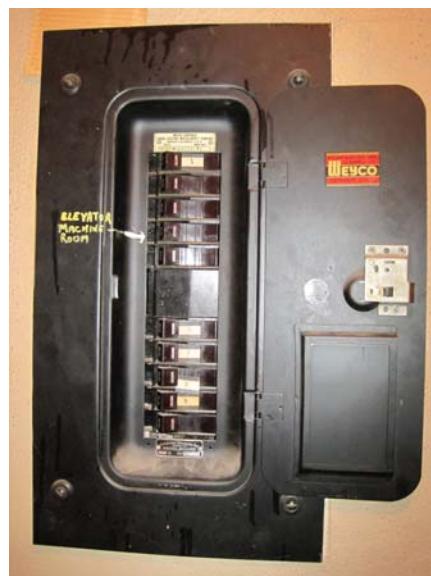
LELE1 VARIOUS ELECTRICAL PANELS

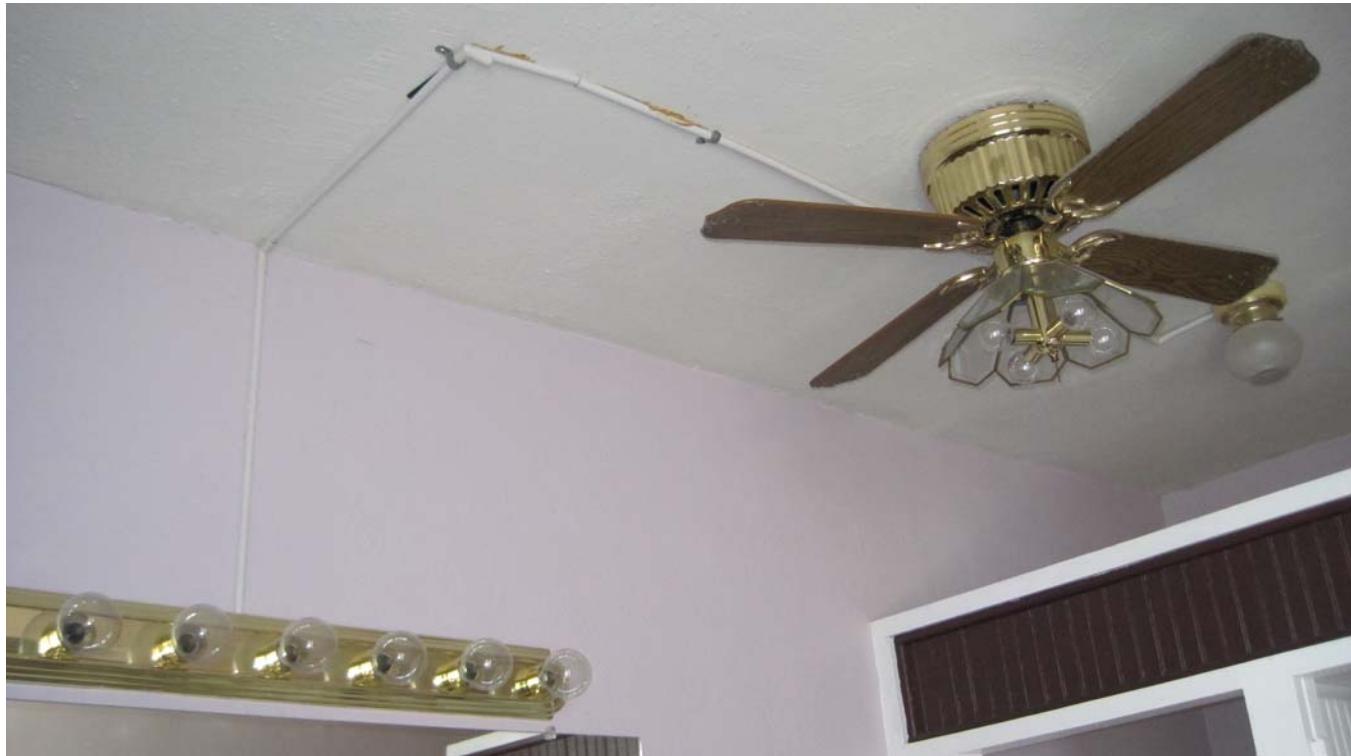
LEL7651 NON-HISTORIC LIGHTING IN SECOND FLOOR WOMEN'S RESTROOM
