Asbestos, LCP and RBM Survey

205 East 6th Street
Loveland, Colorado

January 3, 2018

Terracon Project No. 25177539

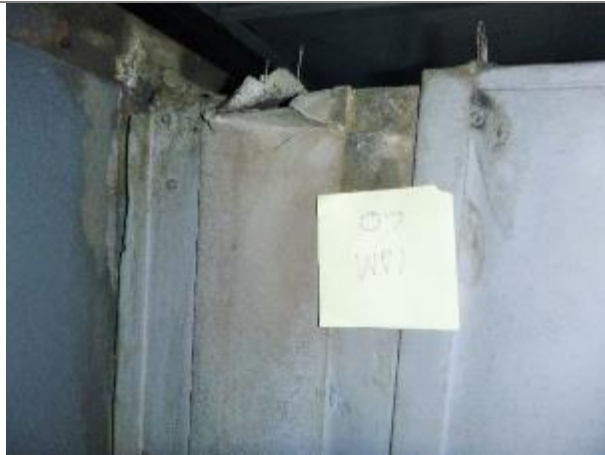
Century Environmental previously identified ACM in the form of interior duct insulation (black coating on fiberglass) in the Mechanical Room air handler and ducts. Terracon's limited sampling did not confirm the presence of ACM on the interior duct insulation, but Terracon did not conduct an extensive destructive investigation of the duct interiors to sample insulation in various locations. Therefore, until additional sampling proves otherwise, the interior duct insulation should be assumed to contain asbestos. In addition, the metal duct work found throughout the ceiling plenum in the 1967 building appeared to have an interior lining. However, additional destructive sampling would be required to verify the presence of interior duct insulation in these locations. Until such time, the interior duct lines should be assumed to contain ACM duct insulation similar to the ACM interior duct insulation identified in the Mechanical Room ducts.

Photo #12 HA-06, black coating on tan fiberglass, duct insulation

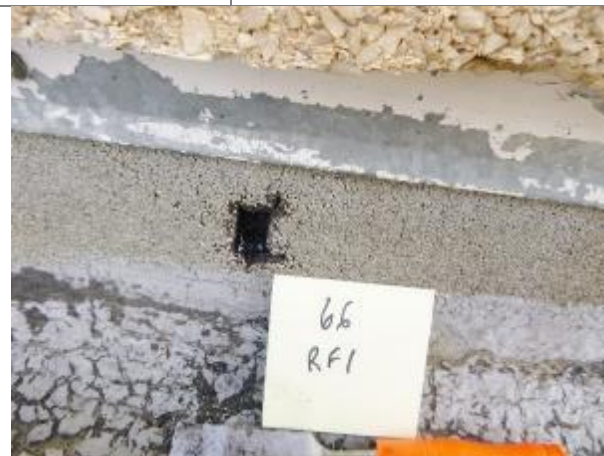
Photo #70 HA-65, silver and black built-up asphaltic roofing

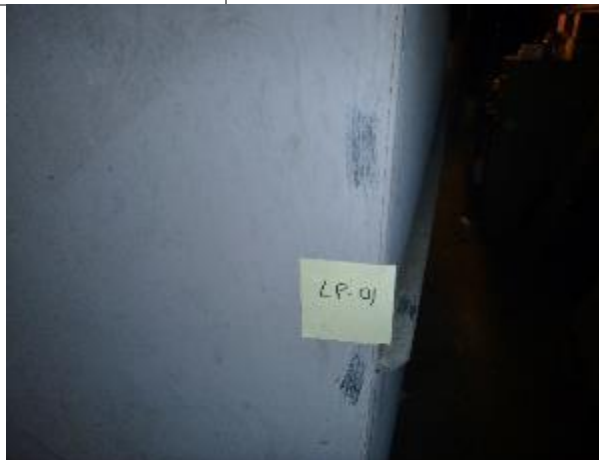
Photo #76 HA-74, Mechanical Room, assumed fuses

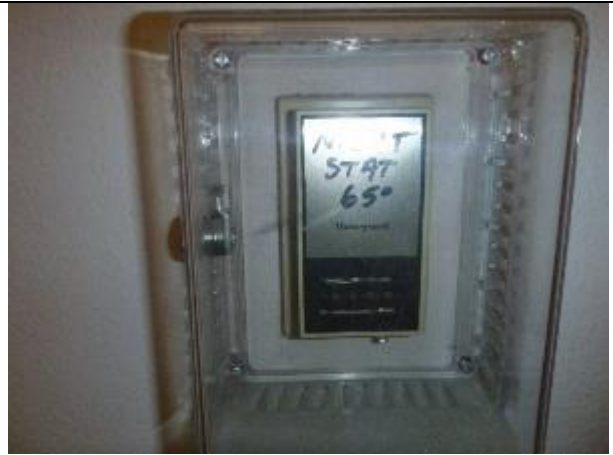
Photo #97 Mechanical Room, suspect mercury-containing thermometer

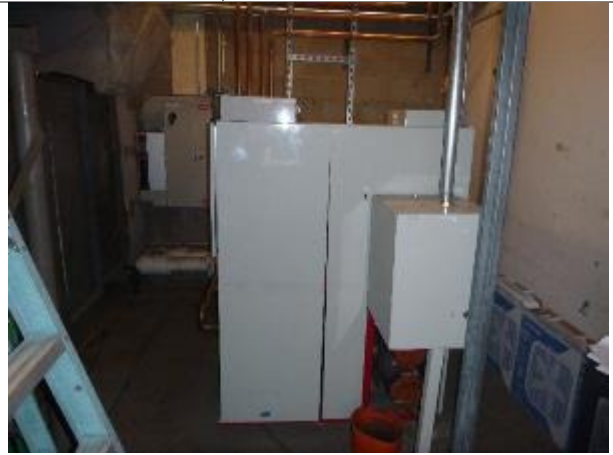
- A chiller unit containing suspect CFCs was observed in the Mechanical Room.
- Two water fountains containing suspect CFCs were observed in the DMV lobby and the Conference Rooms
- Six air conditioning units and a cooling tower containing suspect CFCs were observed on the roof.

Photo #99 Roof-top air conditioning units

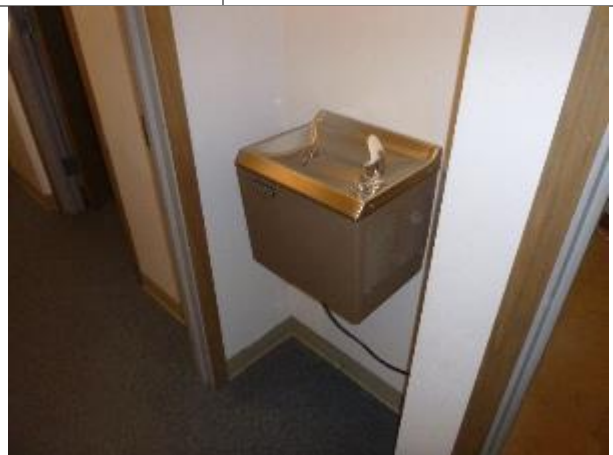
Photo #101 DMV Lobby, water fountain

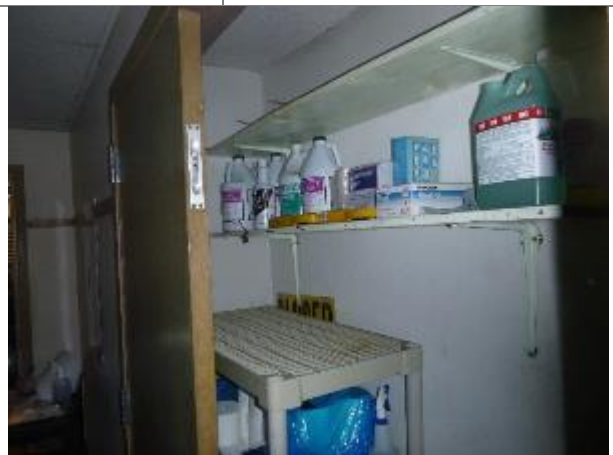
Photo #107 Human Services Janitor's
Closet, cleaning chemicals.
