COLORADO CULTURAL RESOURCE SURVEY

Architectural Inventory Form

1. Resource number: **5LR.4788** Parcel number(s): **9514473017**
 2. Temporary resource number: **N/A**
 3. County: **Larimer**
 4. City: **Loveland**
 5. Historic Building Name: **Van Valin House; Ross House**
 6. Current Building Name: **Cook House**
 7. Building Address: **340 W 5th Street**
 8. Owner Name: **Kevin J. Cook**
 Owner Organization:
 Owner Address: **908 Mountain Ave**
Berthoud, CO 80513

47. Photograph number(s):	CD #4, Images 19-23	CDs filed at:	City of Loveland
48. Report title:	City of Loveland Fifth Street Historic Survey		
49. Date(s):	01/12/08		
50. Recorder(s):	Carl McWilliams Timothy Wilder		
51. Organization:	Cultural Resource Historians		
52. Address:	1607 Dogwood Court Fort Collins, CO 80525		
53. Phone number(s):	(970) 493-5270

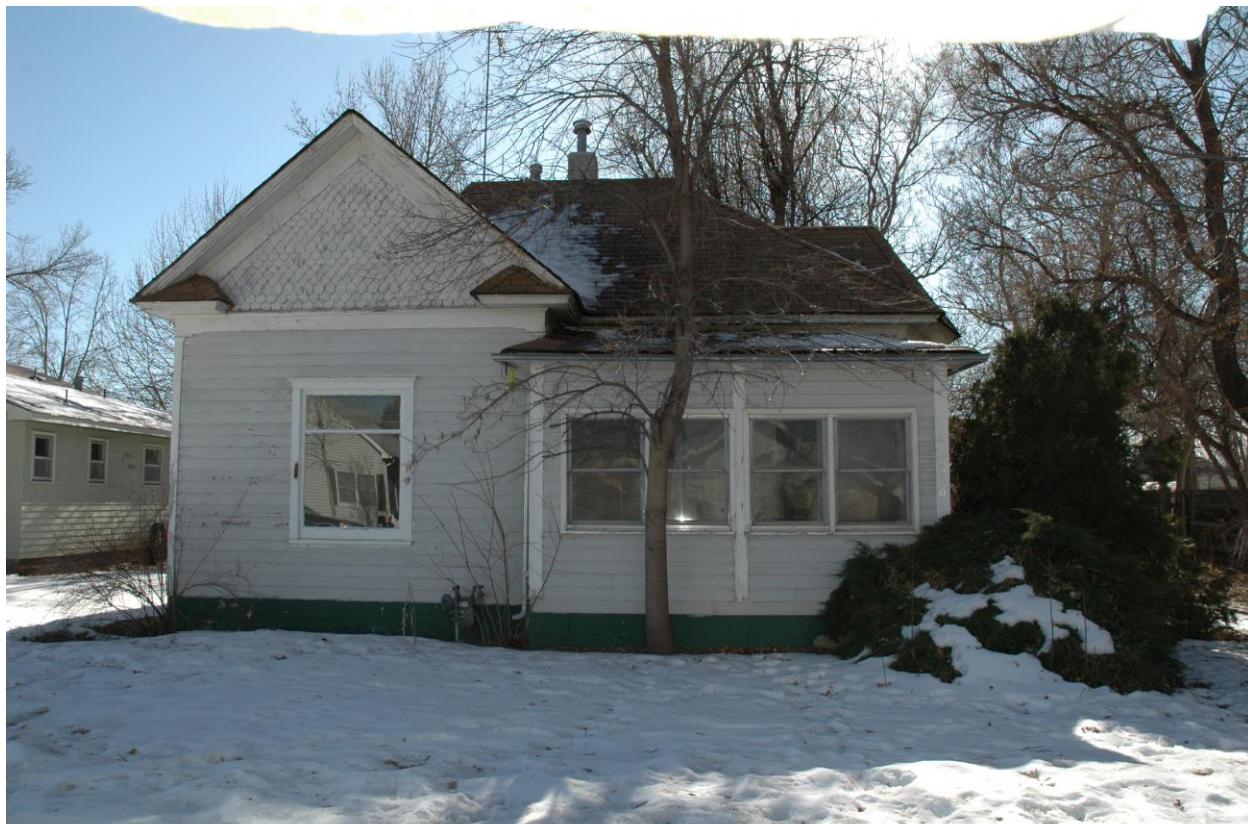
21. General architectural description:
This is a single-story, wood frame, Late Victorian era dwelling. It is supported by a low sandstone foundation, which is painted green on the façade (north elevation), but is covered with concrete pargeting on the east and west elevations. The house's exterior walls are clad with painted pale grey horizontal weatherboard siding, with painted white 1" by 4" corner boards. The truncated hip roof is steeply-pitched, with a prominent intersecting gable over the east end of the façade. Painted white variegated wood shingles appear in the upper gable end. A single-hung sash window penetrates the façade wall directly below the intersecting gable. The roof is covered with brown asphalt shingles, while the eaves are boxed with painted white wood trim. A brick chimney, covered with concrete pargeting, is located on the ridge. A canted bay with a pyramidal roof and with a single 1/1 double-hung sash window is located on the west elevation. Windows elsewhere are primarily 1/1 double-hung sash with painted white wood frames and surrounds. An enclosed hip-roofed porch, which measures 6' by 14', forms the west half of the façade. A silver metal storm door enters the west end of the porch, while a painted white wood-paneled door leads from within the porch into the house. The porch is supported by a non-original concrete block foundation, and its walls are made of painted pale grey horizontal weatherboard siding and painted white bead board. A 3-step concrete rear stoop on the south elevation is badly out of alignment, having been forced out of place by advancing tree roots over a period of several years. A painted white wood storm door enters an enclosed rear porch from the stoop.

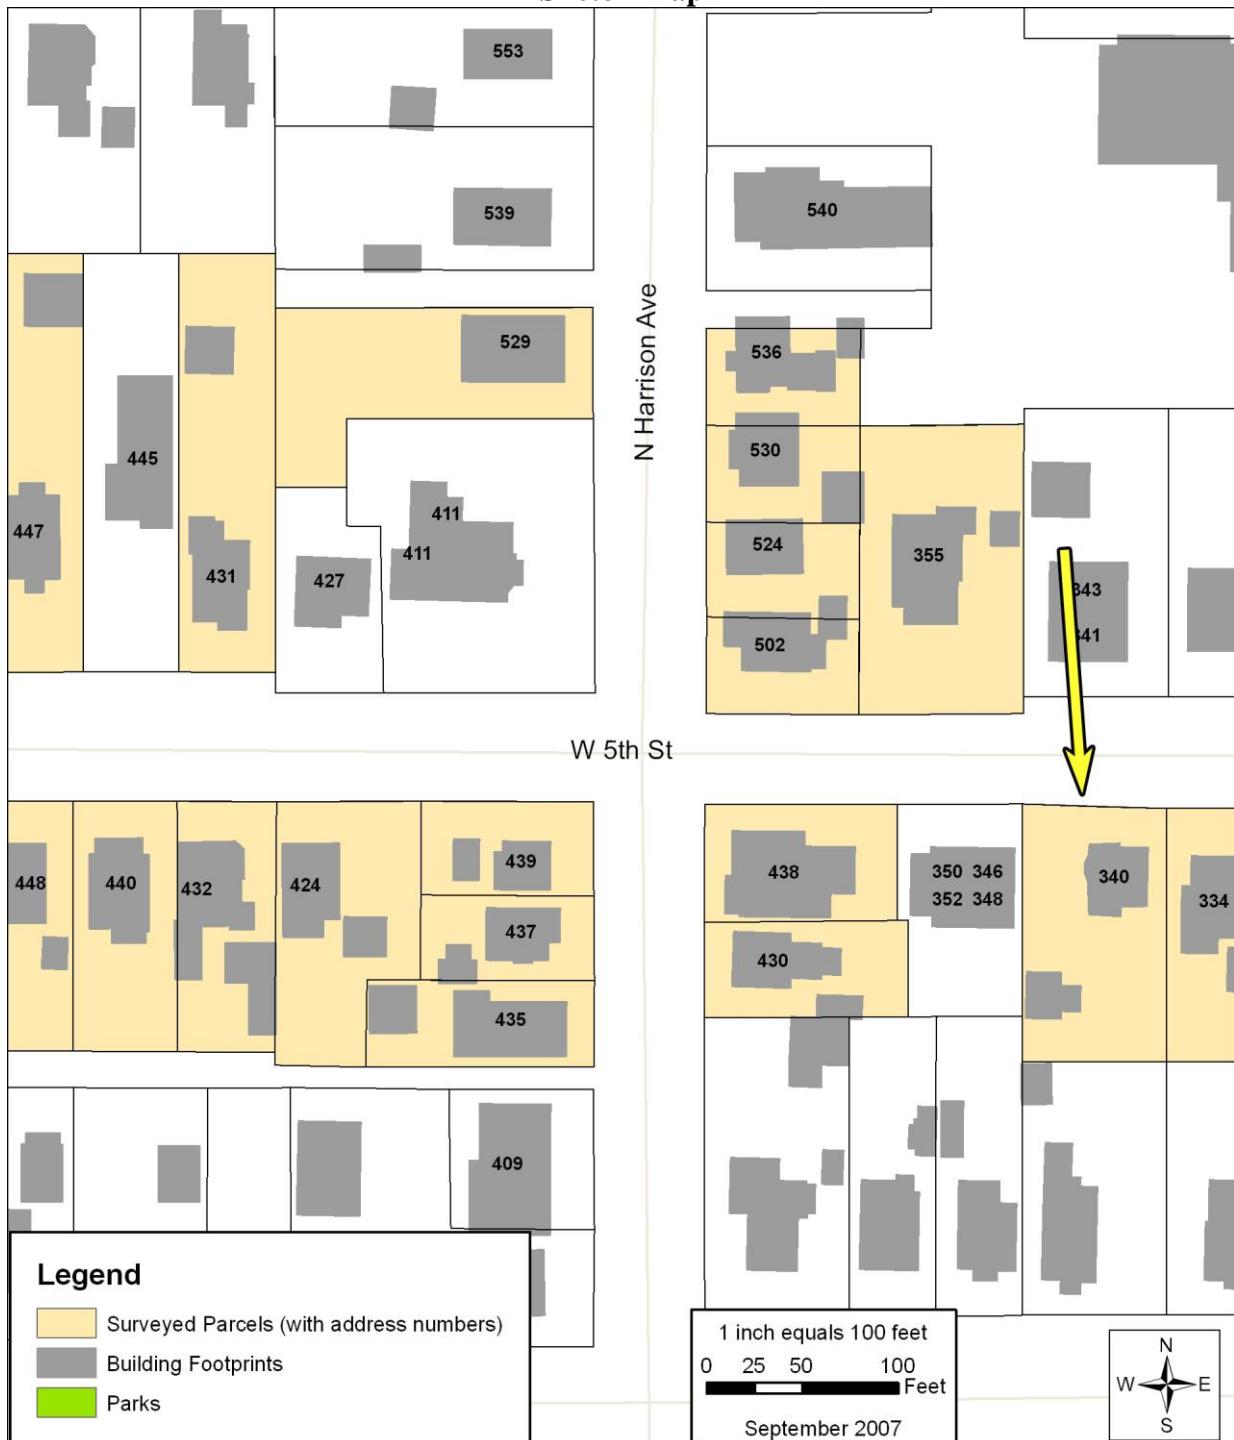
Sketch Map

23. Landscape or special setting features: **This property is located on the south side of West 5th Street in the block between Grant and Harrison Avenues. The traditionally planted grass front yard, large backyard, and side yard to the west of the house have not been maintained in recent years. A planted grass strip of land between the front sidewalk and the street is also suffering from neglect. A woven wire fence extends along the rear portion of the east property line.**

Garage
A wood frame garage, which measures 22' by 16', is located southwest of the house. Built in 1951, the garage is supported by a concrete slab foundation, while its walls are made of painted white concrete blocks. The garage's front gable roof is low-pitched, and is covered with asphalt composition shingles. Painted white horizontal weatherboard siding appears in the upper gable ends, while painted white rafter ends are exposed beneath widely-overhanging eaves. A set of paired, painted white, vertical wood plank garage doors, side-hinged with metal strap hinges, are located on the north elevation. A single painted white wood-paneled door is located on the north end of the east elevation. A 4x4 horizontal sliding window is located on the east elevation.

Shed
A small storage shed, which measures approximately 10' by 8', is located just three feet east of the garage. This building has a wood timbers on grade foundation, painted white horizontal weatherboard exterior walls, and a front gabled roof. The roof is covered with brown asphalt composition shingles laid over 1x wood decking and 2" by 2" wood rafters, with a fascia board. A painted white wood-paneled door, and a 2/2 double-hung sash window, penetrate the north elevation. Another 2/2 double-hung sash window is located on the south elevation.
