COLORADO CULTURAL RESOURCE SURVEY

Architectural Inventory Form

1. Resource number:	5LR.14721	Parcel number(s):
2. Temporary resource no.:	N/A	9513414021
3. County:	Larimer	
4. City:	Loveland	
5. Historic building name:	Cloyd House, Fay House, Johnson House, Weickum House	
6. Current building name:	Dinsmore House	
7. Building address:	733 E. 5th Street	
8. Owner name and address:	Mathew J. Dinsmore P. O. Box 7772 Loveland, CO 80537

48. Report title: **Germans from Russia and the Great Western Sugar Company: A Survey of Historical Properties (Loveland CLG project CO-19-10006)**

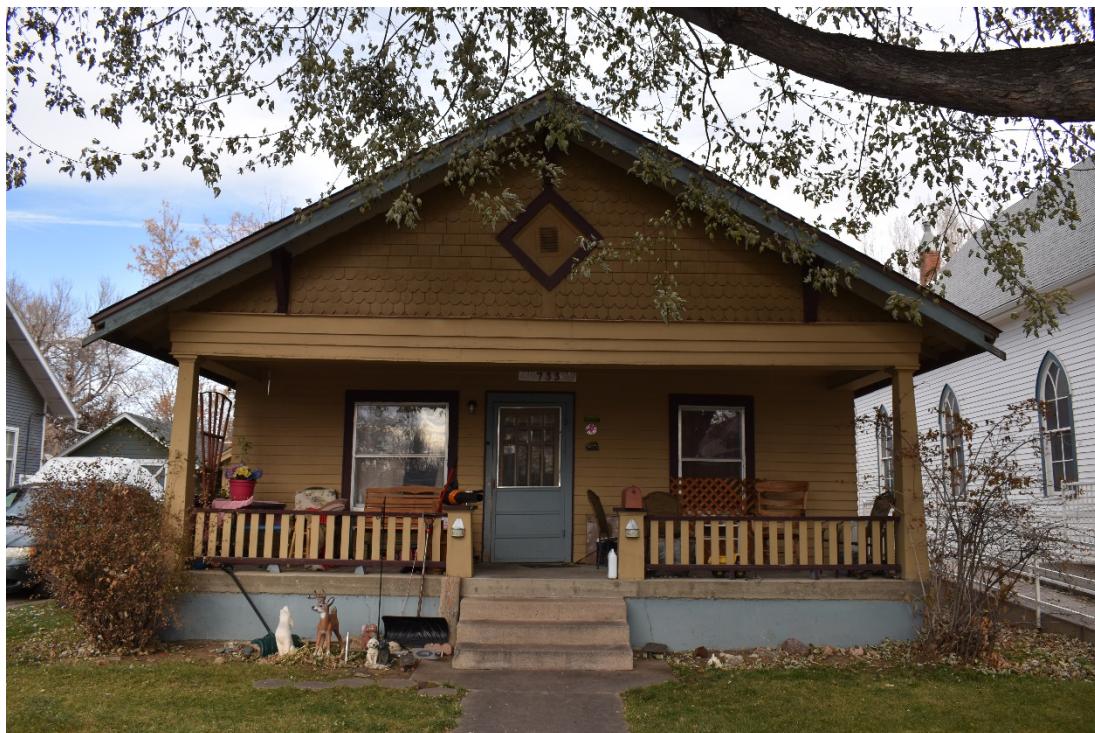
21. General architectural description:
This Bungalow-type dwelling features a basic rectangular-shaped plan that measures 44' N-S x 26' E-W. It is supported by a painted green poured concrete foundation, and its exterior walls are clad with painted gold color horizontal wood siding. The roof is a moderately-pitched front gable, covered with brown asphalt composition shingles. Painted gold color rafter ends, with a fascia board, are exposed beneath the widely-overhanging eaves. Painted brown variegated wood shingles appear in the upper gable ends. A brown brick fireplace chimney is on the west-facing wall, and a brown brick chimney is on the ridge.

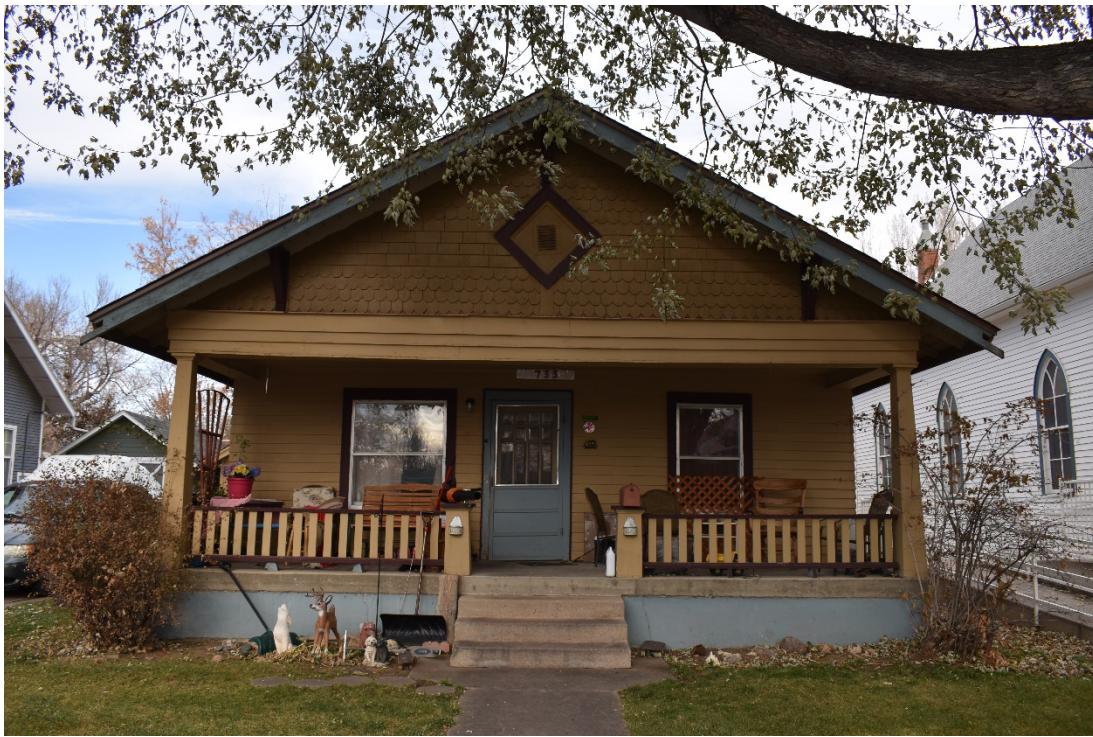
CD 1, Image 57, View to North, of the dwelling

The façade faces south toward 5th Street. A painted white glass-in-wood-frame door enters near the center of the façade from an open full-width porch that measures 7' N-S x 26' E-W, and that is recessed under the main gable roof. Approached by three concrete steps, the porch features a concrete floor, a painted gold and burgundy open wood railing, and painted gold pedestals and tapered piers. A painted white wood-paneled door, with horizontally-oriented upper sash lights, and covered by a painted green wood storm door, enters the west end of the north-facing wall from a concrete stoop. The home's windows have painted white wood frames, painted burgundy wood surrounds, and metal exterior storm windows. The west-facing wall contains a slightly-projecting rectangular-shaped bay, with three one-

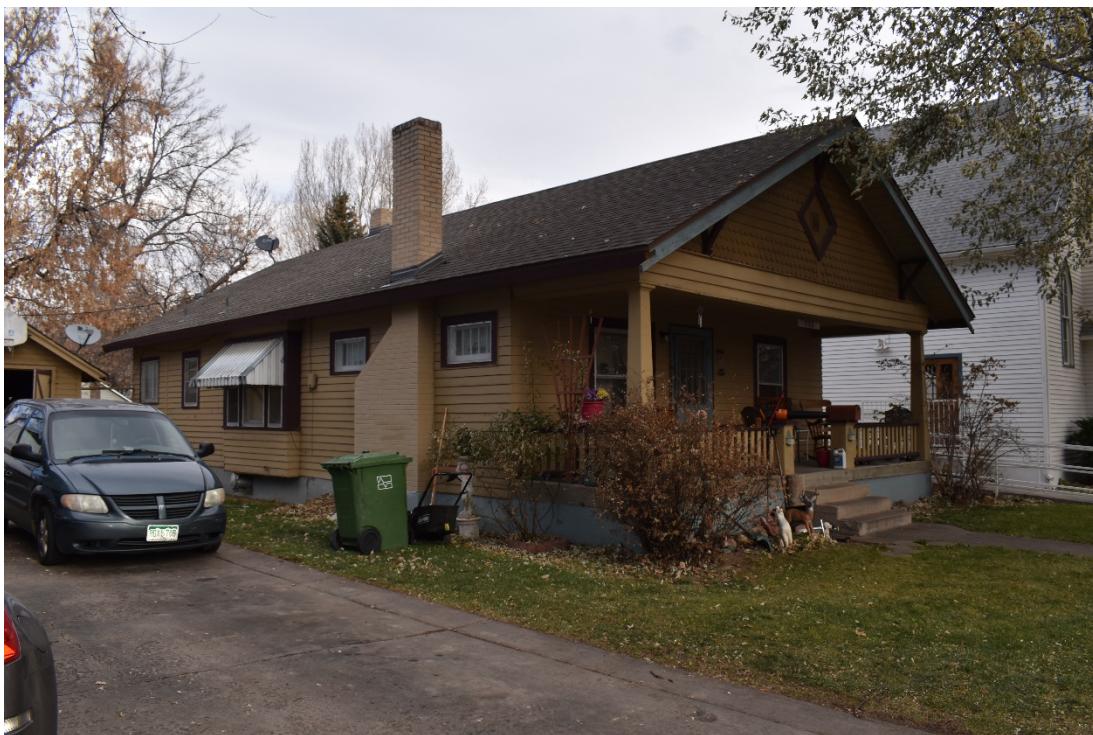
CD 1, Image 59, View to Northeast, of the dwelling

over-one double-hung sash windows covered by a metal awning. Two small horizontally-oriented 5-light, ribbon-style windows flank the fireplace chimney, also in the west-facing wall. The north-facing wall contains a set of paired 6-light windows and a non-historic 1-beside-1 horizontal sliding window. Elsewhere, windows are single and paired one-over-one double-hung sash.

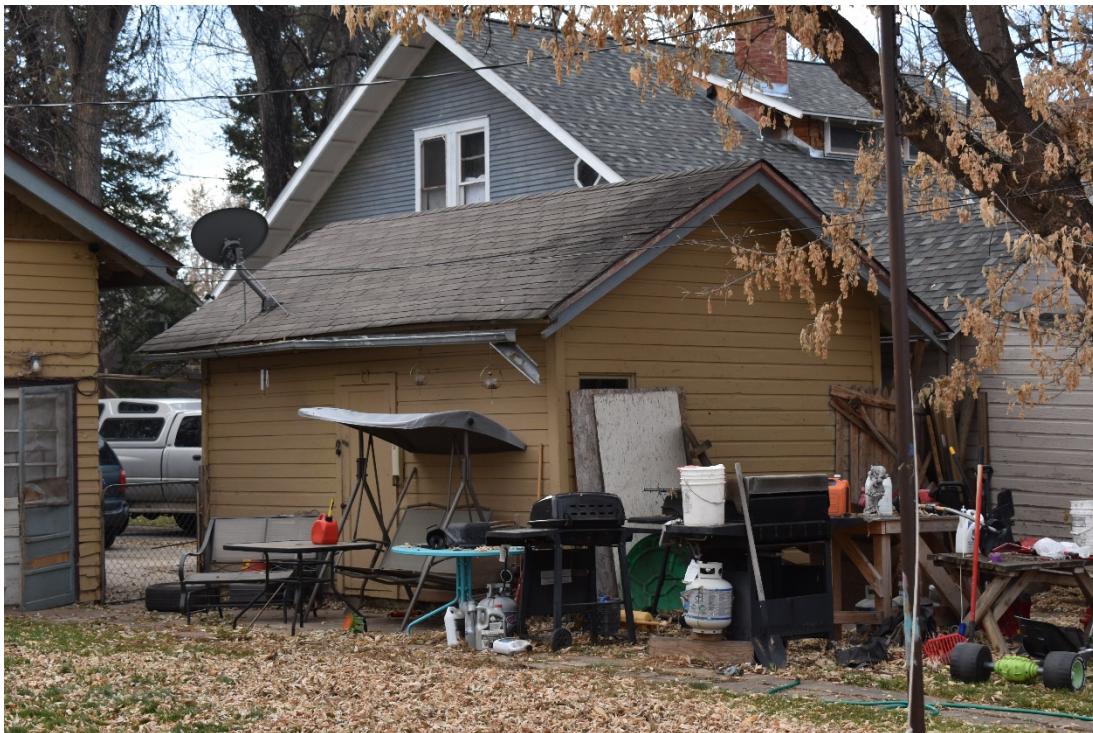
CD 1, Image 61, View to Southwest, of the garage

A single-stall garage that measures 18' N-S x 12' E-W is located northwest of the dwelling. Supported by a poured concrete foundation and floor, its exterior walls are clad with painted gold color horizontal wood siding with 1" x 4" corner boards. The garage is covered by a moderately-pitched front gable roof, with brown asphalt composition shingles laid over 1x wood decking and 2x wood rafters. The rafter ends are painted gold, and are exposed beneath the eaves. The south-facing wall contains a set of paired vertical wood plank doors, side-hinged with metal strap hinges. These doors open onto the driveway that extends along the west side of the house to East 5th Street. The east-facing wall contains a single-entry vertical wood plank door that accesses the garage from the backyard.
