**Big Thompson River Watershed
Source Water Quality Conditions**

Summer 2024

September 25, 2024

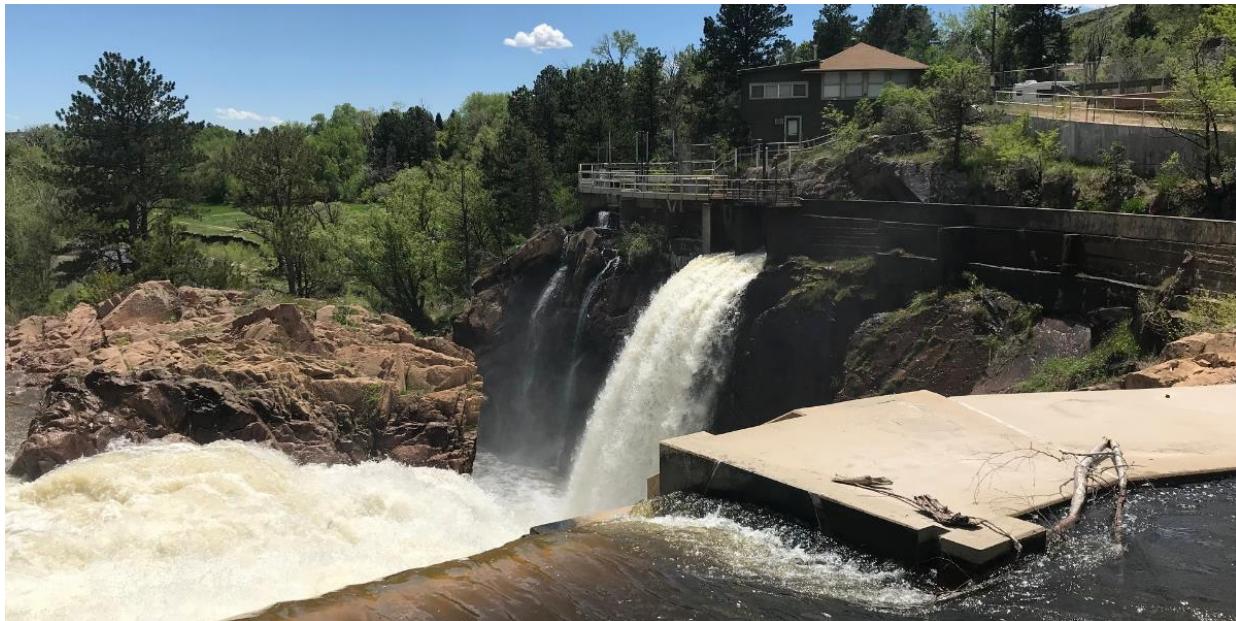
Loveland Water & Power drinking water intake. The Home Supply Canal visible on the far side of the Big Thompson River.

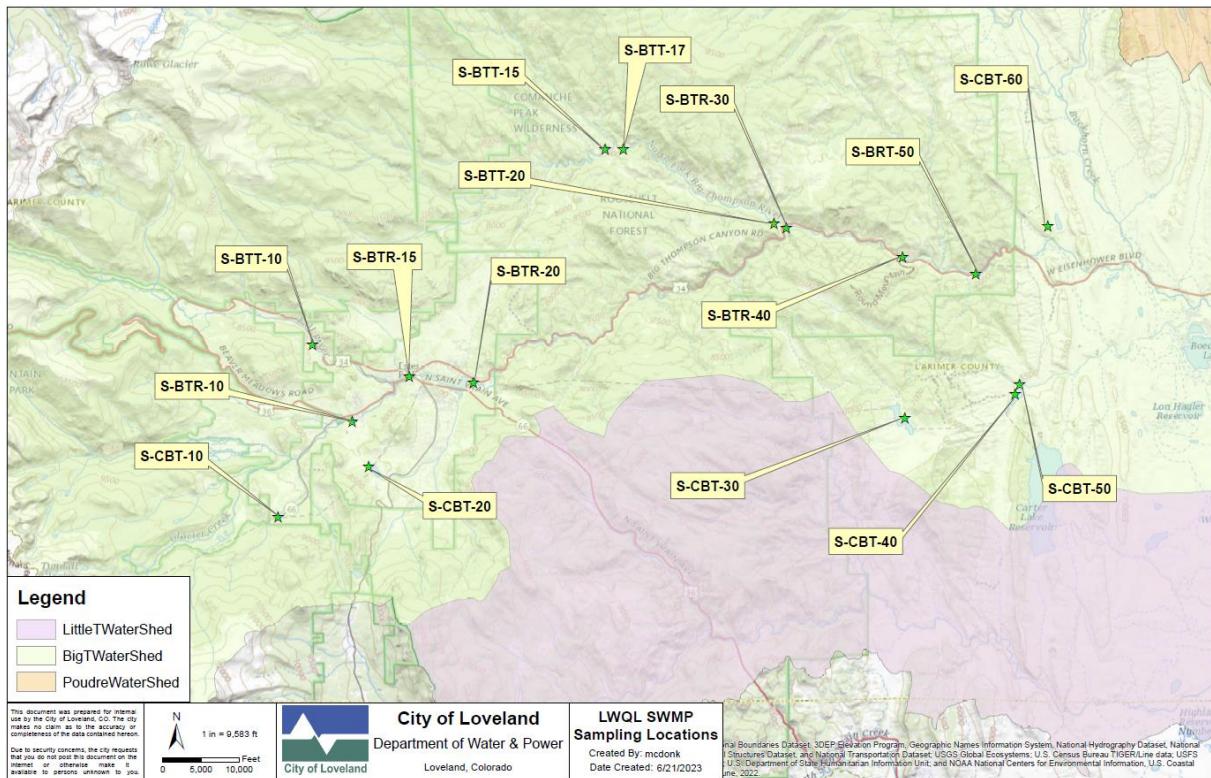
Figure 1. 2024 Source Water Monitoring Program water quality sampling sites.

Water quality information is routinely collected from 15 sites. Of these sites, two are intake locations at the Loveland Water Treatment Plant (river intake and reservoir intake), two are tributary sites (Fall River and North Fork Big Thompson River), seven are associated with the Colorado-Big Thompson River project (CB-T), and four are mainstem river sites (Table 1, Figure 1). Three additional sites were added beginning in April 2023. One location is upstream of the Estes Park Sanitation District outfall (by the Rocky Mountain National Park visitor center). Another site added in spring 2023 is located on the North Fork, upstream of the confluence with Miller Fork. Miller Fork has been a substantial contributor of water affected by the Cameron Peak Fire (CPF) to the mainstem of the Big Thompson River. The site located above the

confluence of Miller Fork with the North Fork will assist in providing context for Miller Fork contributions. The final site is in Miller Fork itself, just above the confluence with the North Fork. All these sites are located upstream of the Loveland drinking water intake and therefore water quality results from these locations have implications for Loveland water treatment and drinking water quality.

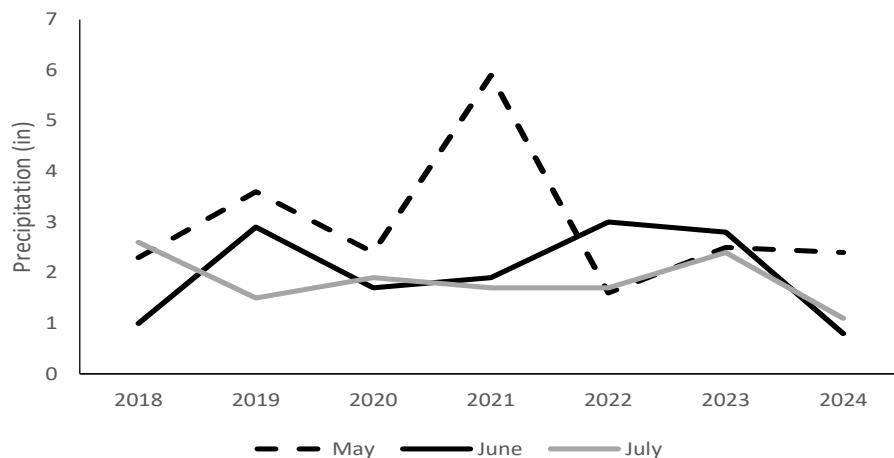
Figure 2. Monthly precipitation by year at the Bear Lake Natural Resources Conservation Service Snow Telemetry (SNOWTELE) station.

The amount of precipitation is directly proportional to the amount of water present in the Big Thompson River. In addition, the amount of precipitation can indicate the relative quality of the water, as large rain events and runoff often result in increased turbidity and decreased water quality. Precipitation in the summer of 2024 was low and helped establish dangerous fire

conditions that facilitated the ignition and spread of the AMF, which started approximately two weeks after the final data included in this report were collected (July 29, 2024) (Figure 2).

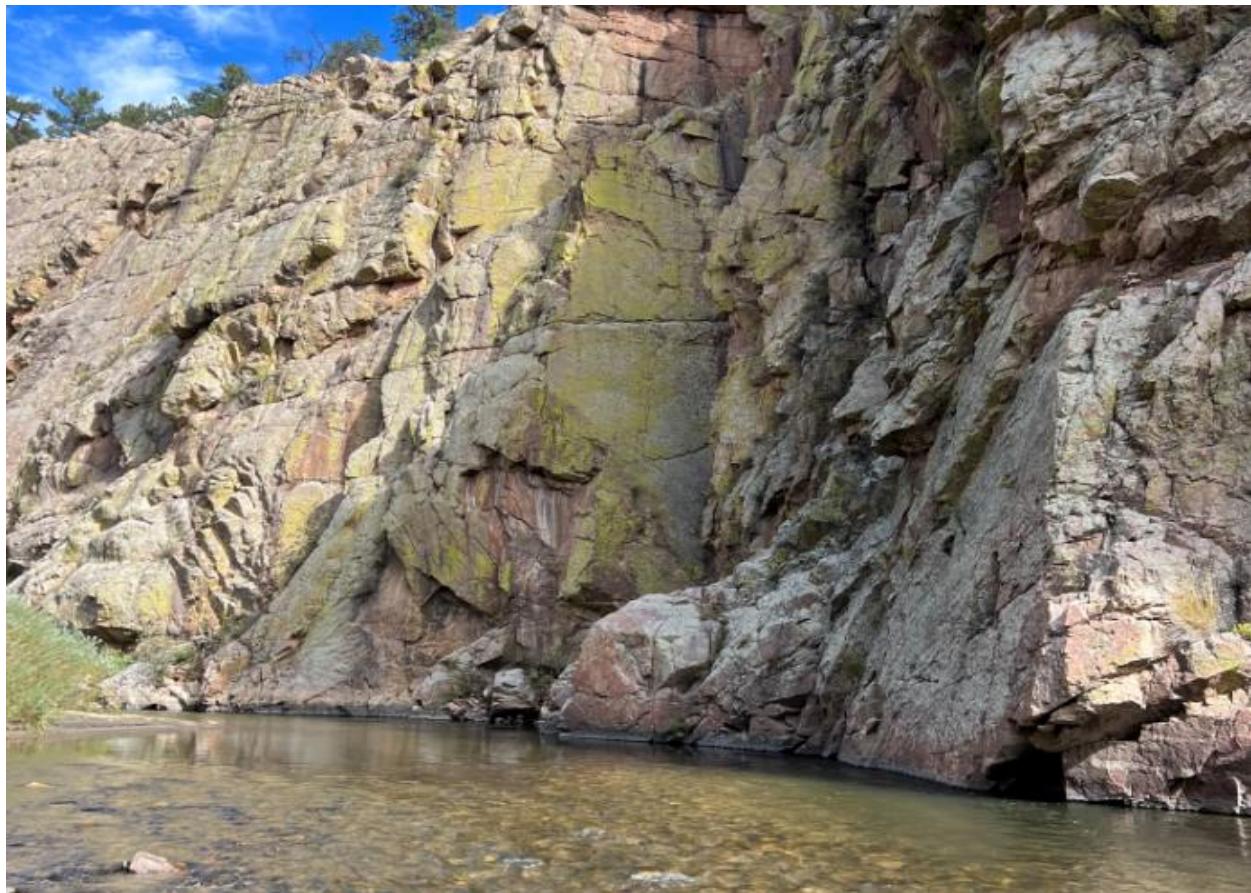
Summer 2024 temperatures were close to five-year average values, which indicates relatively high temperatures compared to values over a longer time (water temperatures during the five-year reference period included the fourth, sixth, and ninth warmest years on record in Colorado, (1886-present; Figure 3).

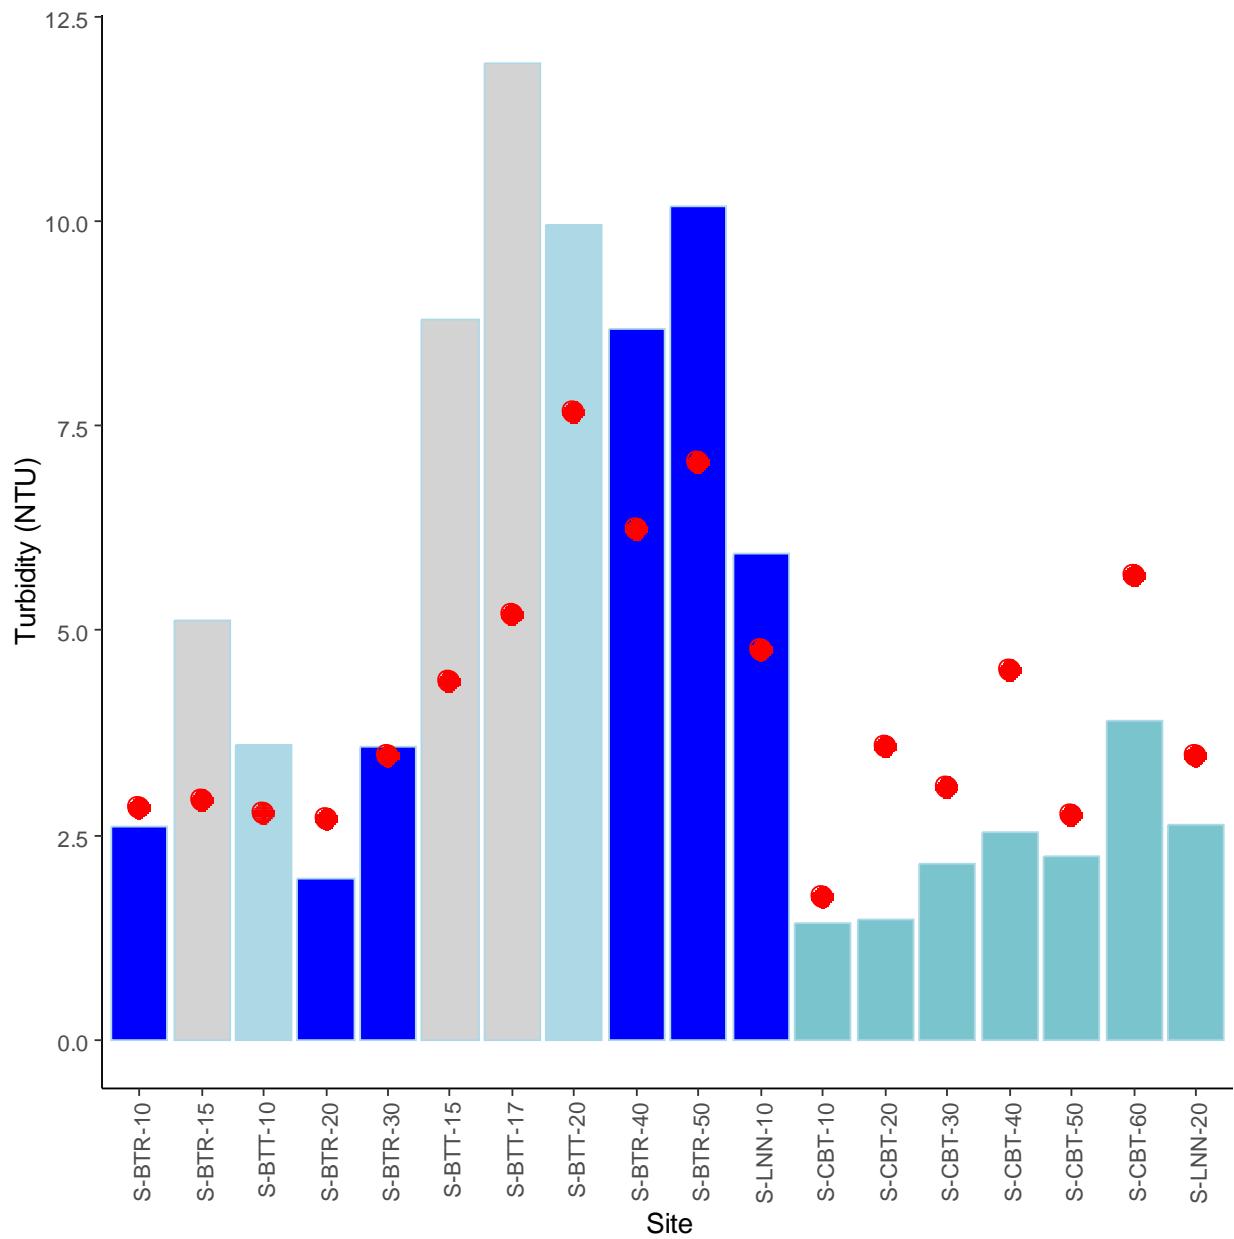
Turbidity levels in the summer of 2024 were near five-year average values at many sites but notably lower in the North Fork and mainstem sites downstream of the confluence with the North Fork (Figure 4). These results reflect both continued recovery from the CPF and the relatively dry conditions documented in the summer of 2024. Relatively low precipitation generally translates to lower flows, which in turn decreased erosive capacity. As a result, summer 2024 turbidity values were substantially lower than comparable values from summer 2023.

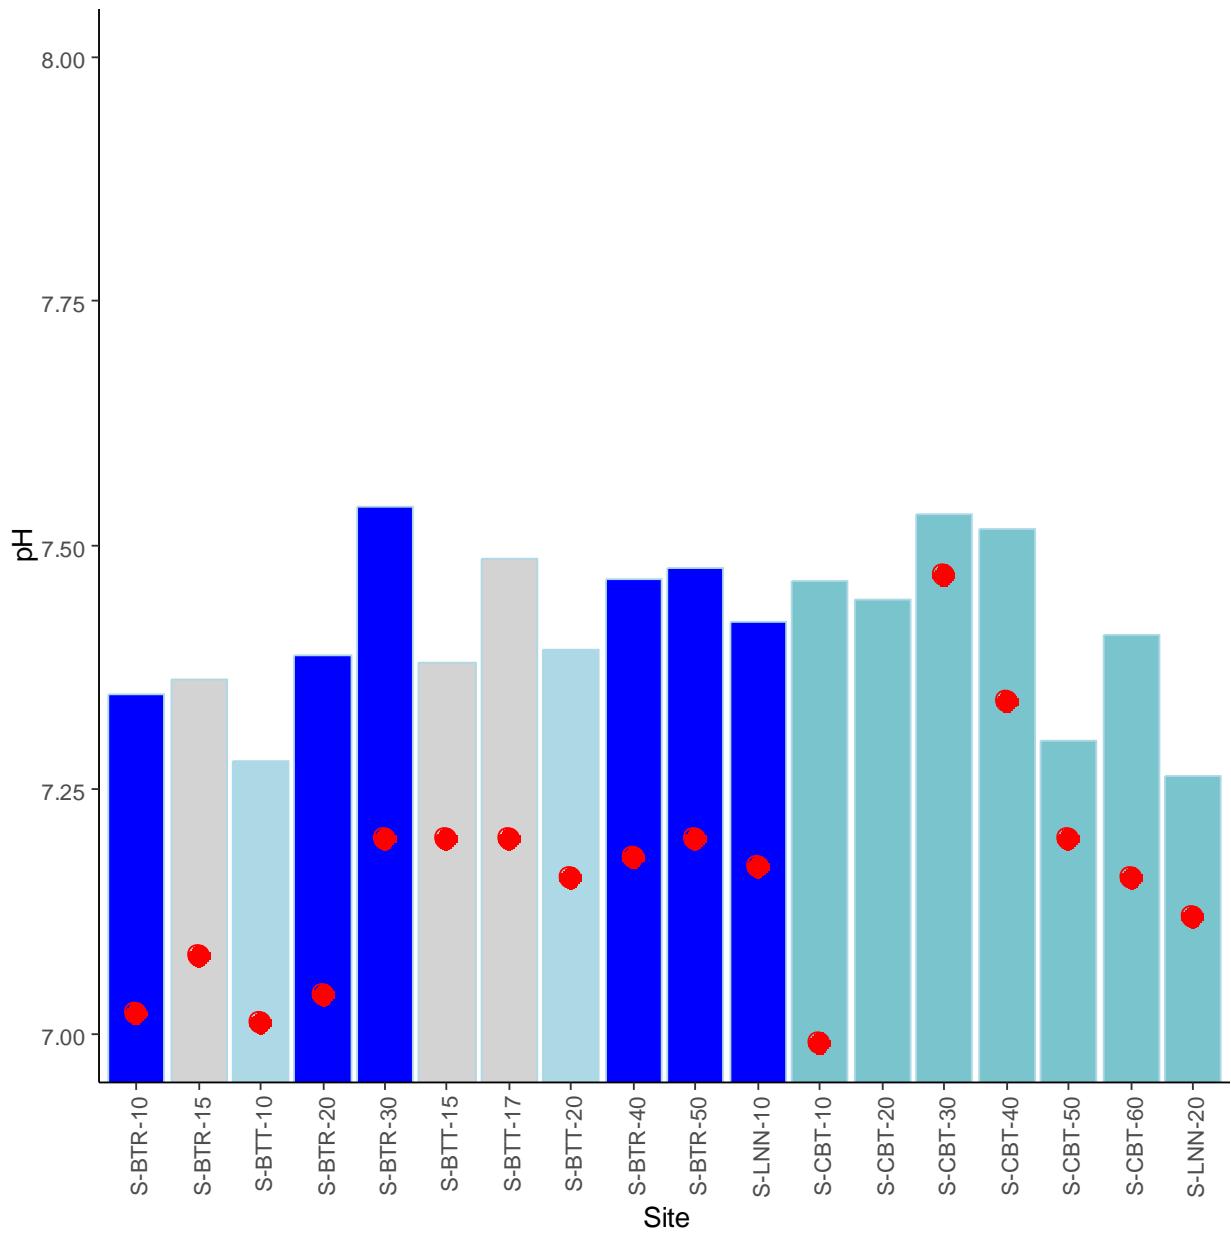
Mean pH values were somewhat lower than the five-year average values at most sites in the summer of 2024 (Figure 5). These results are similar to those documented in spring 2024 and are substantially lower than those documented in summer 2023. These lower values are consistent with watershed recovery from wildfire as white ash from wildfires is generally basic (Rodela et al. 2022). Since all the sites continue to receive lower and lower amounts of ash from the CPF or the East Troublesome Fire as time goes on, it is reasonable to expect pH levels to decline.

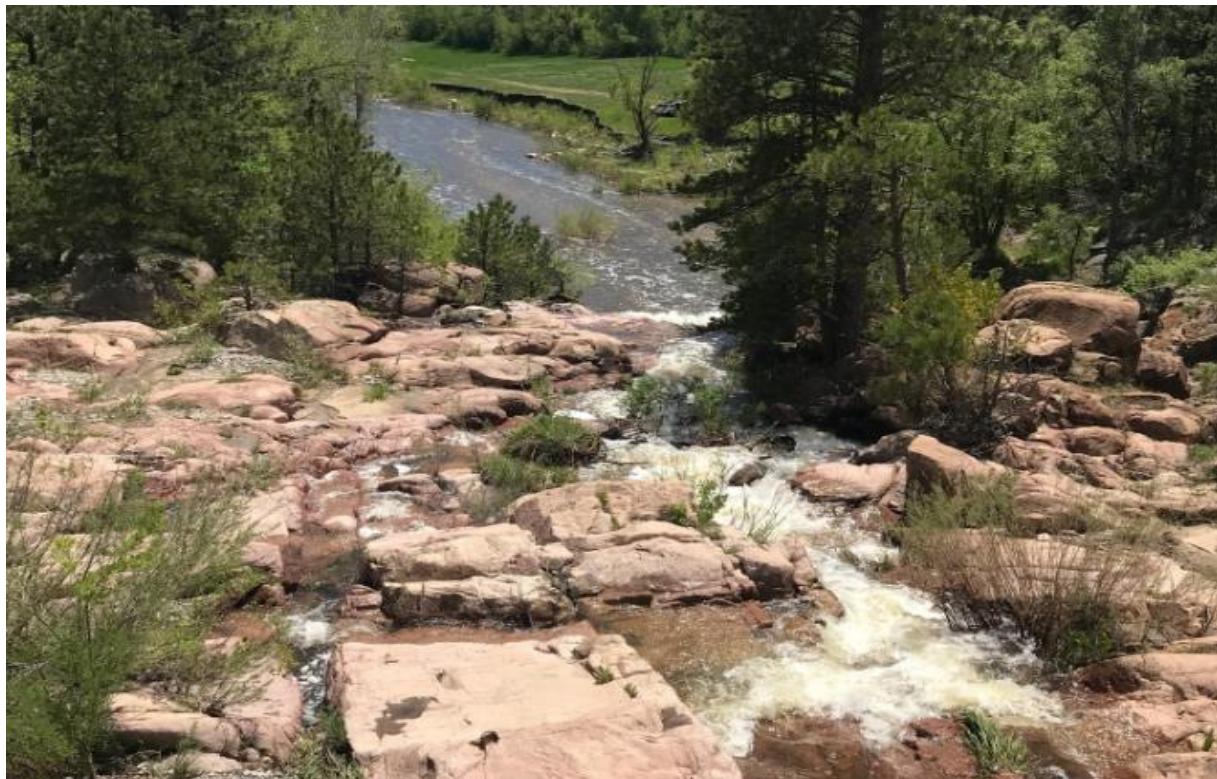
Summer 2024 dissolved oxygen levels were generally near five-year average values across sites (Figure 6). Although dissolved oxygen concentrations were generally near historical values, the spring 2024 dissolved oxygen concentration at the Reservoir Laboratory Line (S-LNN-20) was notably above the five-year average. The cause of this observation is unclear

although dissolved oxygen levels at this site vary dramatically depending on the depth of the intake gate. If the intake gate is at or below the thermocline in Green Ridge Glade Reservoir, dissolved oxygen levels are likely to be relatively low, while if it is above the thermocline, they are likely to be relatively high.

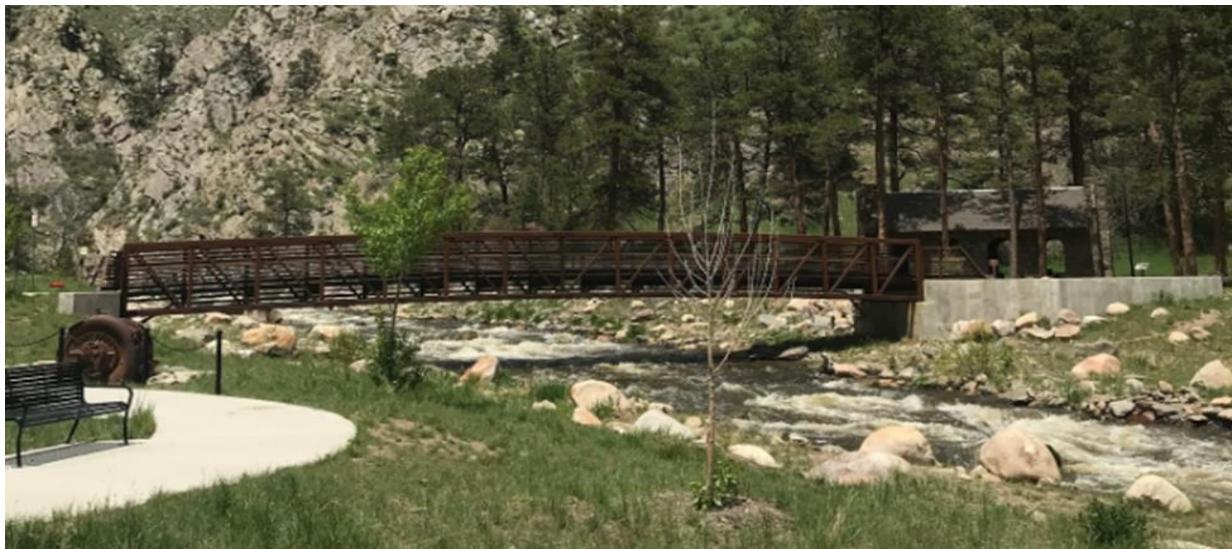
The differences between average spring values in spring 2024 and average spring values over the previous five years were small (Figure 7). However, spring 2024 average values appear higher than spring 2023 values at both sites most affected by the CPF (S-BTT-15 and S-BTT-17). This result is consistent with recovery from wildfire, as alkalinity values generally decline after a wildfire (Rust et al. 2018) and increase during recovery.

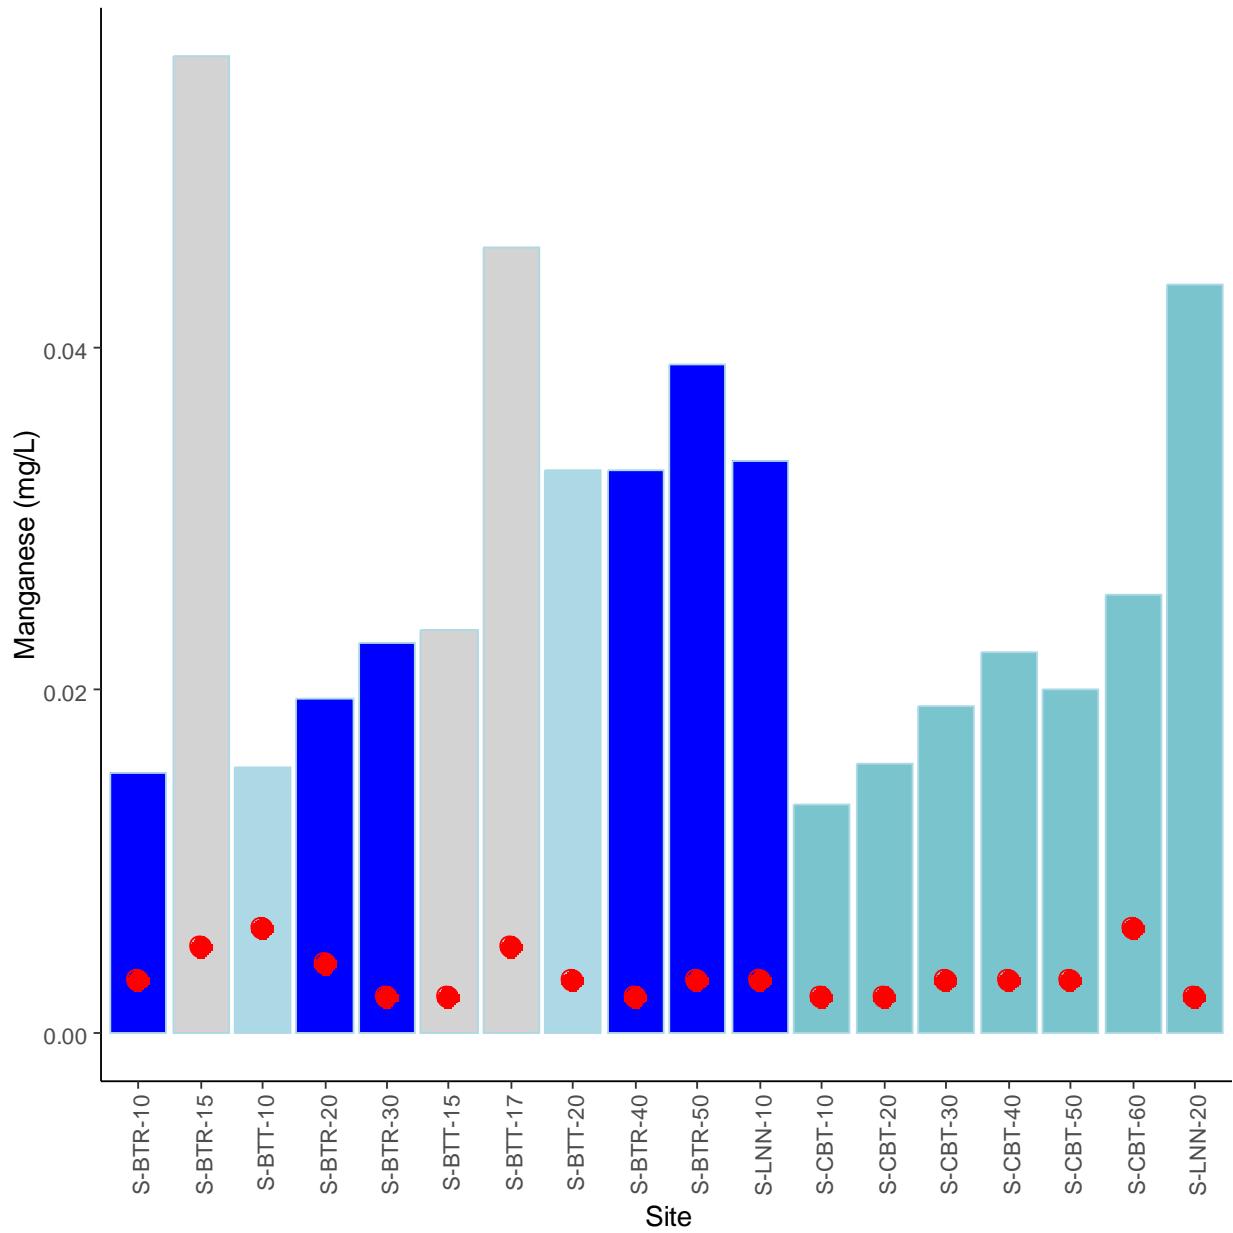
Concentrations of manganese were substantially lower than the five-year average values at all sites. This result is a welcome change from very elevated manganese levels experienced at sites downstream of the CPF in recent years. Summer 2024 values were substantially lower than concentrations measured both in spring 2024 and summer 2023. However, the CPF influence can still be observed in the slightly elevated manganese concentration in Miller Fork (site S-BTT-17) relative to other sampling locations. Increased manganese levels have been associated with the post-wildfire effects, and the fact that they appear to be declining is consistent with ongoing recovery of the watershed from the CPF. Elevated manganese levels are also associated with runoff events and high turbidity. Universally low manganese concentrations are also consistent with the relatively low turbidity and dry conditions in summer 2024.

The EPA has a “secondary” standard of 0.05 mg/L (ppm) for manganese. This level does not make water unsafe to drink, but the water may be aesthetically unpleasing due to a reddish/black/brown color, which can stain laundry, plumbing, sinks, and showers. Mean summer 2024 manganese concentrations were well below this standard at all sampling locations.

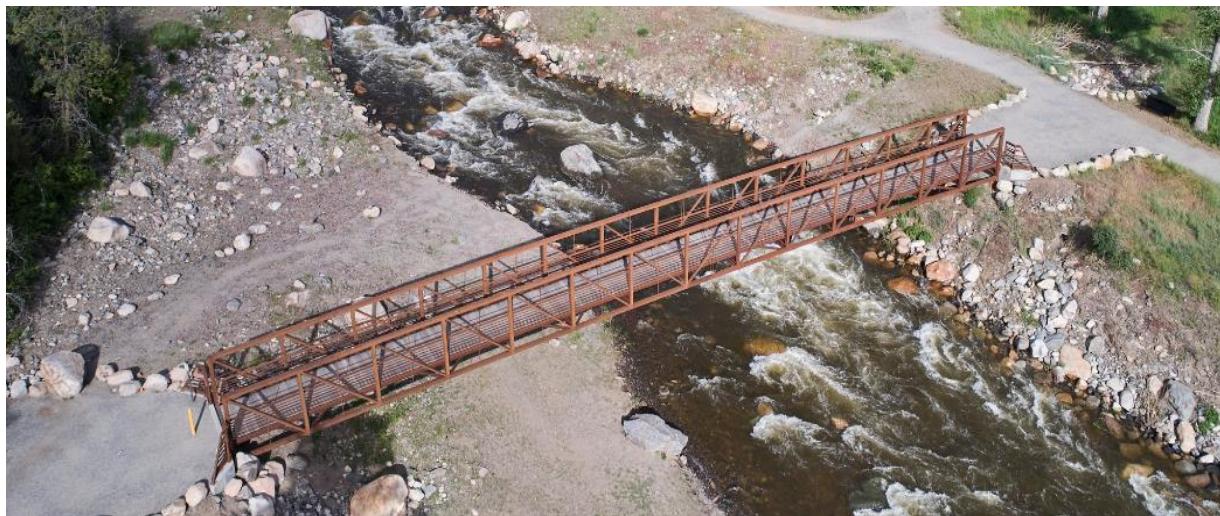
Total copper levels in the summer of 2024 were below five-year average values (Figure 9), and total copper levels were generally lower in the post-CPF period. While these lower levels indicate continued effects of the CPF, they are also positive from a water quality perspective and represent one of the few positive outcomes of the CPF. There was a dramatic decrease in total copper concentration in the first spring after the full fire effects were apparent (i.e., summer 2021) at locations impacted by the fire, and these lower levels seem to persist.

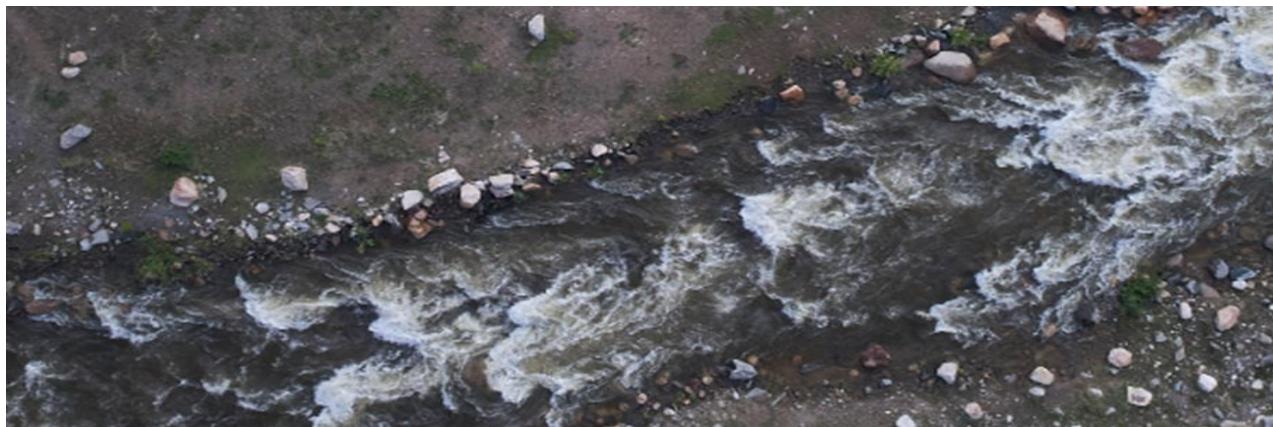
Average total iron concentrations in summer 2024 are generally near five-year average values at most sites (Figure 10). The area in the North Fork watershed above the sampling site was included in the area that was most severely burned during the CPF in the fall of 2020, and total iron levels have been elevated at this location in the years since the fire. The fact that summer 2024 concentrations were substantially below the five-year average value at the North Fork sampling location (S-BTT-17) and were similar to other sampling locations indicates that the watershed is continuing to recover from the fire.

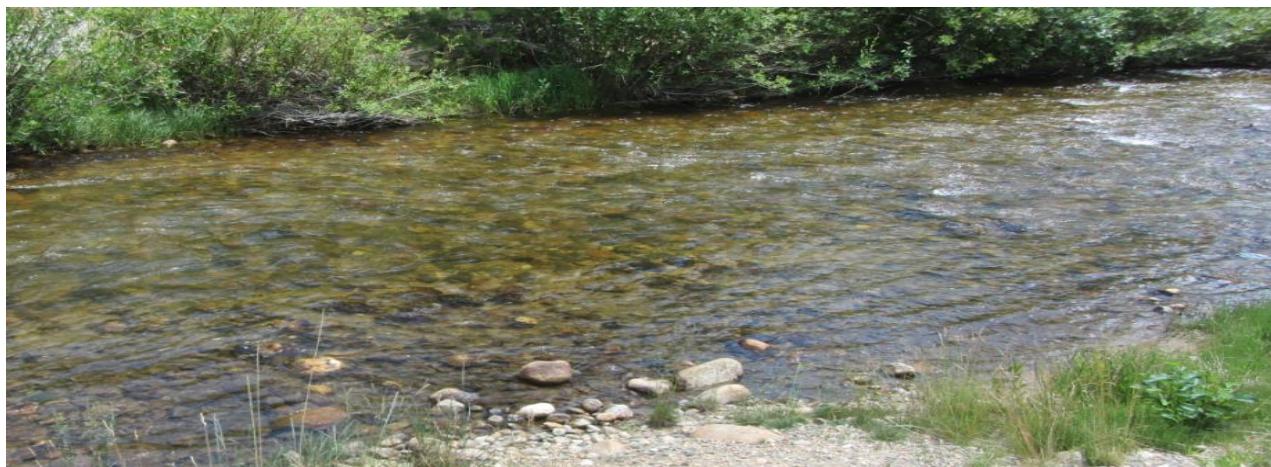
Except for the Miller Fork site (S-BTT-17), nitrate concentrations in spring 2024 were near five-year average values. While values at the Miller Fork site (S-BTT-17) were substantially lower than in summer 2023, they were still elevated compared to other sites. Given that elevated nitrate can and has been an aftereffect of the CPF (Rust et al. 2018), and that we have documented elevated nitrate as a continuing effect of the CPF in previous seasonal and annual reports, near-average or below-average values are another positive indication that the Big Thompson watershed is recovering from the CPF.

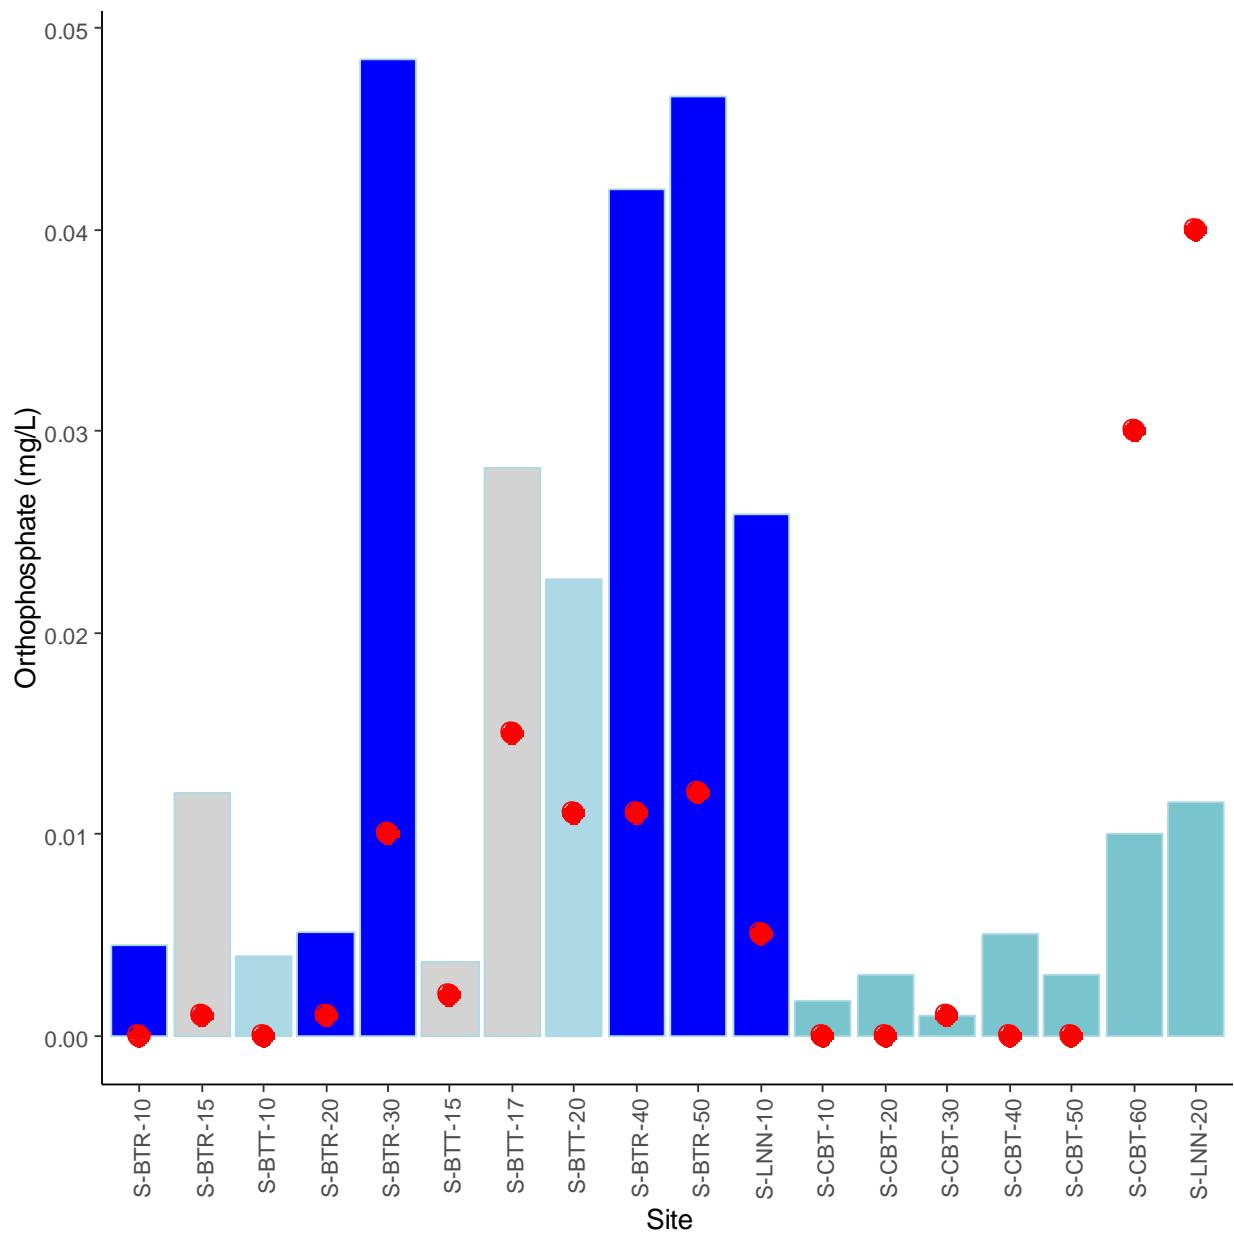
Similar to spring 2024, summer 2024 orthophosphate concentrations were generally low compared to the five-year average values for most sites (Figure 12). This result is positive from a water quality perspective. These low and declining orthophosphate concentrations were observed in the last year and hopefully will persist. Conversely, orthophosphate levels at both the Hansen Feeder Canal near the outlet leading to Green Ridge Glade Reservoir and the Green Ridge Glade Reservoir laboratory line were substantially higher than the five-year average value. The cause of these two elevated values is unknown. These high values are particularly of note because the upstream sites in the CB-T (Hansen Canal below Flatiron Reservoir and above) have relatively low orthophosphate concentrations compared to the five-year average.

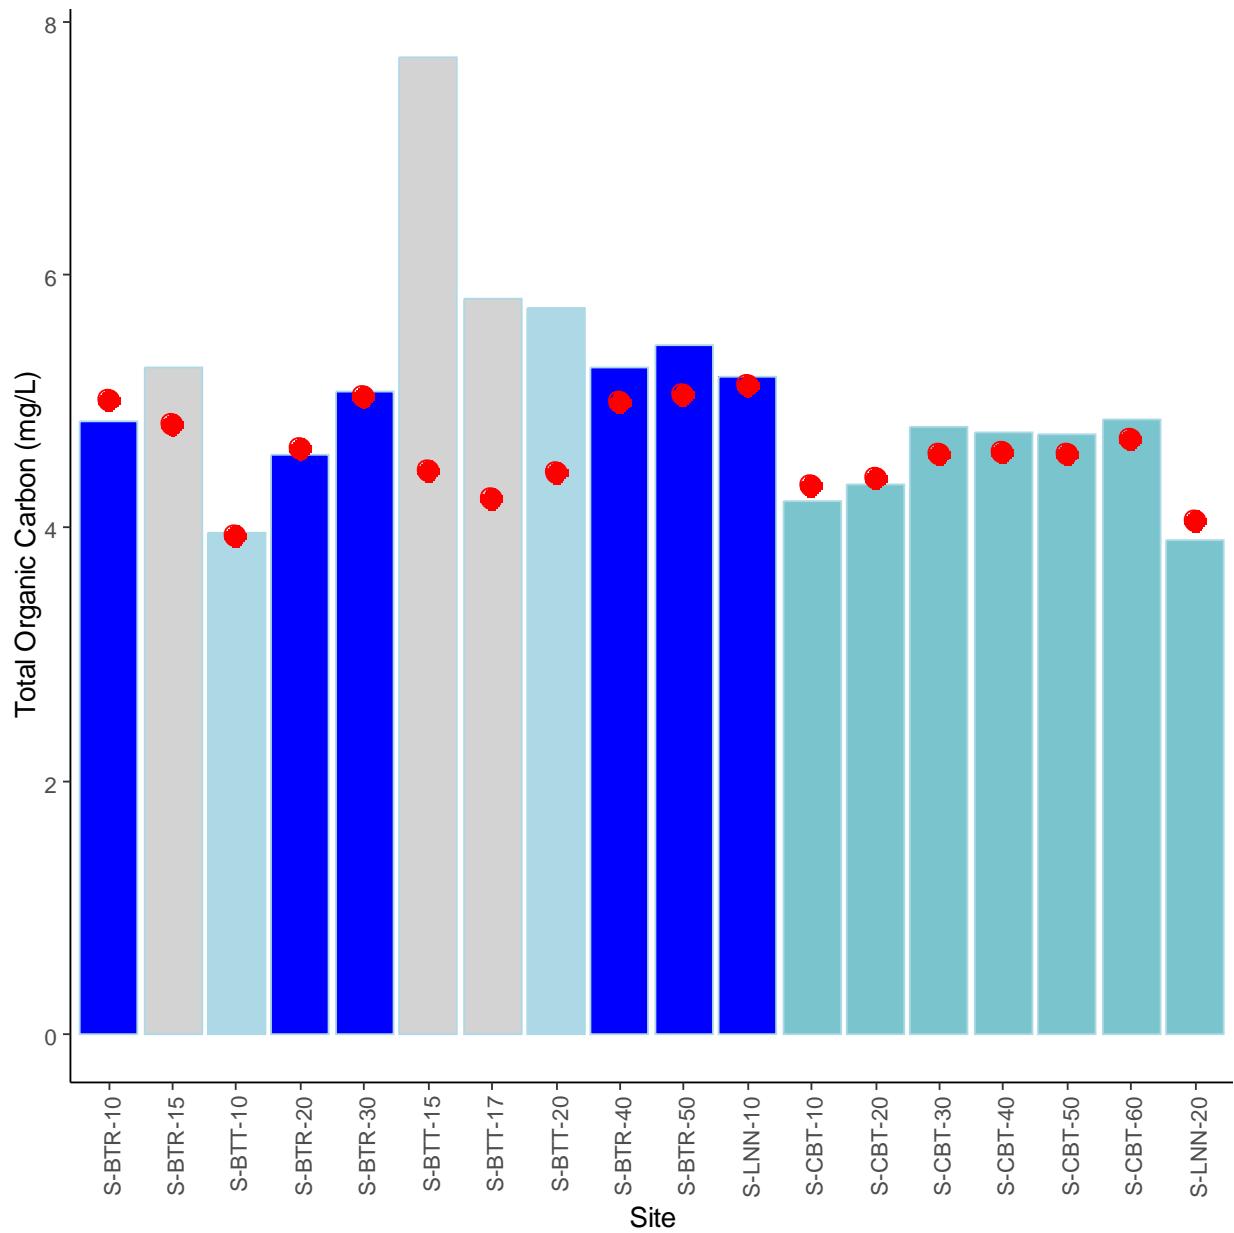
Summer 2024 TOC values were similar to five-year average values at virtually all sites (Figure 13). Organic carbon is often reduced in severely burned areas compared to unburned areas immediately after a fire (Rhoades et al. 2019). Near-average TOC values suggest that TOC concentrations have increased modestly from lows immediately following the CPF and this observation is consistent with fire recovery.

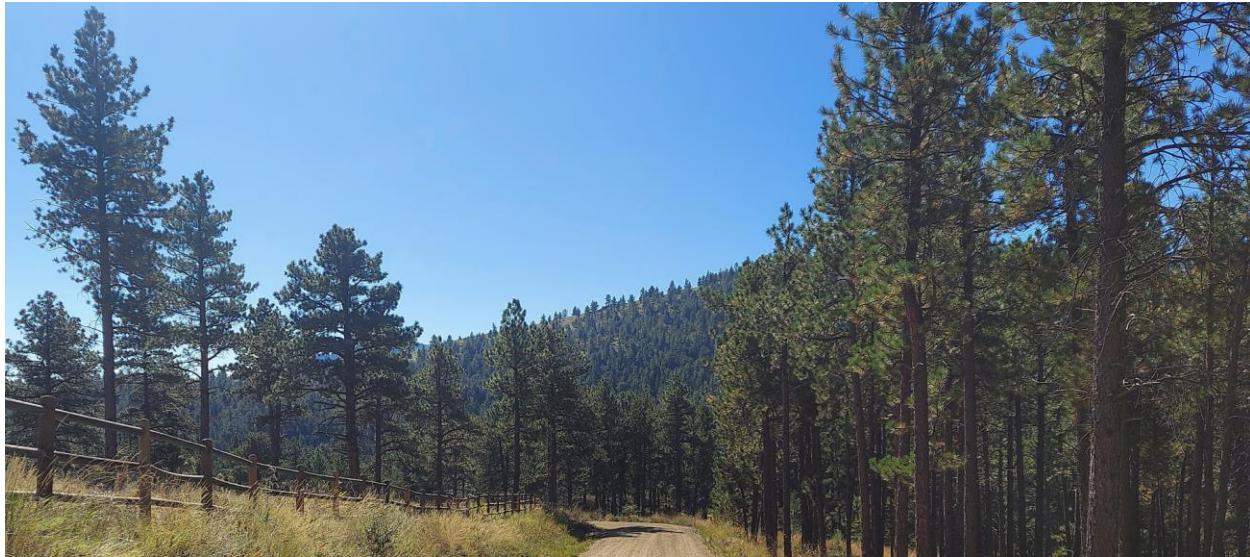
Figure 14. An example of forest management in the Big Thompson River watershed. The forest on the left side of the road has been thinned to historic tree density. The forest on the right side of the road has not been treated.
