HISTORIC LOVELAND ELKS LODGE (BPOE #1051) BUILDING

HISTORIC STRUCTURE ASSESSMENT PHOTOS

PAGE NUMBER EC-1	HISTORIC STRUCTURE ASSESSMENT HISTORIC BPOE #1051 BUILDING CHS/SHF #2011-HA-012	EXISTING CONDITIONS PHOTOS PREPARED BY: P. Berglund CHECKED BY: R. S. Beardmore, PE

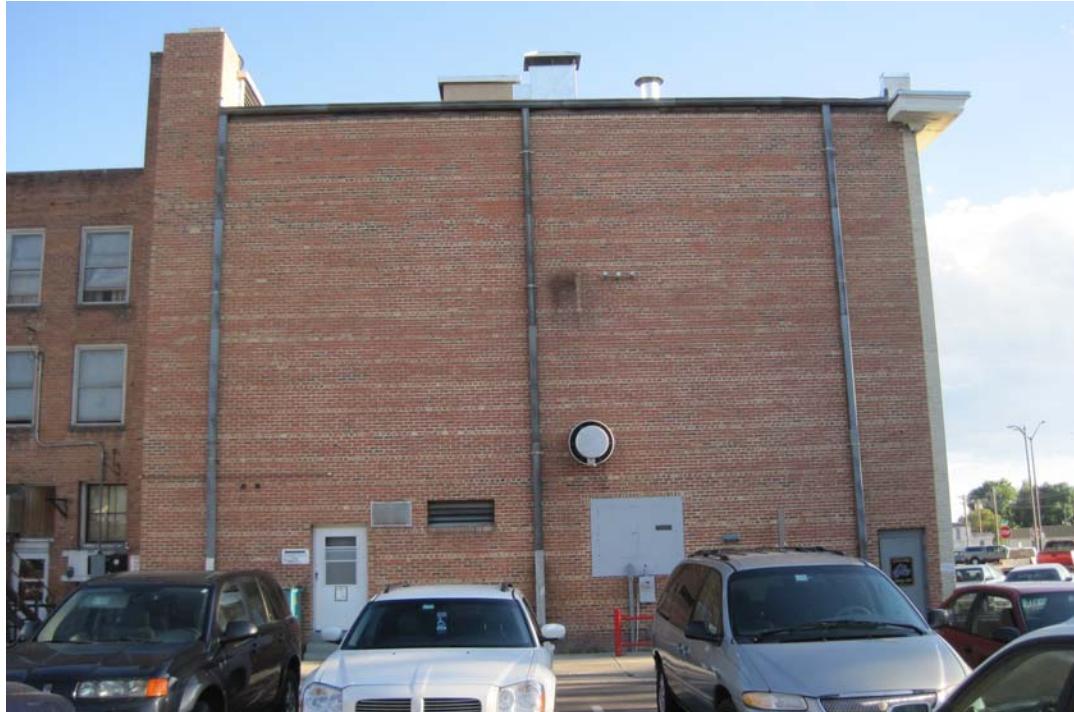
LEL9324 NORTH (REAR) ELEVATION

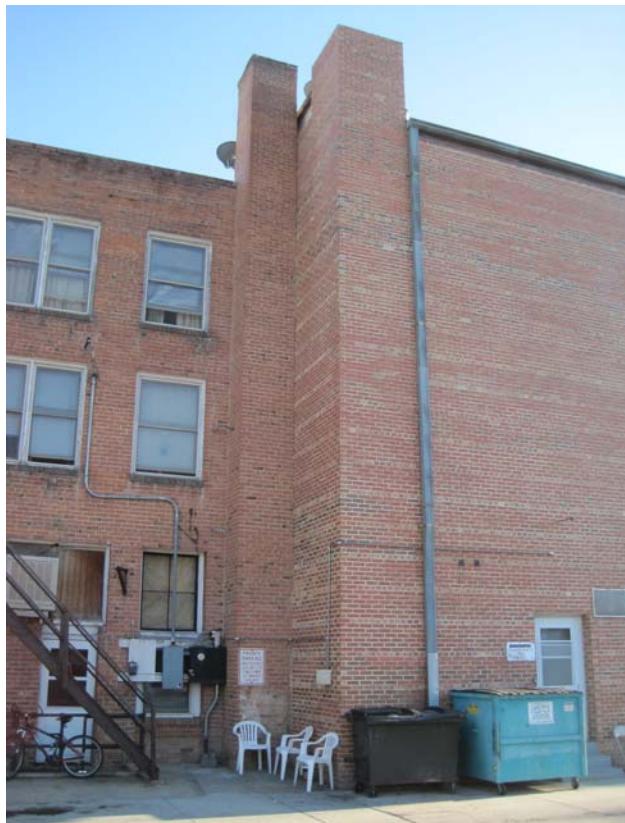
LEL9326 NORTHEAST CORNER VIEW SHOWING
ADJACENT STRUCTURE TO EAST

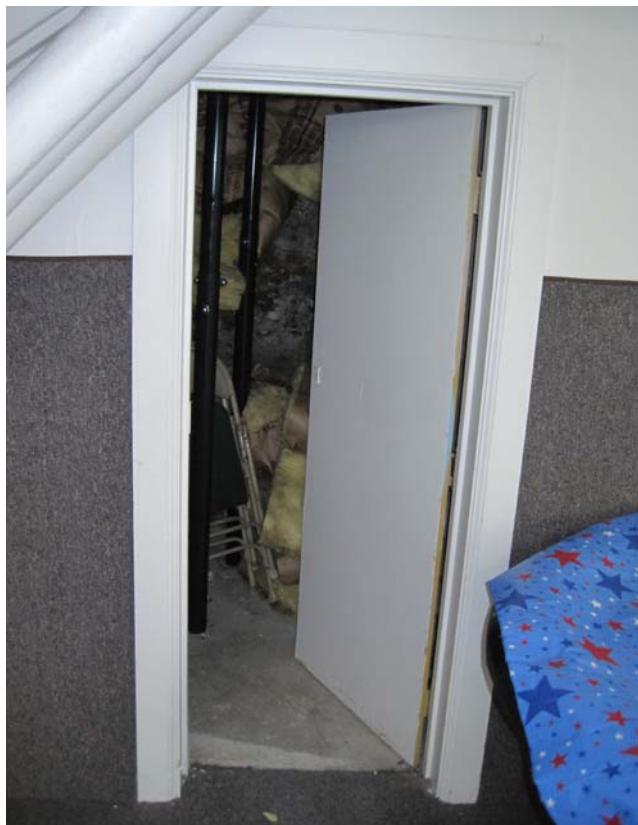
LEL7419 DOORWAY INTO REMAINING WEST
SUB-SIDEWALK VAULT

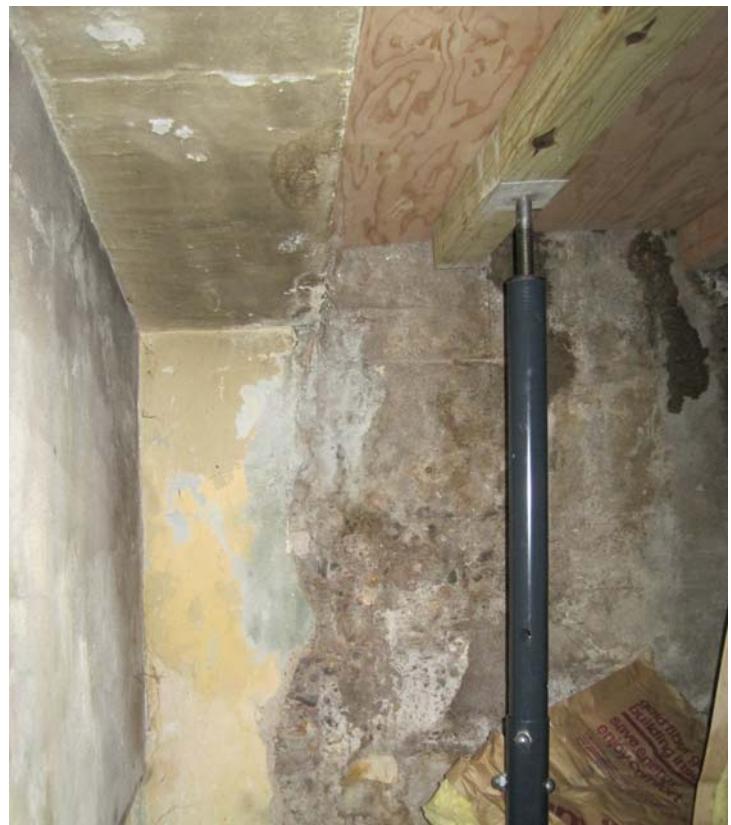
LEL7420 HISTORIC PLASTERED ARCH (AT LEFT), BRACING,
AND SUB-SIDEWALK CONCRETE (AT RIGHT)

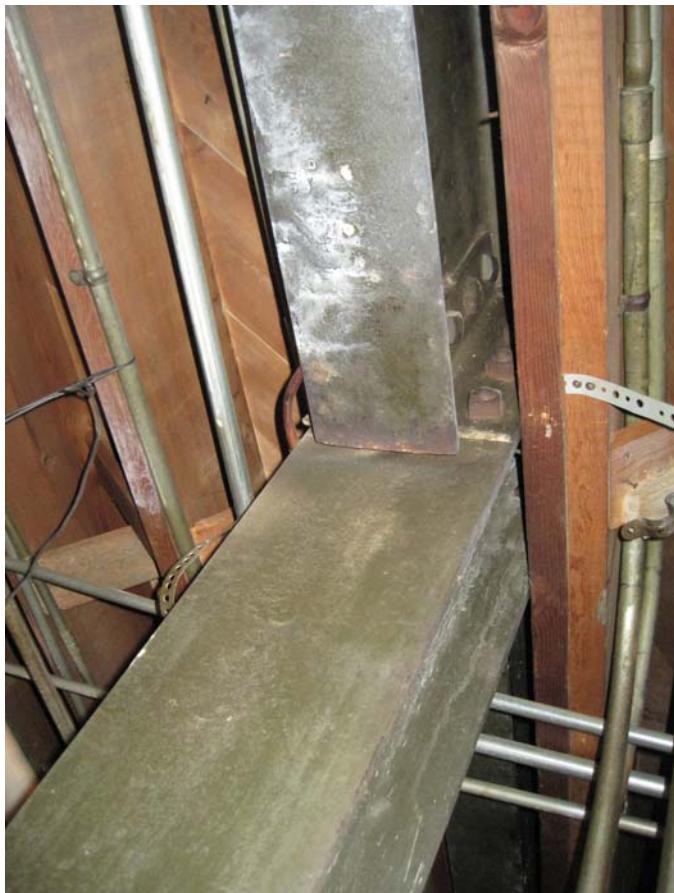
LEL7353 STEEL COLUMN AND BEAM IN BASEMENT
BOILER ROOM

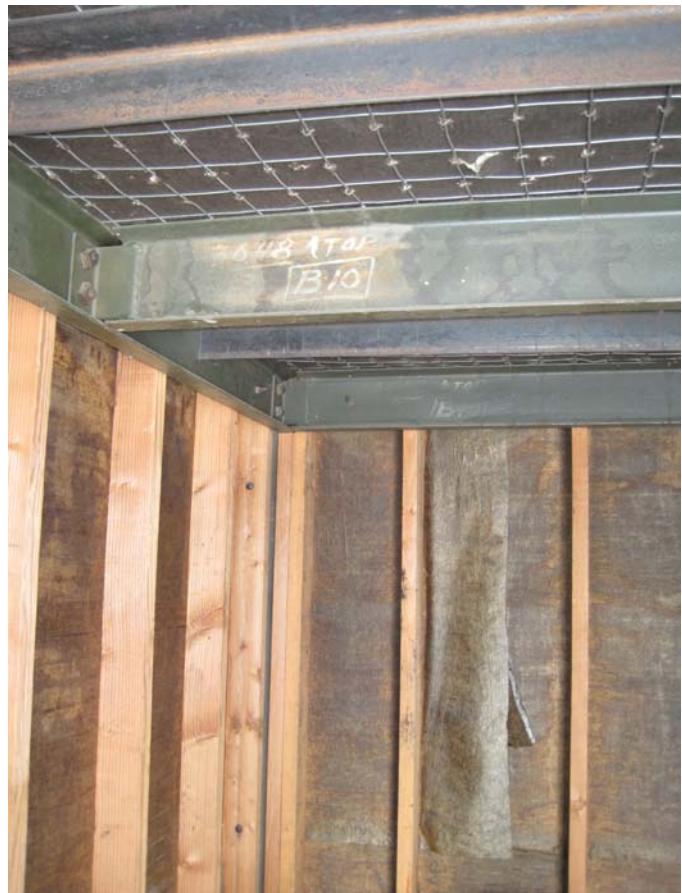
LEL7744 WOOD AND STEEL STRUCTURAL SYSTEM OF
ROOFTOP ELEVATOR ENCLOSURE

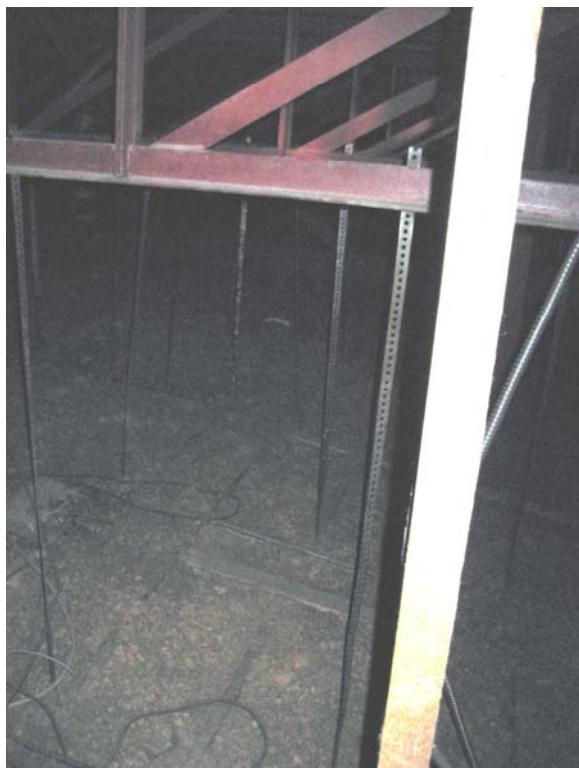
LEL7749 STEEL TRUSSES WITH STRAPS SUPPORTING LODGE ROOM CEILING

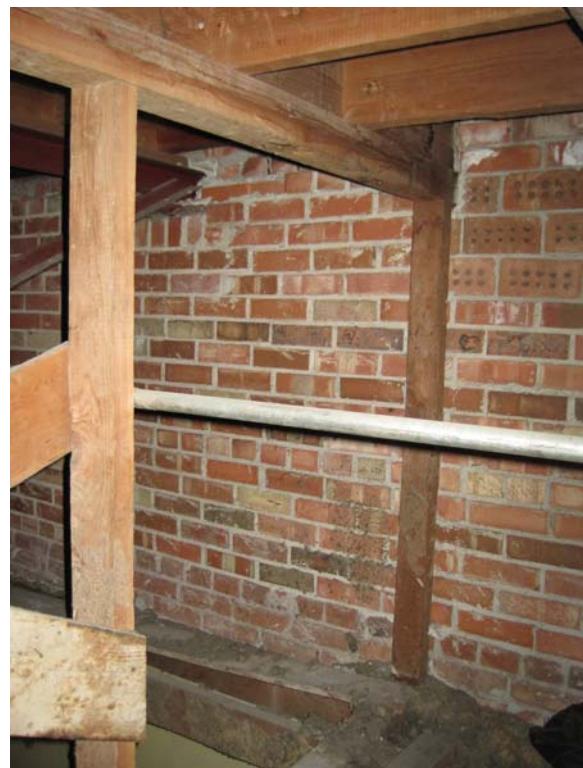
LEL7754 STEEL TRUSS (IN BACKGROUND) BEARING ON WEST BRICK MASONRY WALL

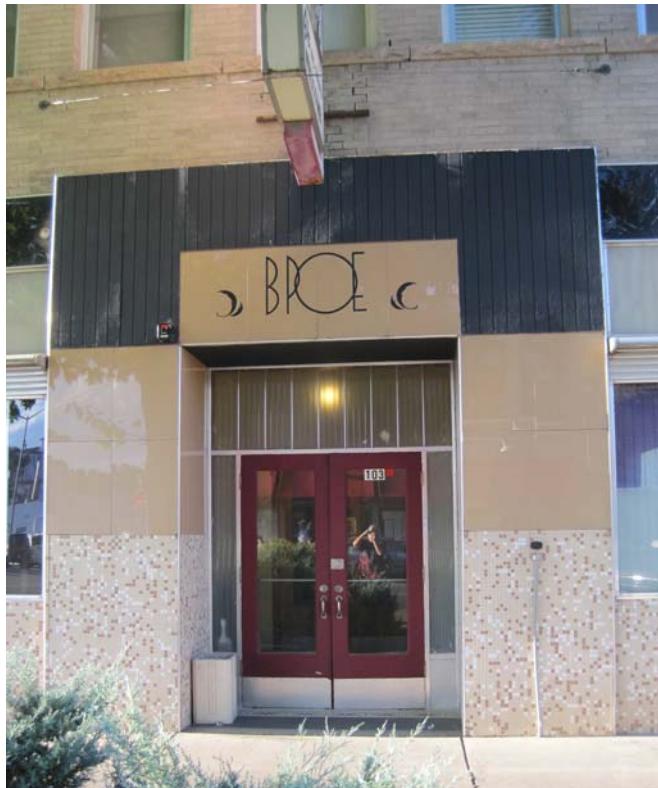
LEL9352 EXTERIOR STOREFRONT FINISHES, FURRED AND FACE APPLIED AT SOUTH GROUND LEVEL

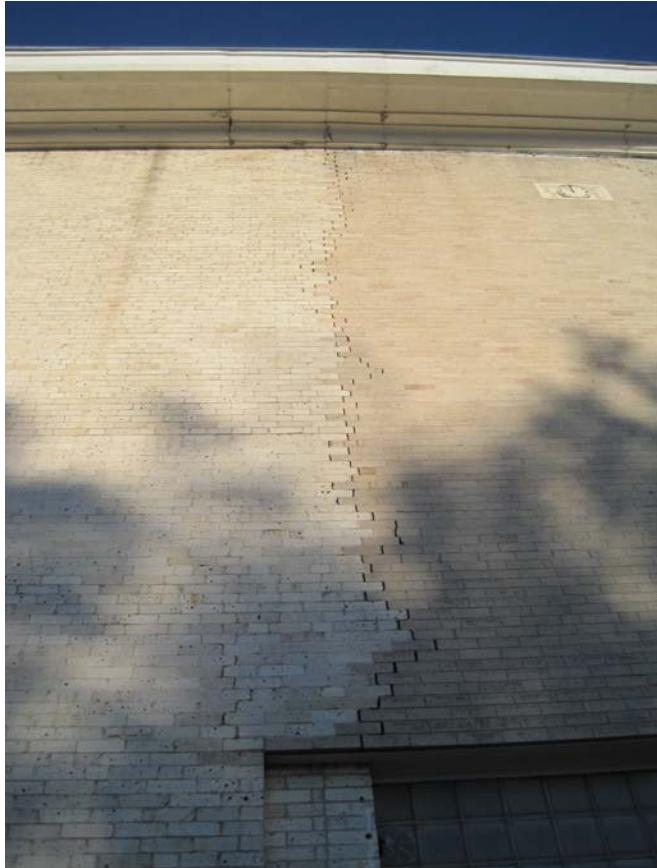
LEL9336 OPEN TOOTHING AT NORTH ADDITION INTERFACE WITH OLDER MASONRY

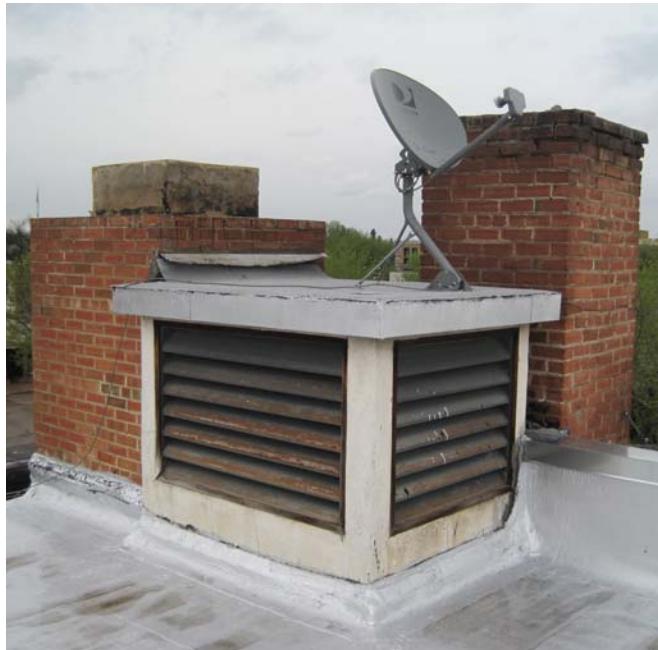
LEL7724 NORTHEAST CORNER VENT CHASE AND CHIMNEY (ACTIVE BOILER FLUE)

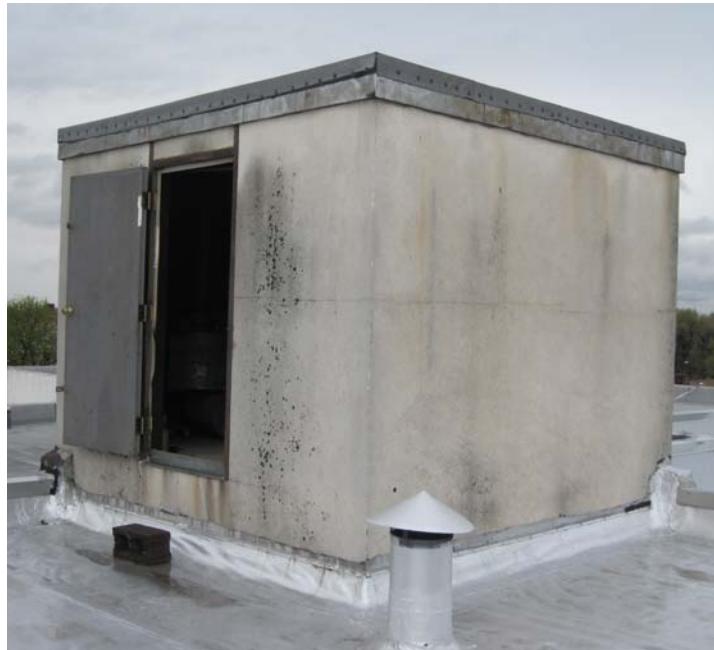
LEL7741 ELEVATOR ENCLOSURE

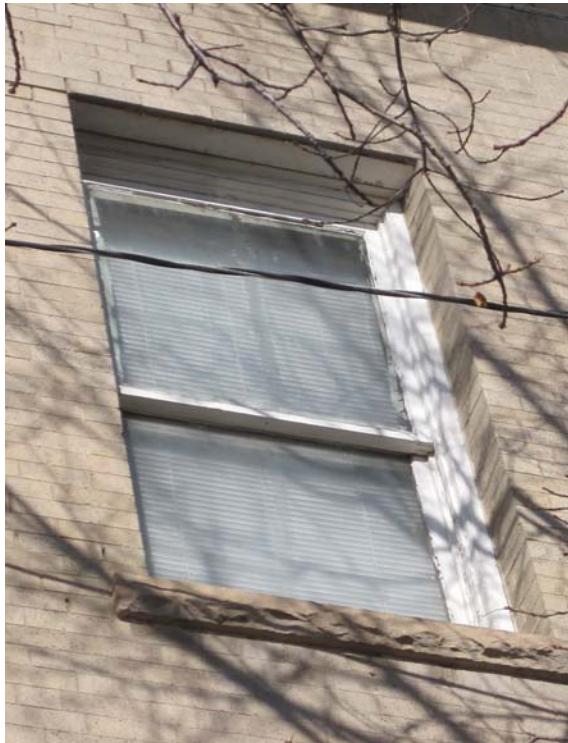
LEL1051 WESTERNMOST SOUTH ELEVATION
THIRD FLOOR WINDOW

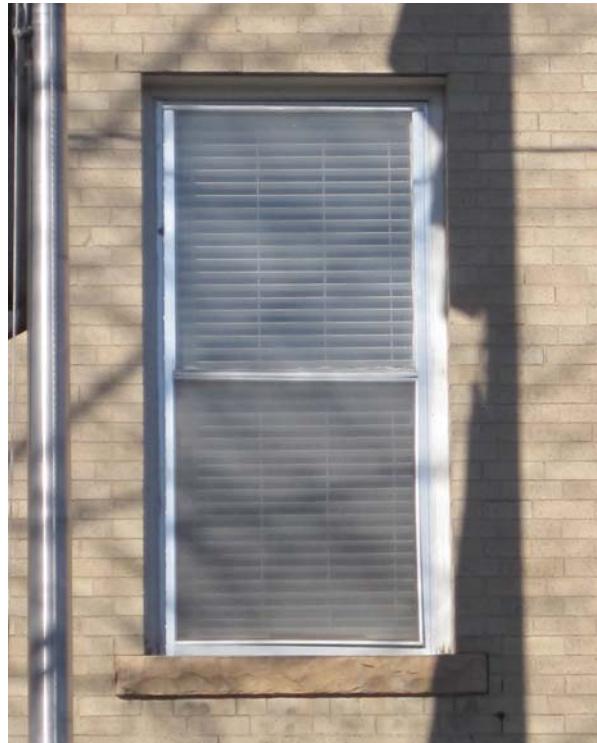
LEL1048 EASTERNMOST SOUTH ELEVATION
SECOND FLOOR WINDOW

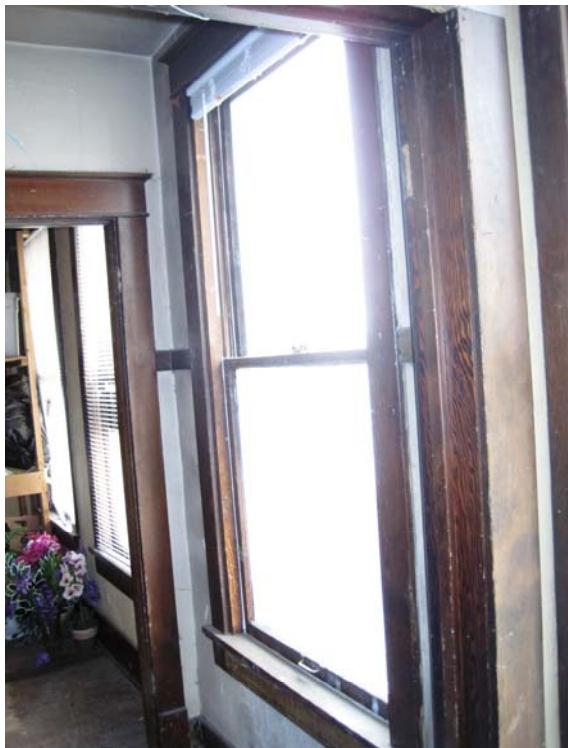
LEL7790 SOUTH ELEVATION WINDOW AND
ADJACENT INTERIOR FINISHES

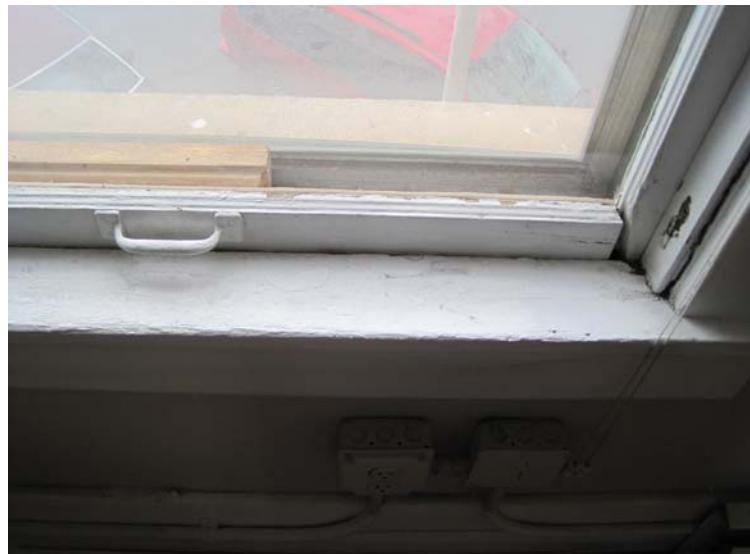
LEL7635 INTERIOR OF EASTERNMOST SOUTH ELEVATION
WINDOW

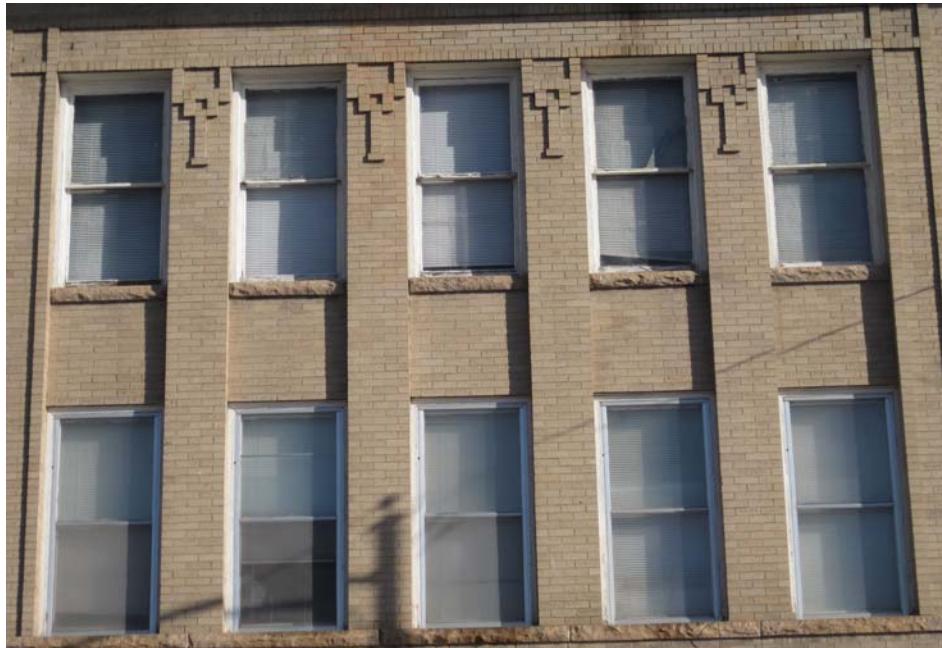
LEL1052 SECOND AND THIRD FLOOR WINDOWS ON WEST ELEVATION OF SOUTH (ORIGINAL) SECTION OF BUILDING

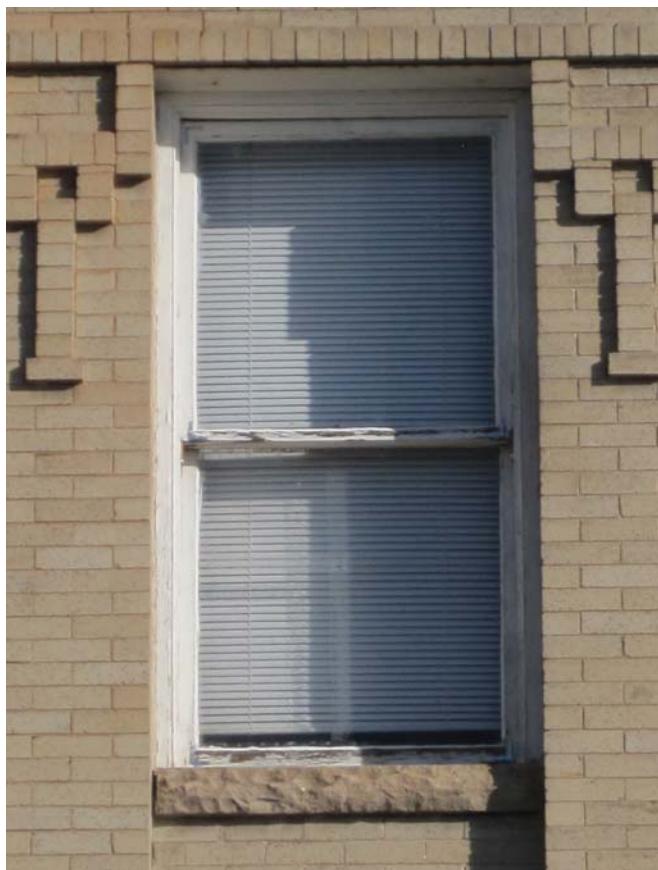
LEL1053 SOUTH BUILDING WEST ELEVATION THIRD FLOOR WINDOW AND CONTEXT

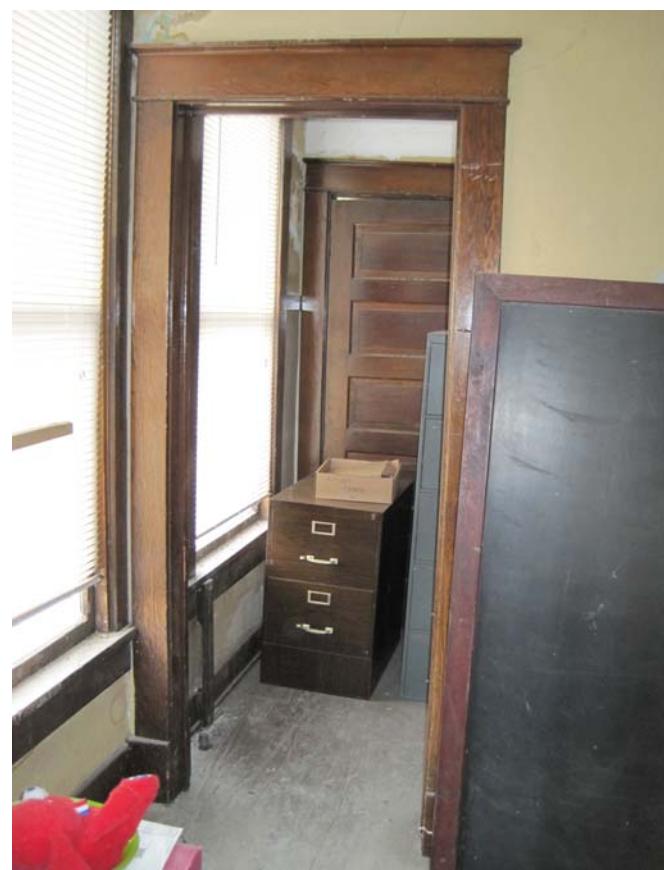
LEL7808 WINDOWS, DOORS, AND OTHER THIRD FLOOR INTERIOR FINISHES

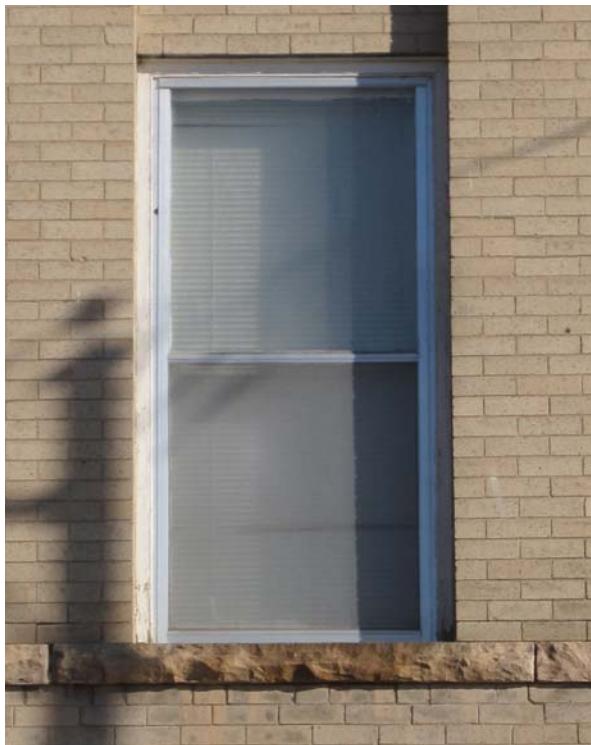
LEL1055 SOUTH BUILDING WEST ELEVATION
SECOND FLOOR WINDOW

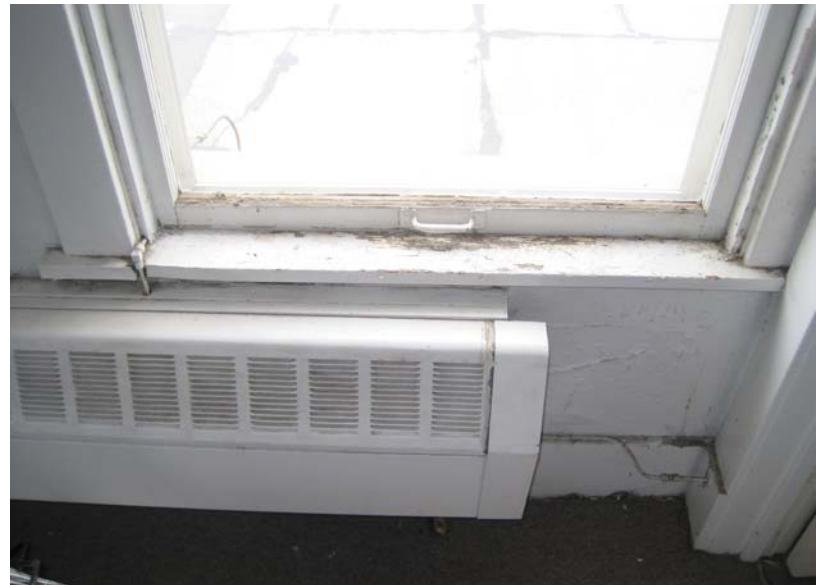
LEL7666 INTERIOR OF SECOND FLOOR WINDOW AND ADJACENT
FINISHES AND FEATURES

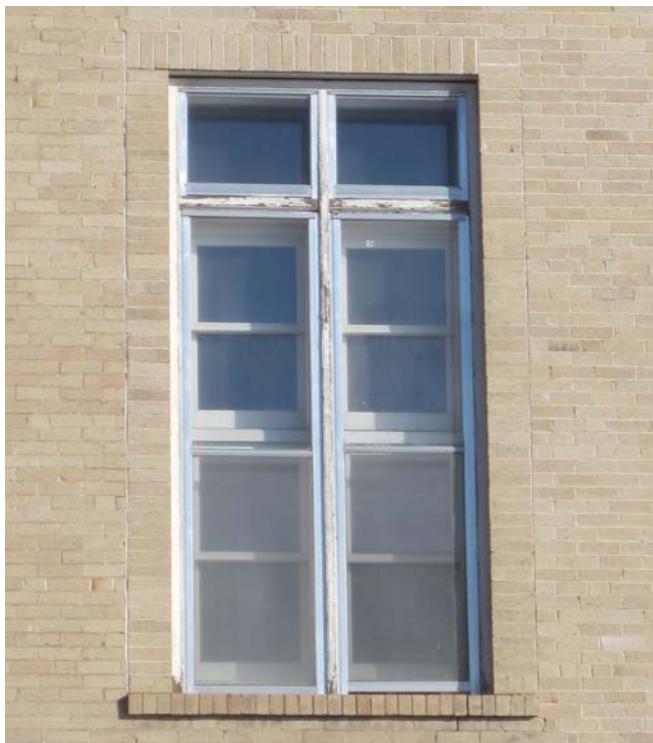
LEL1058 WEST ELEVATION LODGE ROOM STACKED
PAIRED DOUBLE HUNG WINDOWS

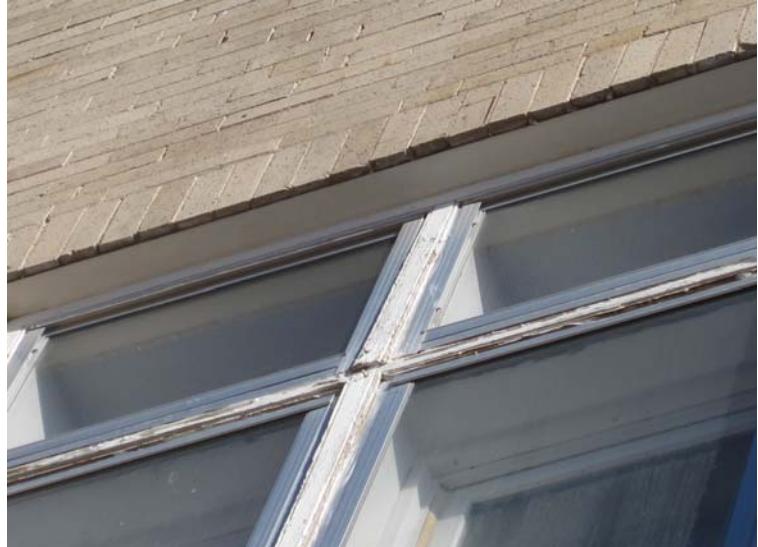
LEL1064 CLOSER VIEW OF DETAIL OF WINDOW SHOWN IN
LEL1058

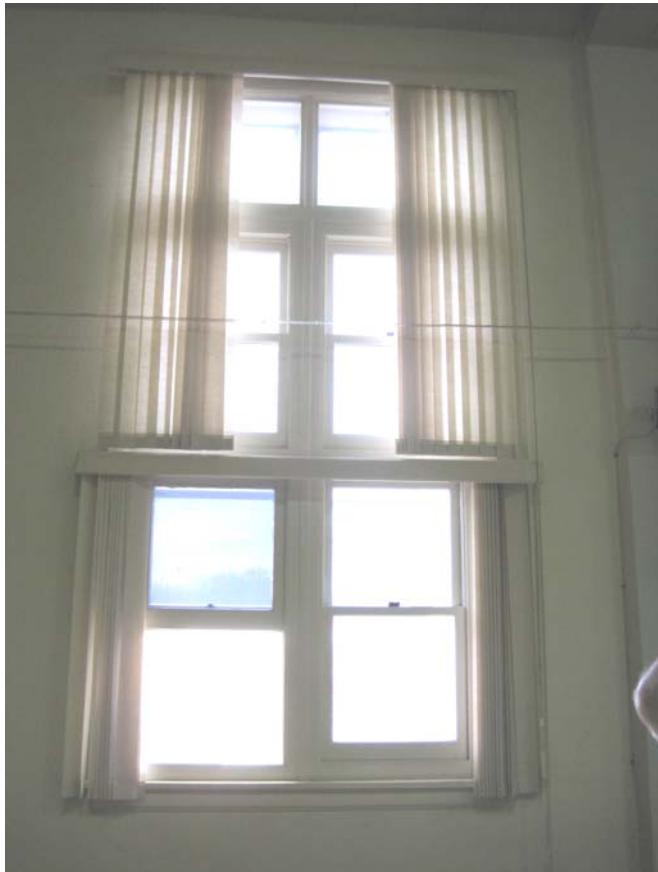
LEL7608 LODGE ROOM WINDOW ASSEMBLY

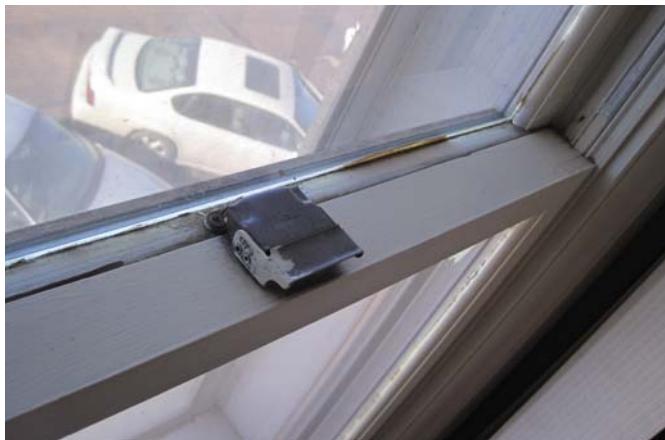
LEL1018 SASH LOCK ON LODGE ROOM WINDOW

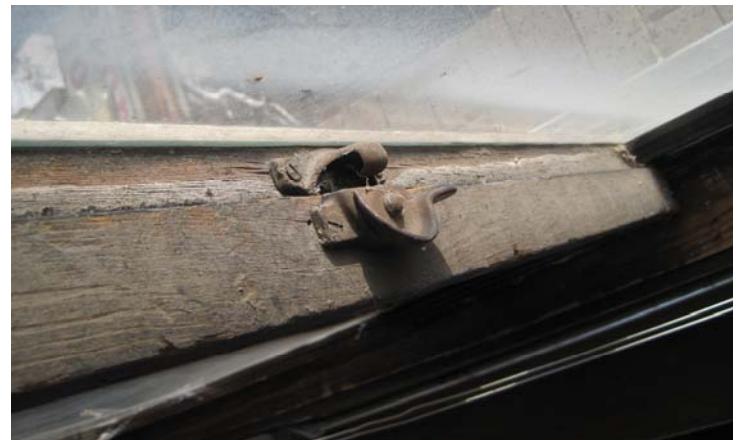
LEL0993 SASH LOCK ON ORIGINAL SOUTH WINDOW

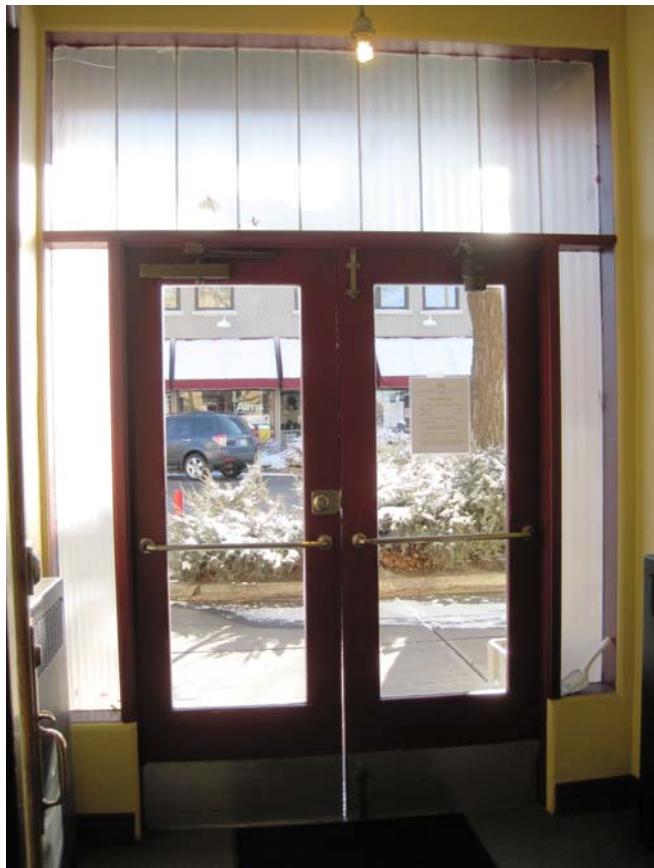
LEL1036 INTERIOR OF SOUTH ENTRY DOORS

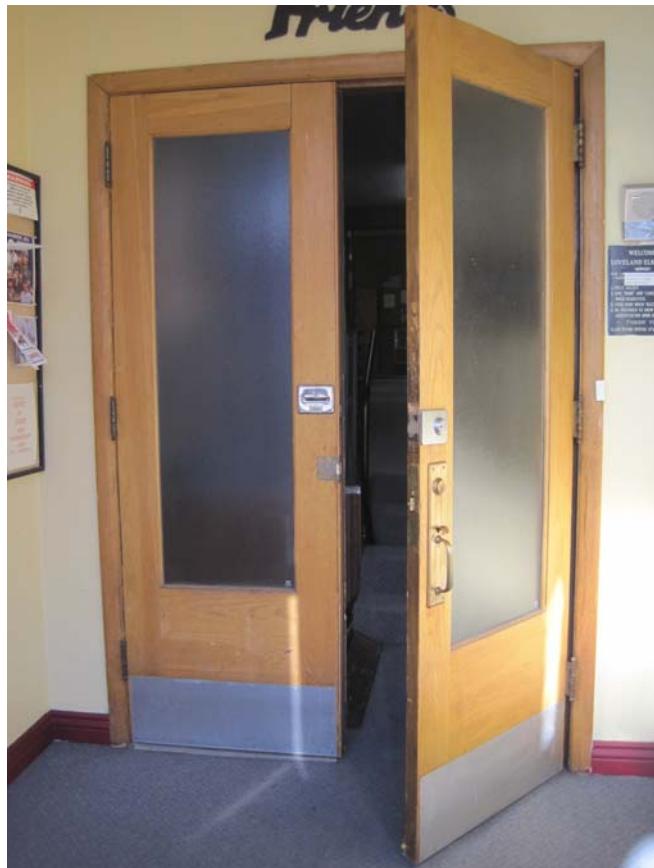
LEL1035 INTERIOR DOORS OF SOUTH VESTIBULE

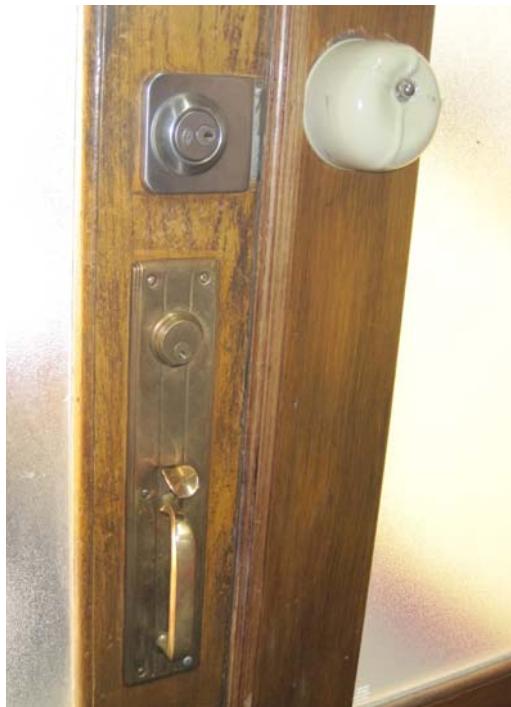
LEL1038 VESTIBULE DOOR HARDWARE

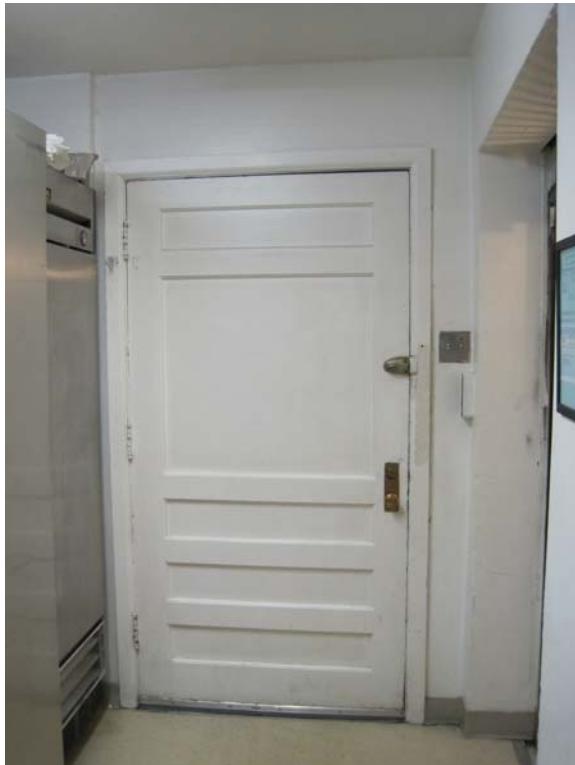
LEL8799 INTERIOR OF NORTH EXTERIOR DOOR
OPENING INTO FIRST FLOOR KITCHEN

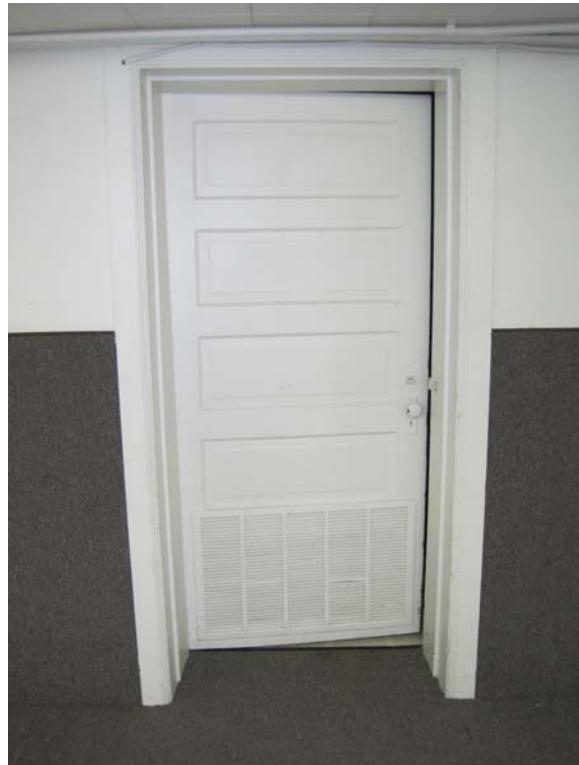
LEL7490 BASEMENT DOOR WITH LOWER GRILLE

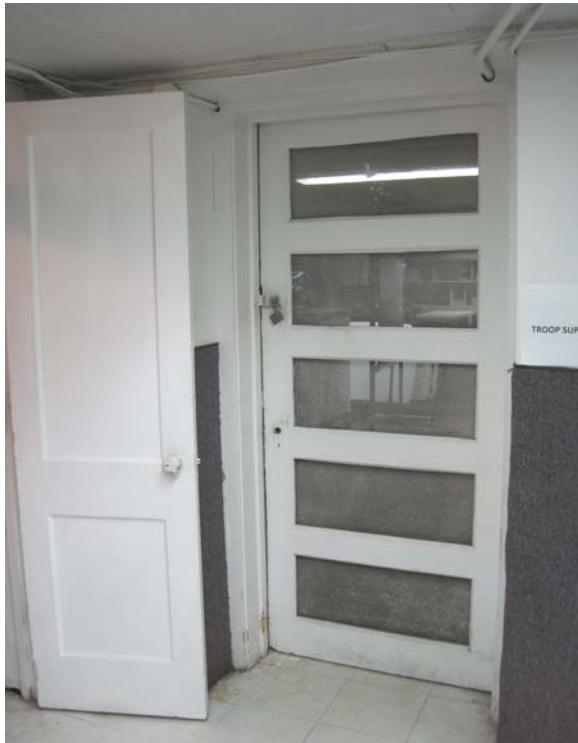
LEL7478 SCREEN DOOR TO BASEMENT LARGE
STORAGE ROOM

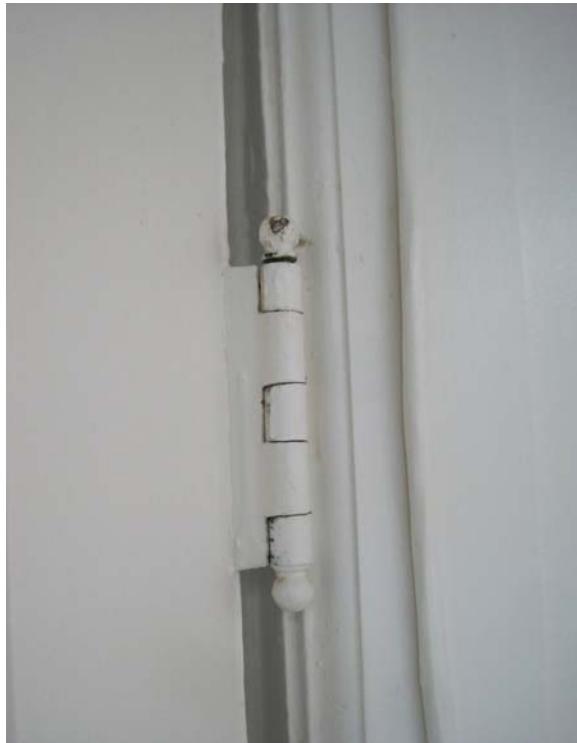
LEL7326 TYPICAL HISTORIC BASEMENT DOOR
BALL TIPPED HINGE

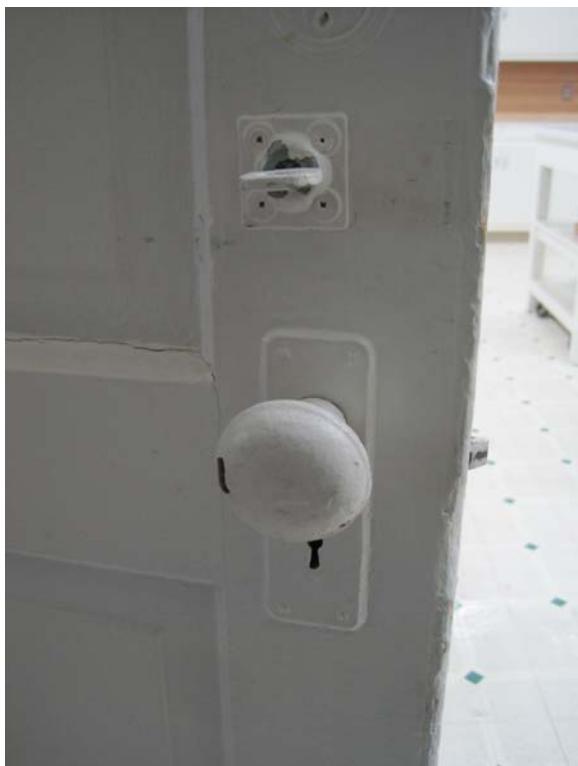
LEL7328 HISTORIC BASEMENT DOOR HARDWARE

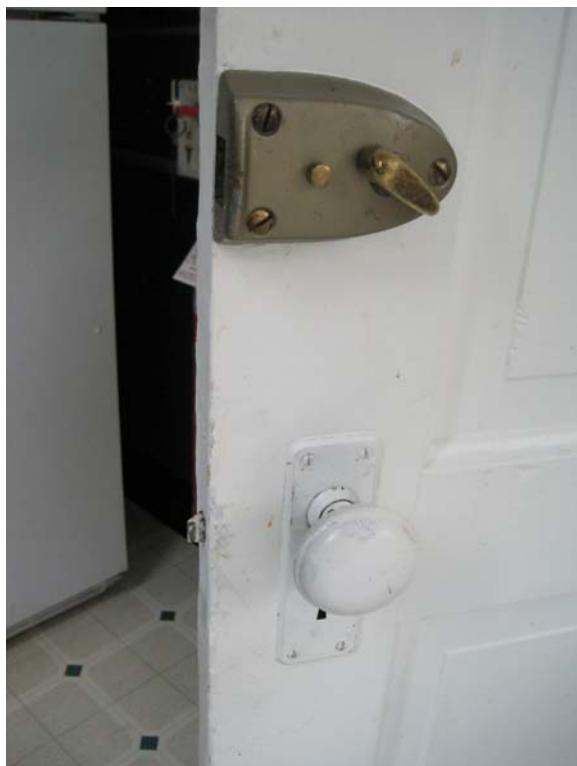
LEL7327 BASEMENT DOOR HARDWARE

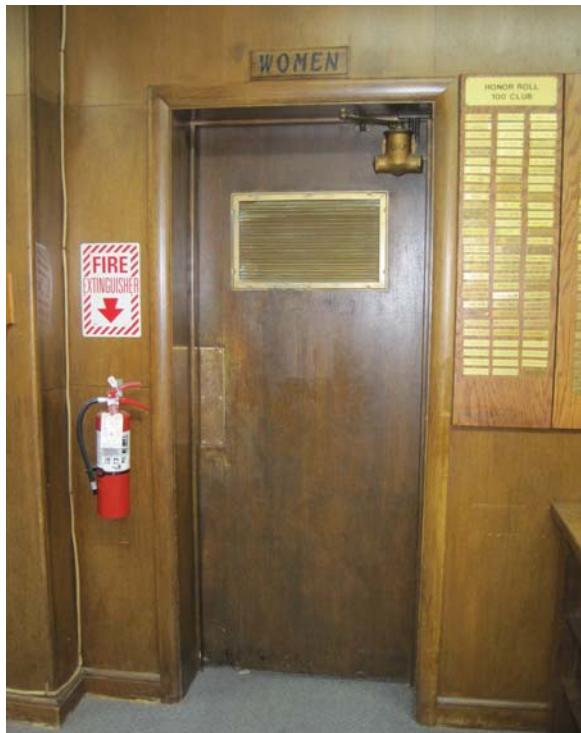
LEL7876 FIRST FLOOR HISTORIC DOOR WITH GRILLE

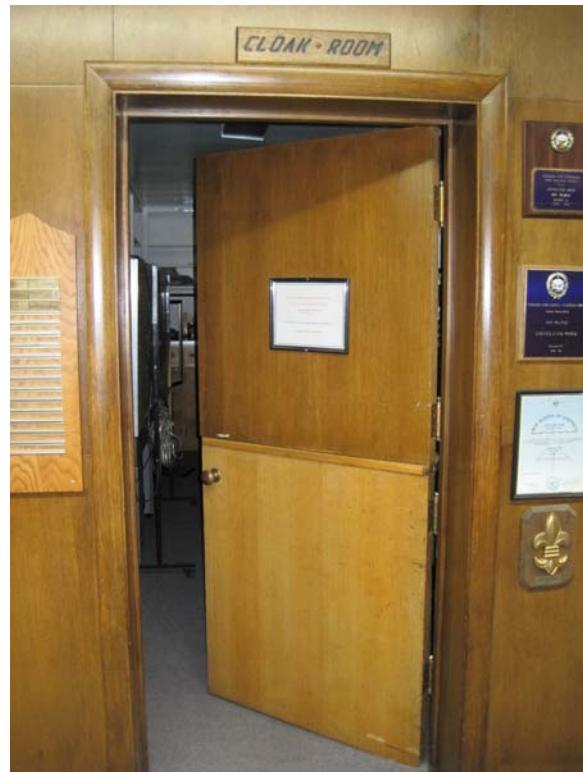
LEL7870 REDESIGNED "DUTCH" DOOR AT FIRST FLOOR CLOAK ROOM

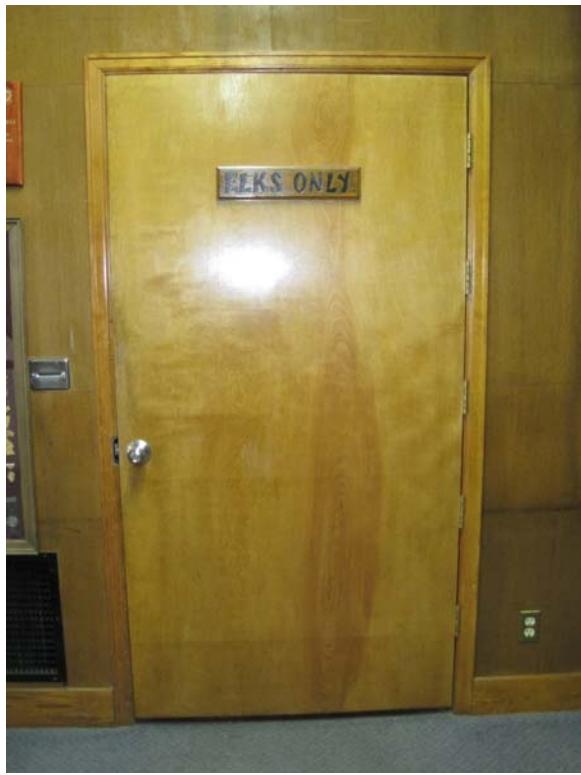
LEL8763 FIRST FLOOR DOOR TO CLUB ROOM

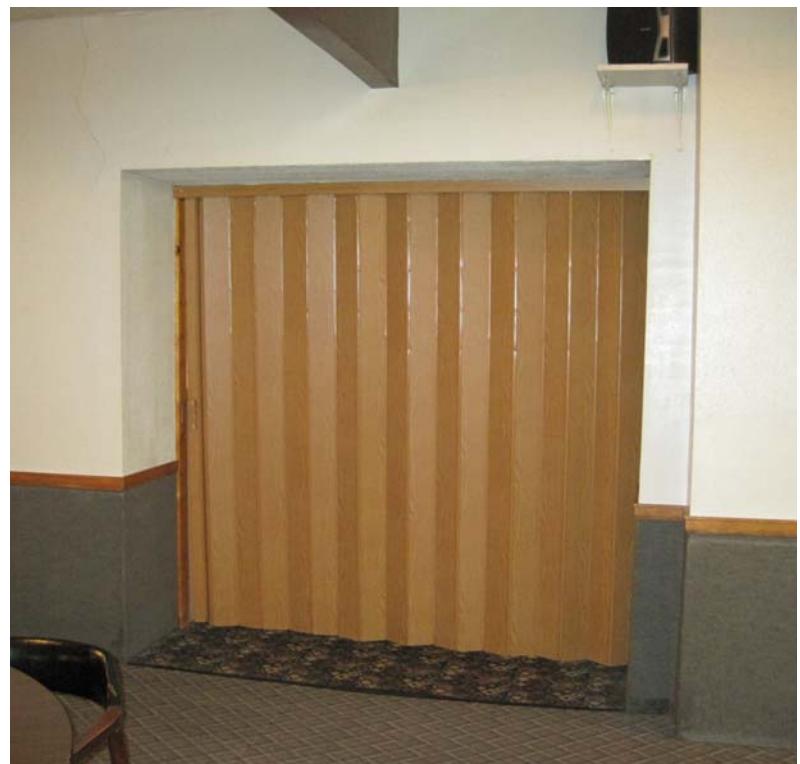
LEL8821 NON-HISTORIC ACCORDION DOOR IN RANGE ROOM

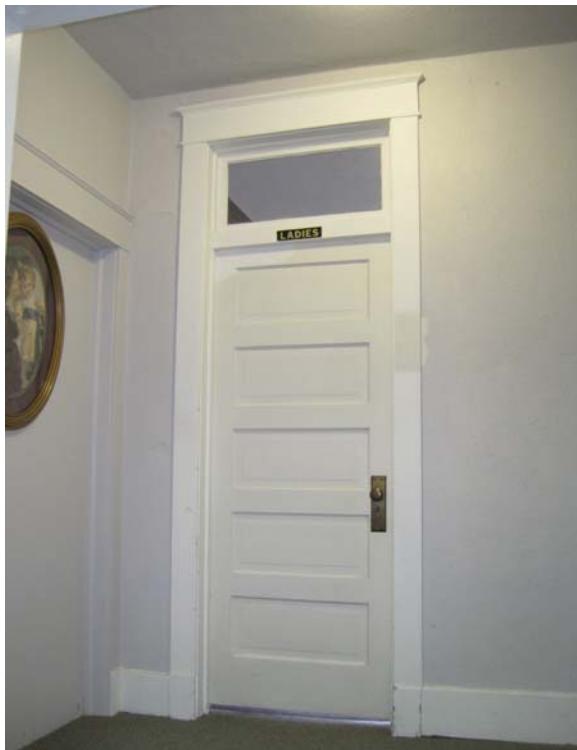
LEL7641 TYPICAL SECOND FLOOR HISTORIC FIVE PANEL DOOR WITH TRANSOM

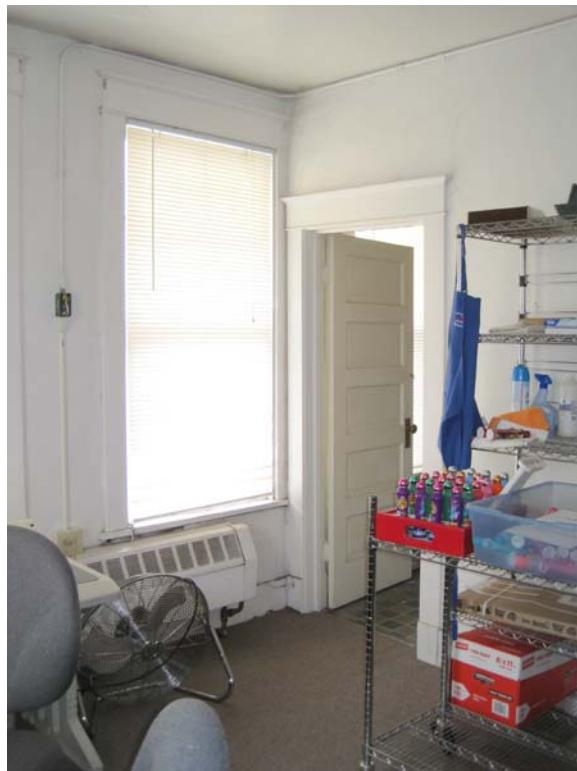
LEL7663 SECOND FLOOR HISTORIC FIVE PANEL DOOR WITHOUT TRANSOM (NOTE HOODED TRIM)

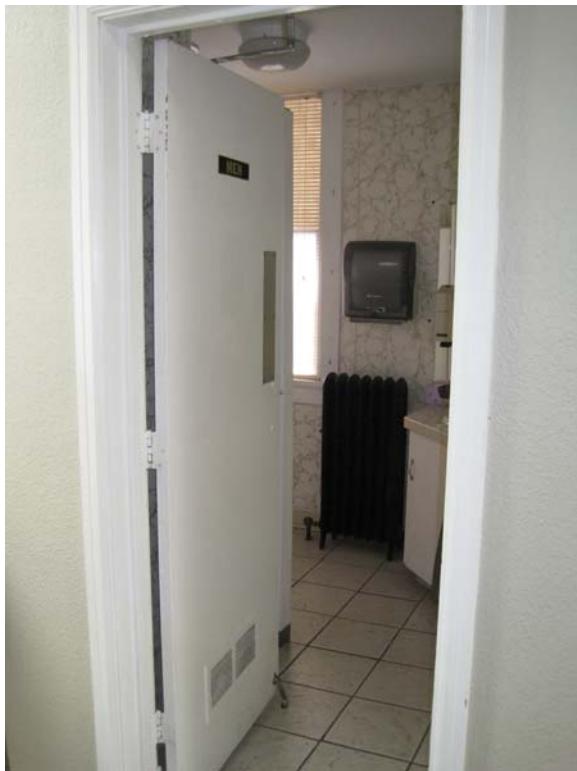
LEL7622 FLUSH HISTORIC DOOR WITH GRILLE

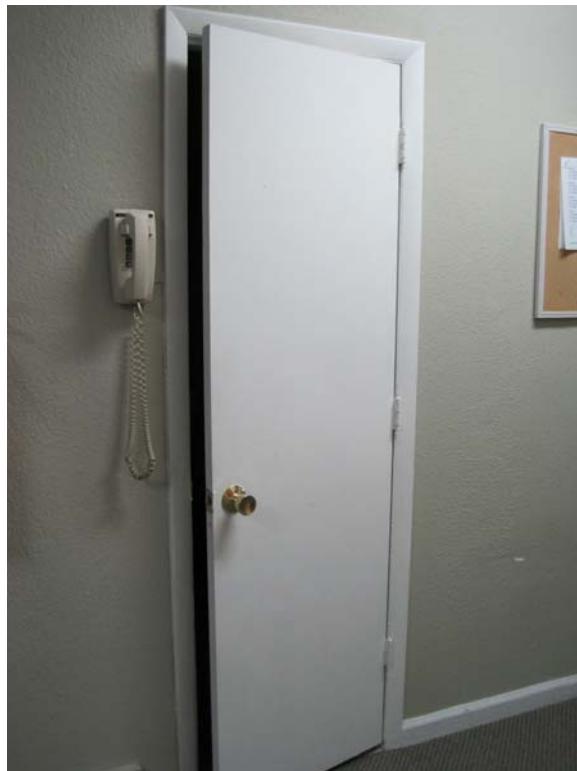
LEL7620 TYPICAL NON-HISTORIC DOOR AND TRIM

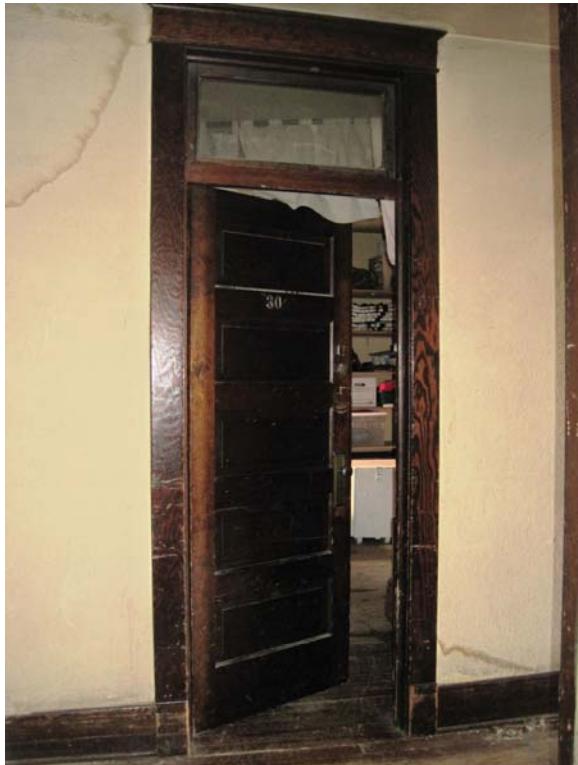
LEL0985 TYPICAL THIRD FLOOR HISTORIC FIVE PANEL DOOR WITH TRANSOM

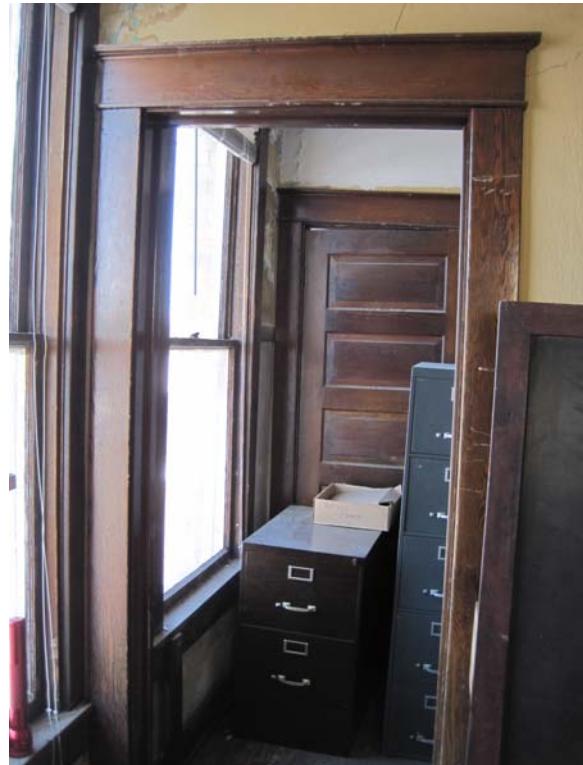
LEL1000 HISTORIC DOOR WITHOUT TRANSOM IN BACKGROUND (NOTE TRIM)

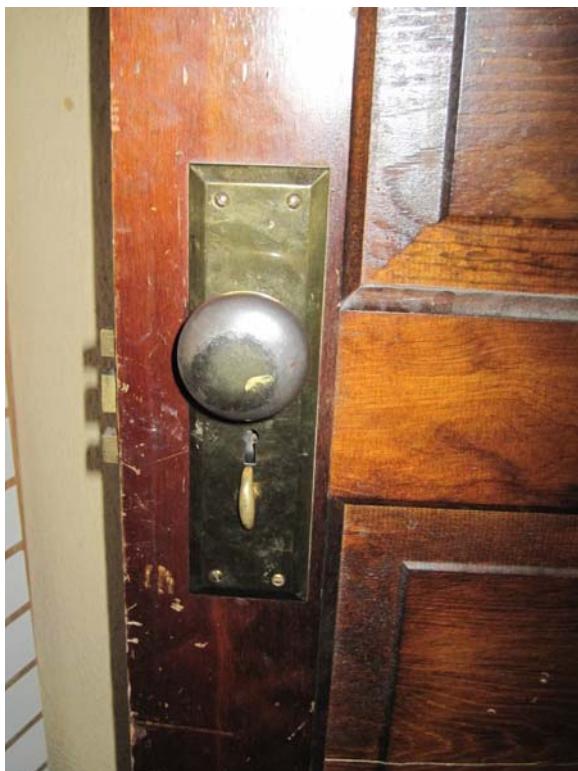
LEL0987 HISTORIC THIRD FLOOR LOCKSET
