HISTORIC LOVELAND ELKS LODGE (BPOE #1051) BUILDING

HISTORIC STRUCTURE ASSESSMENT PHOTOS

PAGE NUMBER EC-1	HISTORIC STRUCTURE ASSESSMENT HISTORIC BPOE #1051 BUILDING CHS/SHF #2011-HA-012	EXISTING CONDITIONS PHOTOS PREPARED BY: P. Berglund CHECKED BY: R. S. Beardmore, PE

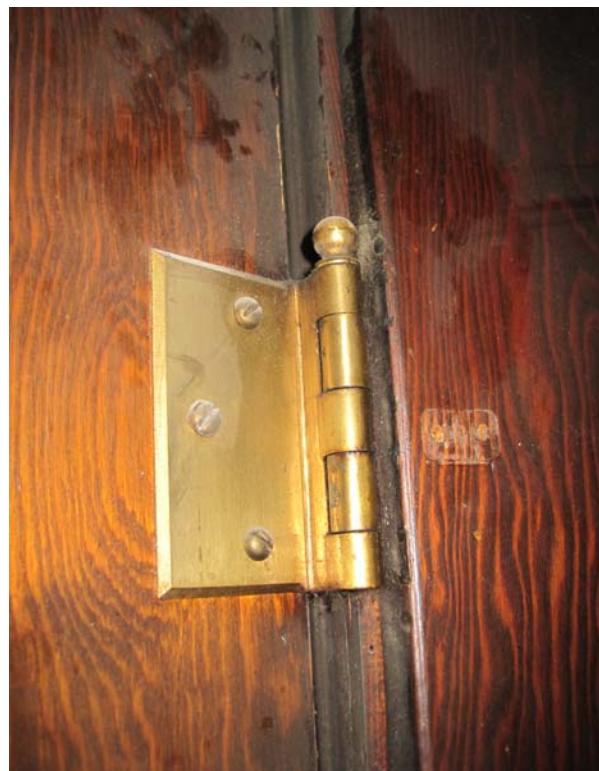
LEL0988 HISTORIC THIRD FLOOR BALL TIPPED HINGES

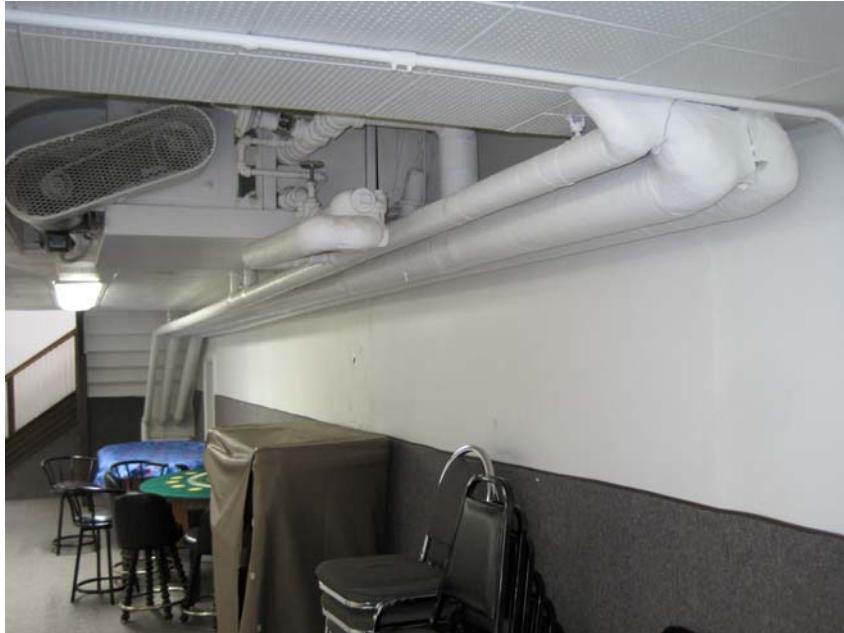
LEL7418 BASEMENT FINISHES ALONG WEST WALL AND CEILING

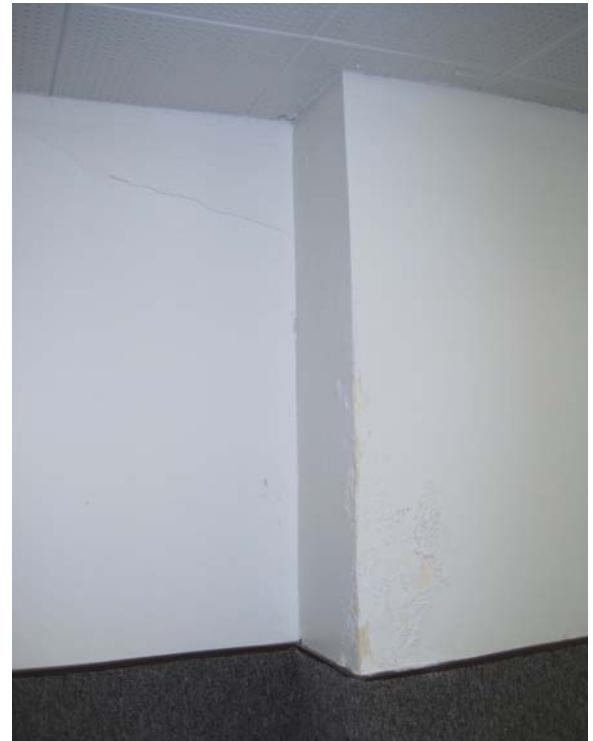
LEL7413 BUBBLED PAINT ON BASEMENT WEST WALL

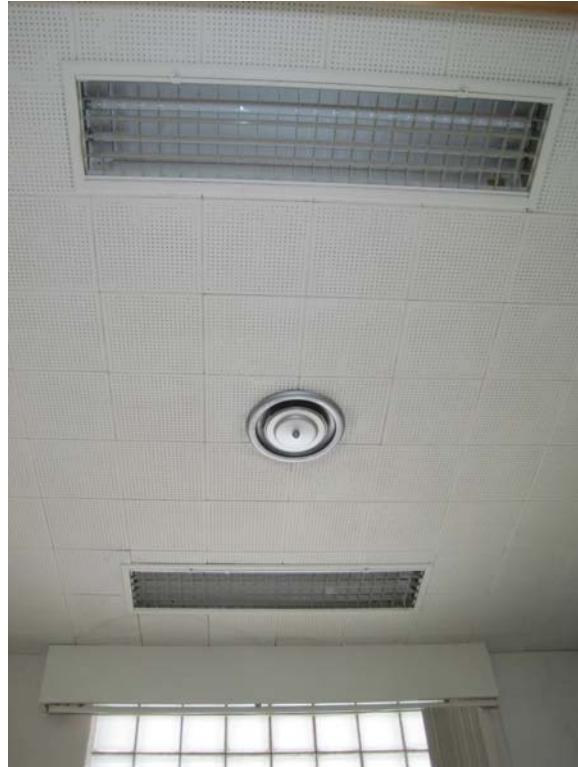
LEL7874 CEILING OF WESTERNMOST OFFICE

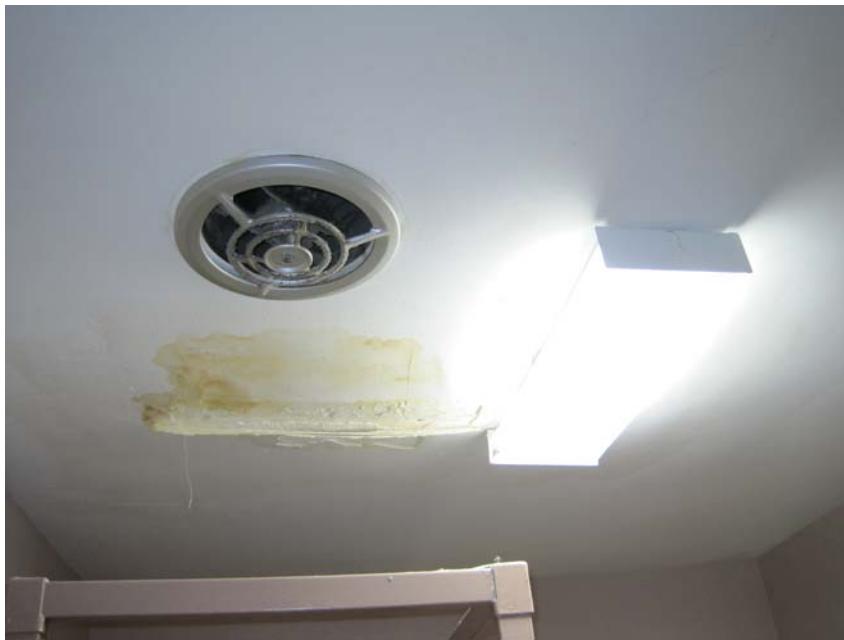
LEL7888 FIRST FLOOR MEN'S RESTROOM CEILING

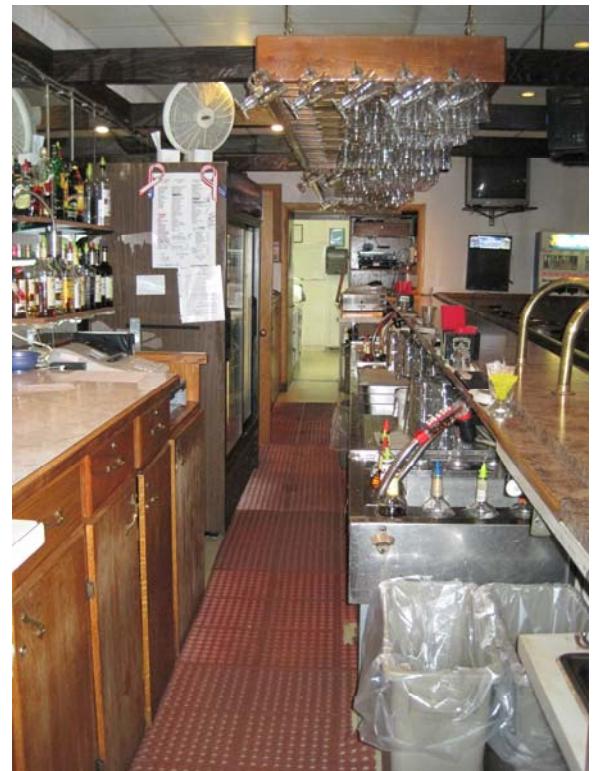
LEL8782 CLUB ROOM BAR

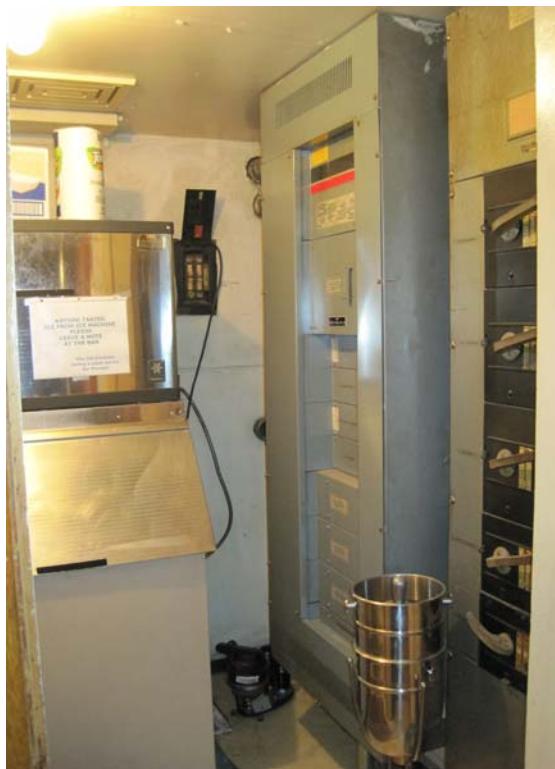
LEL8786 CLUB ROOM JANITOR'S CLOSET

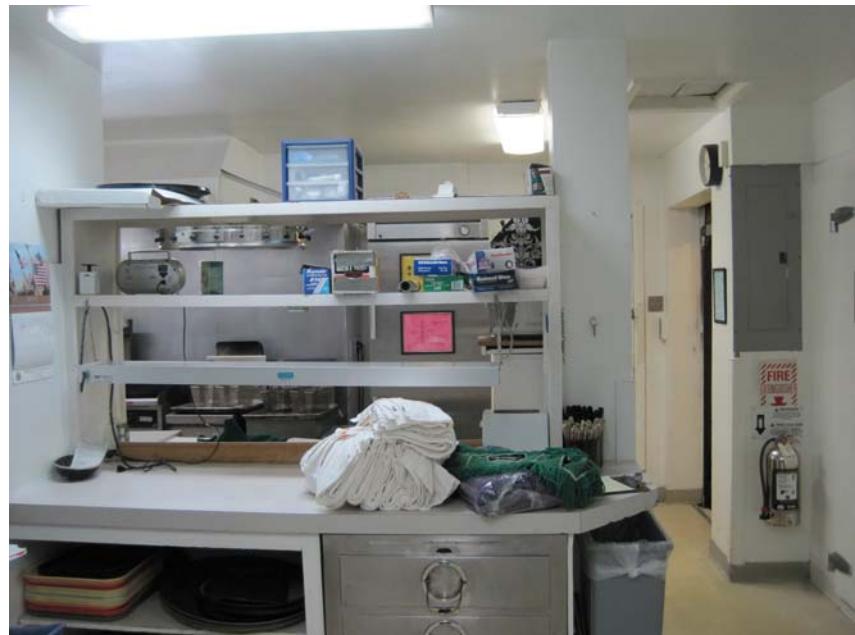
LEL8795 FIRST FLOOR KITCHEN, CAMERA FACING NORTH

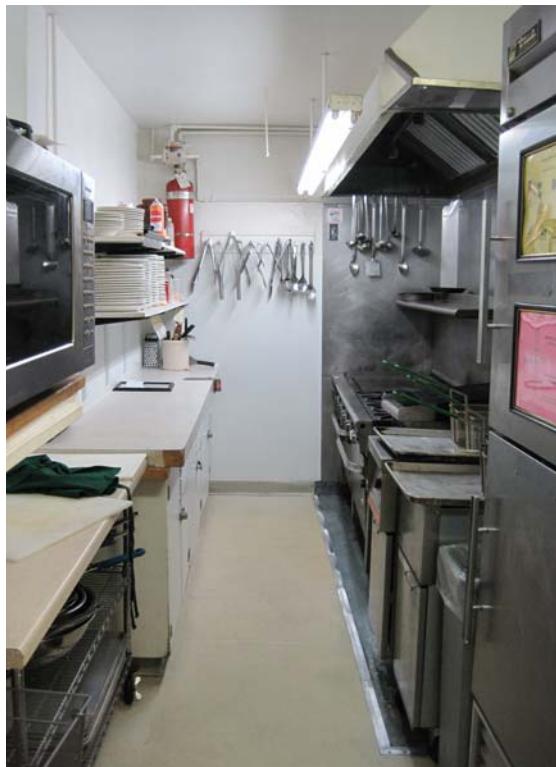
LEL8796 FIRST FLOOR KITCHEN EQUIPMENT

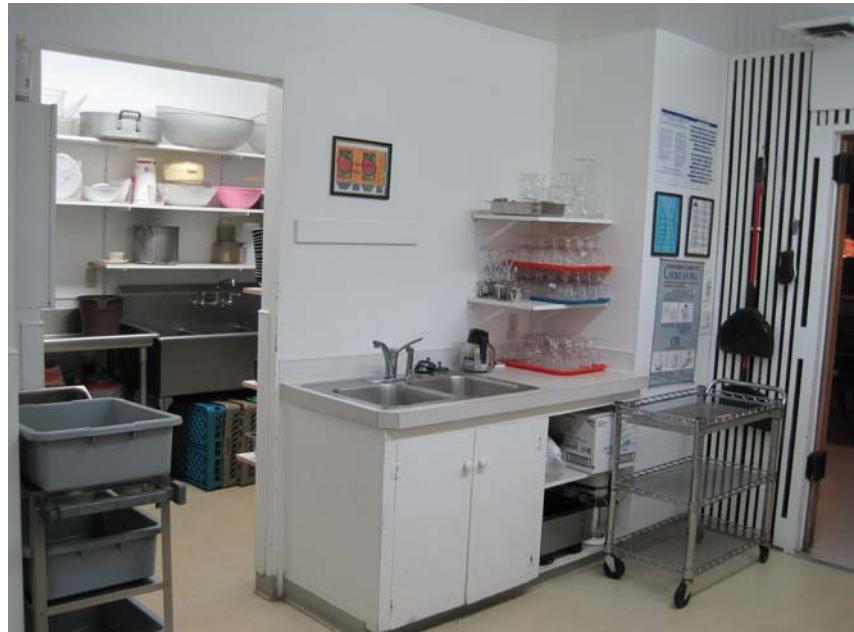
LEL8808 FIRST FLOOR KITCHEN SERVER STAGING AREA

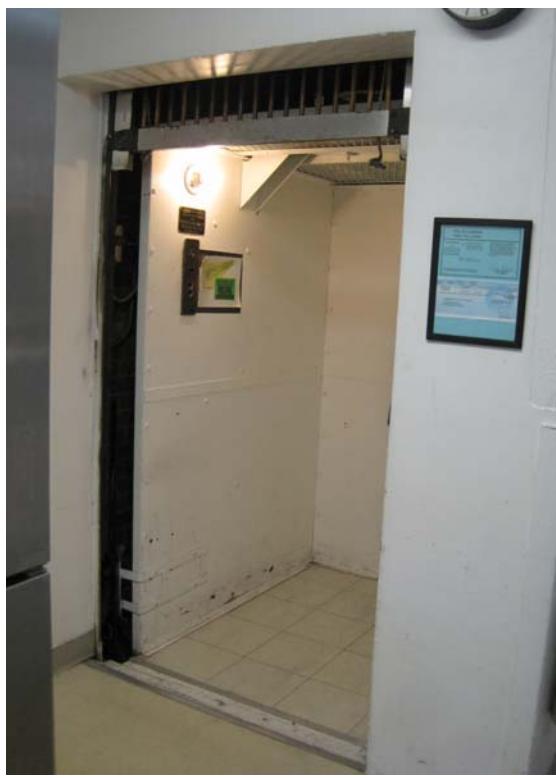
LEL8801 NORTHEAST CORNER ELEVATOR

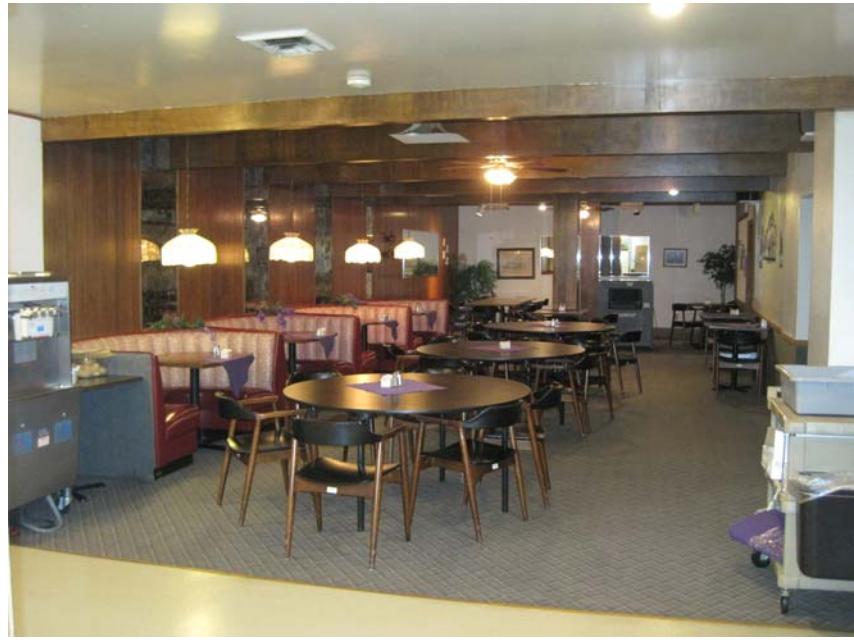
LEL8814 FIRST FLOOR DINING ROOM, CAMERA FACING SOUTH

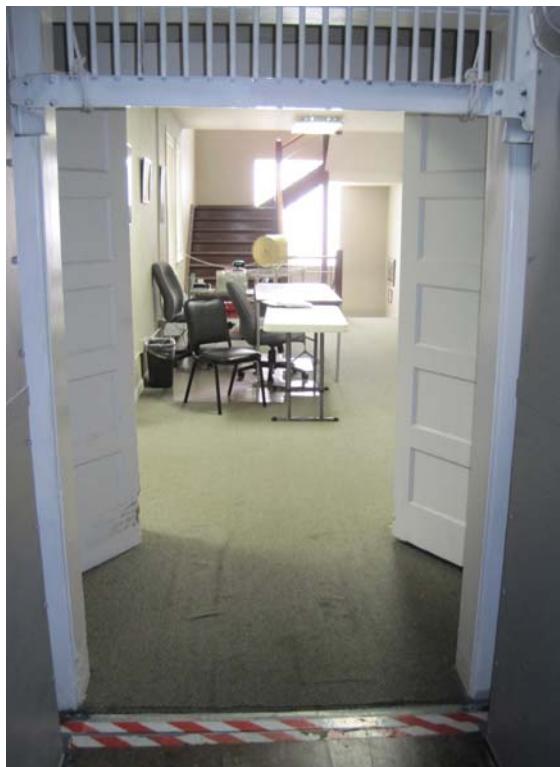
LEL7540 VIEW FROM ELEVATOR TO SECOND FLOOR LOBBY

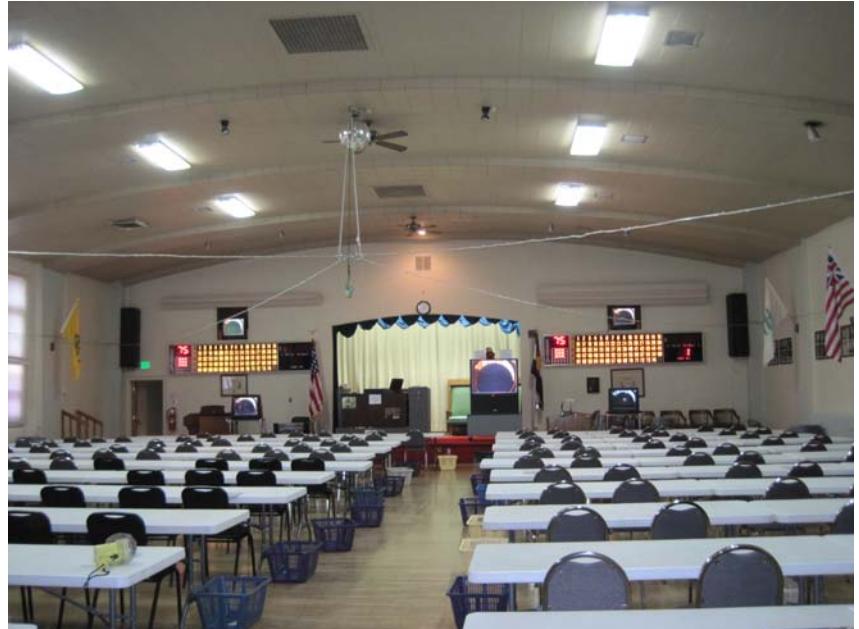
LEL7550 SECOND FLOOR LODGE ROOM AND STAGE, CAMERA FACING NORTH (NOTE ENGAGED PILASTERS ON EAST AND WEST WALLS AND RIBS ON CEILING, INDICATING STRUCTURAL TRUSS/FRAMING LOCATIONS)

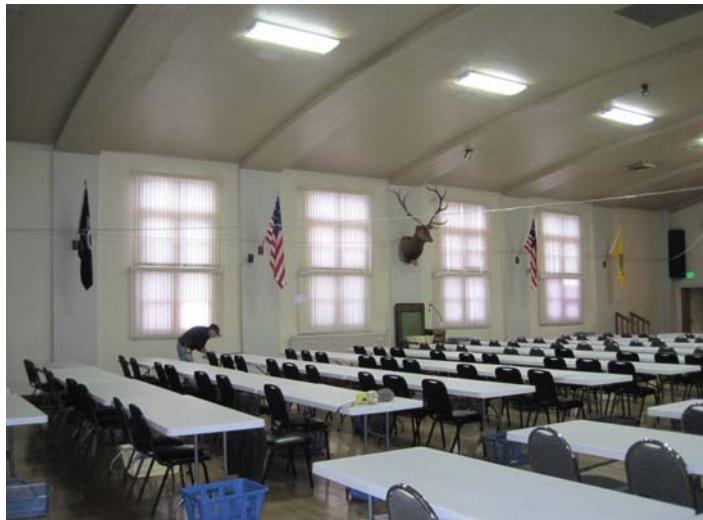
LEL7552 WESTERN HALF OF LODGE ROOM

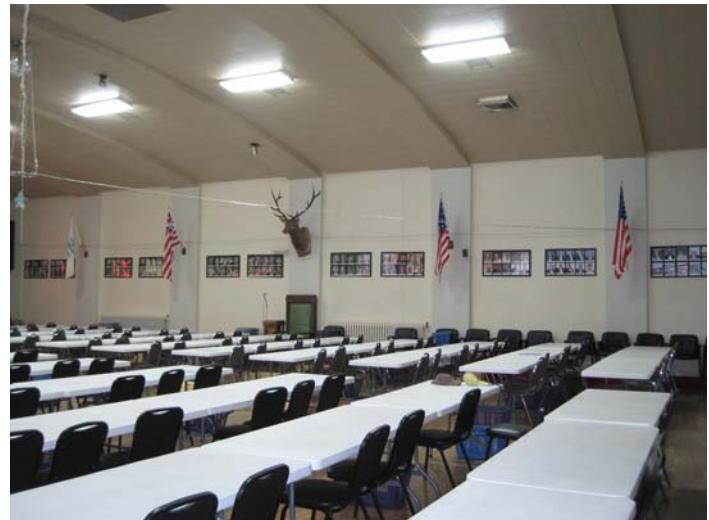
LEL7553 EASTERN HALF OF LODGE ROOM

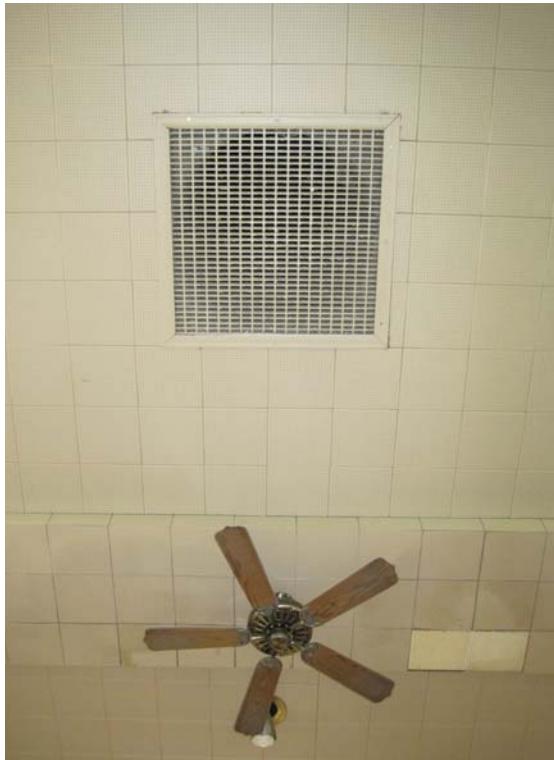
LEL7600 CEILING DETAIL OF LODGE ROOM

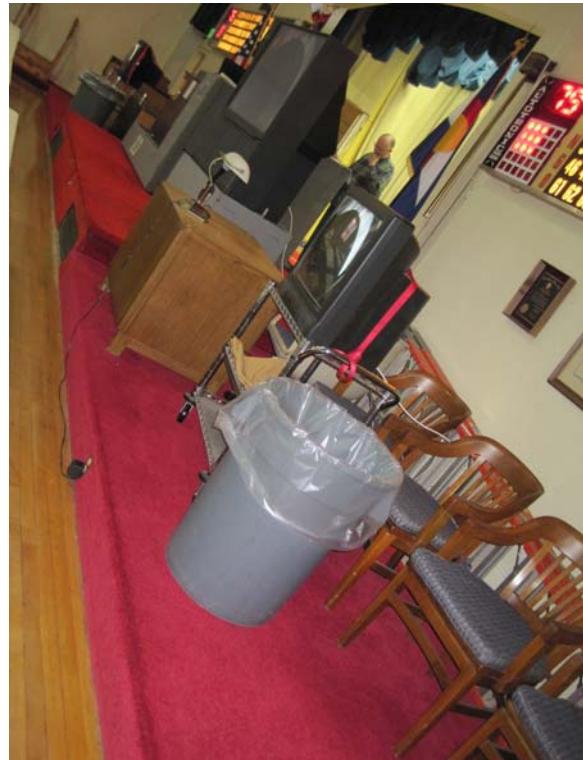
LEL7556 PLATFORM IN FRONT OF STAGE WITH RAISED STAGE TO THE RIGHT

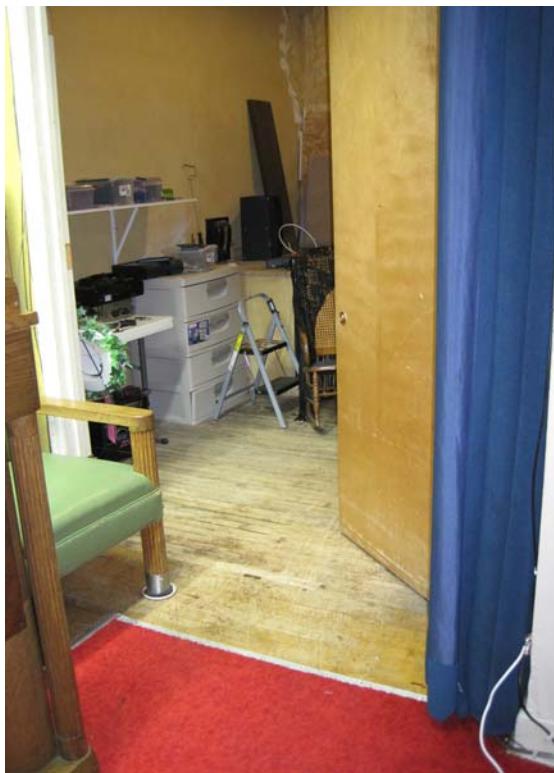
LEL7559 FORMER DRESSING ROOM AT EAST OF STAGE

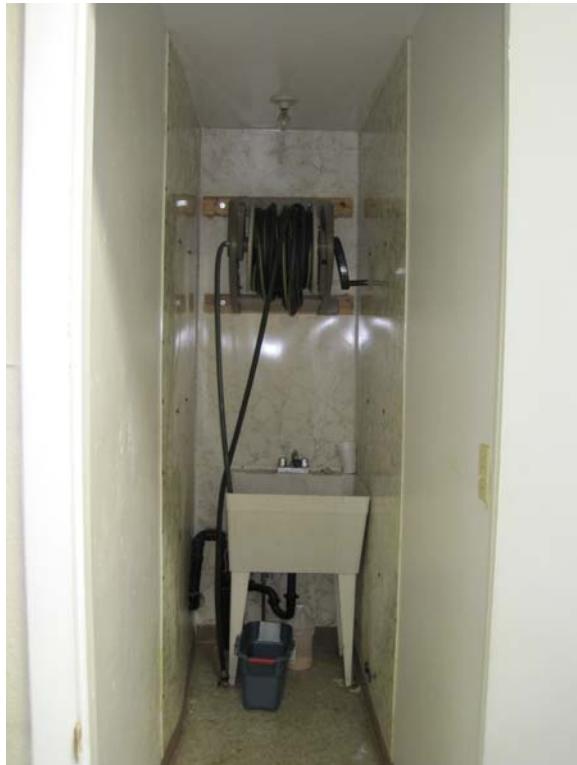
LEL7621 SECOND FLOOR EAST JANITOR'S CLOSET

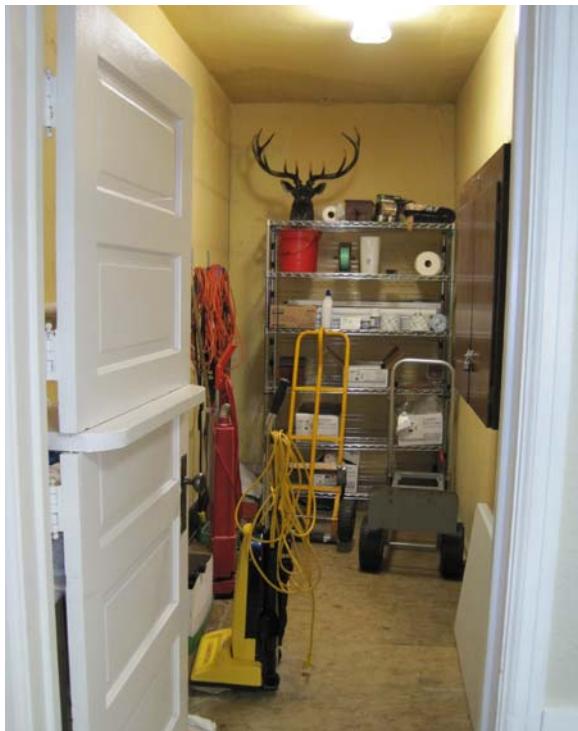
LEL7616 STORAGE ROOM SOUTH OF LODGE
ROOM

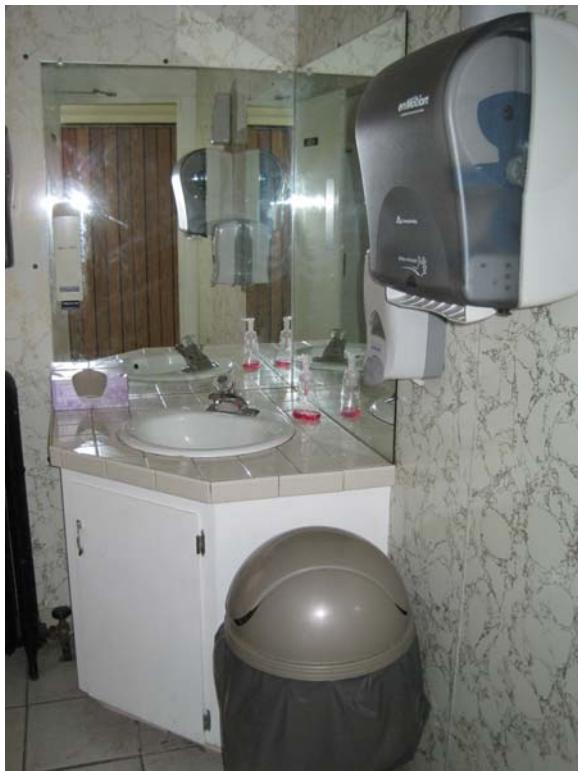
LEL7623 SECOND FLOOR MEN'S RESTROOM

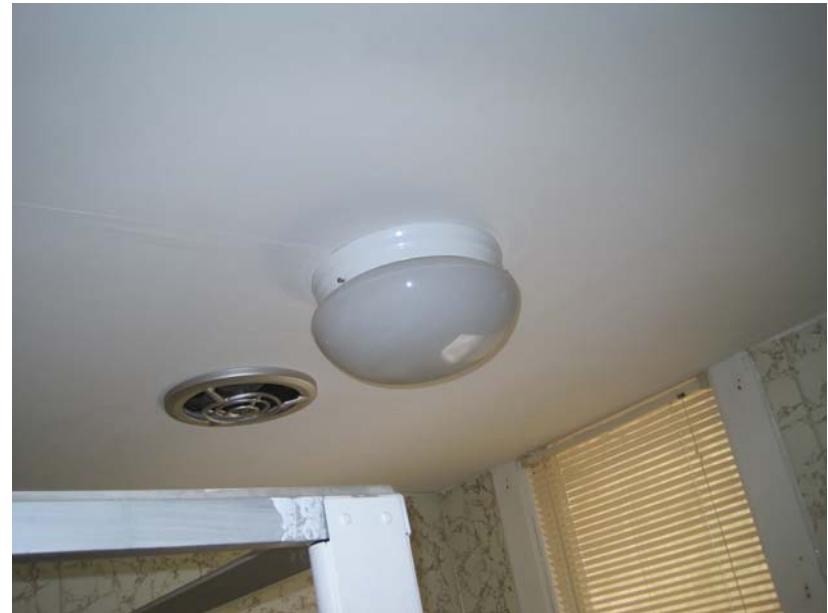
LEL7630 CEILING OF SECOND FLOOR MEN'S RESTROOM

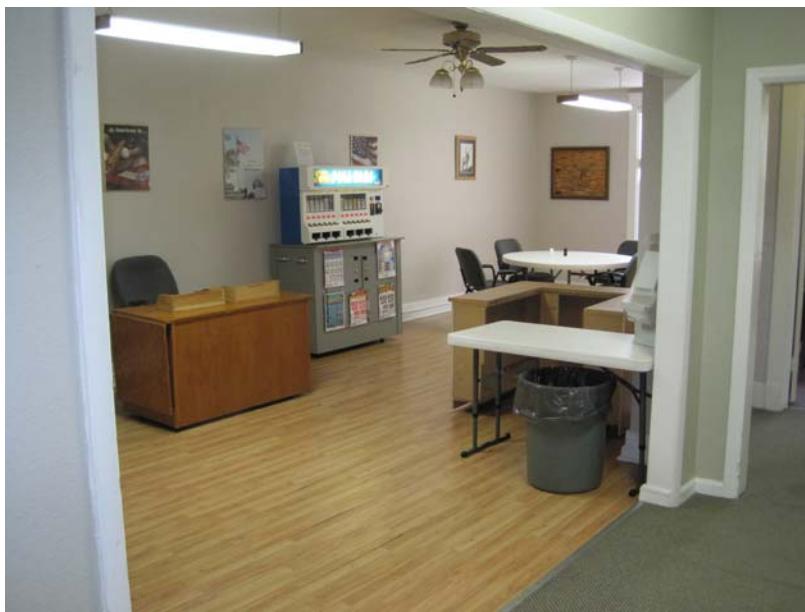
LEL7631 SECOND FLOOR COMMITTEE ROOM

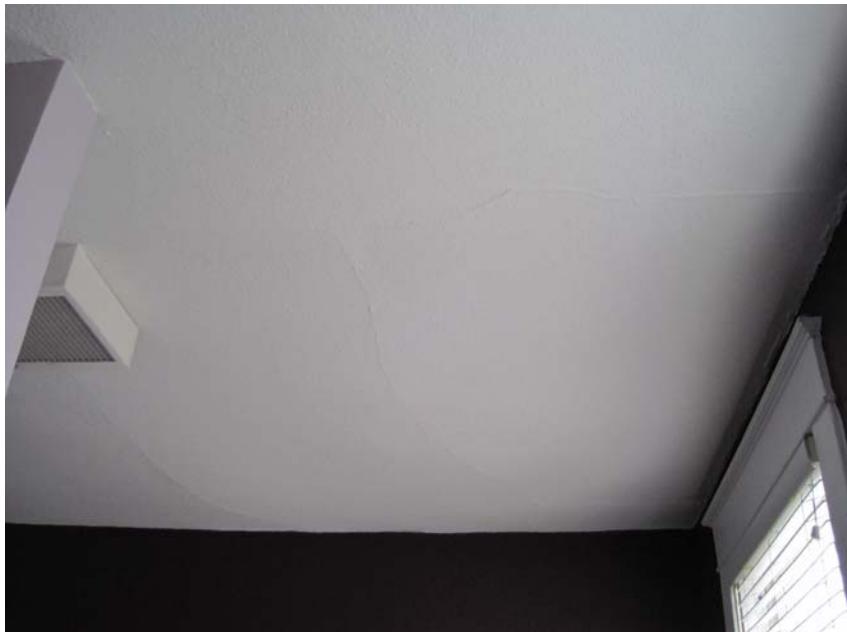
LEL7654 CEILING OF SECOND FLOOR WOMEN'S RESTROOM

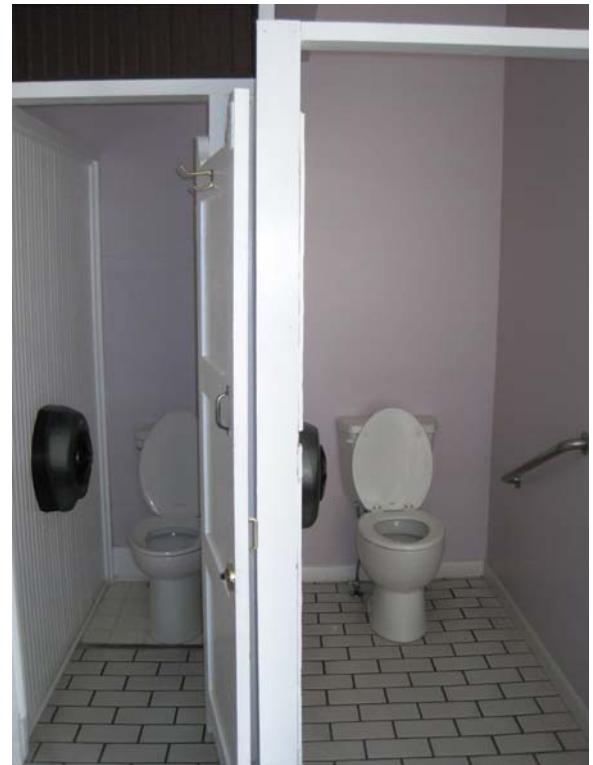
LEL7650 TWO OF THE STALLS IN SECOND FLOOR WOMEN'S RESTROOM (NOTE FLOORING)

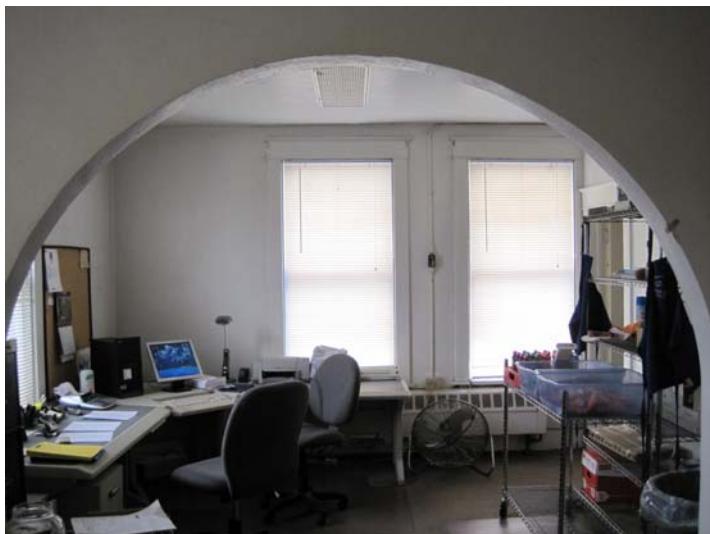
LEL7659 ARCHED OPENING IN SECOND FLOOR AUXILIARY ROOM, CAMERA FACING WEST

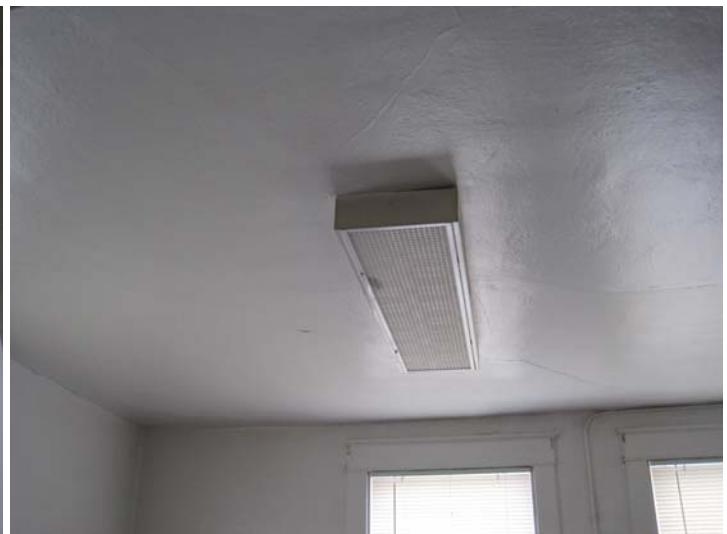
LEL7662 CEILING OF SECOND FLOOR AUXILIARY ROOM

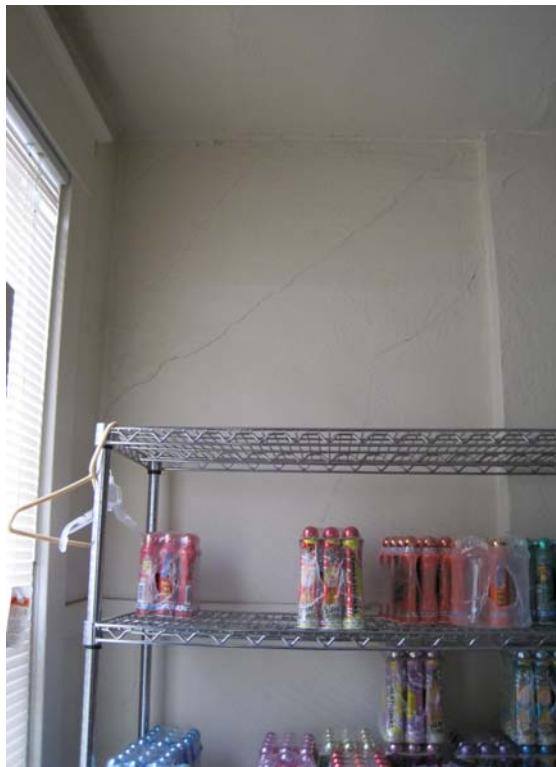
LEL7670 NORTH WALL OF SECOND FLOOR STORAGE ADJACENT TO AUXILIARY

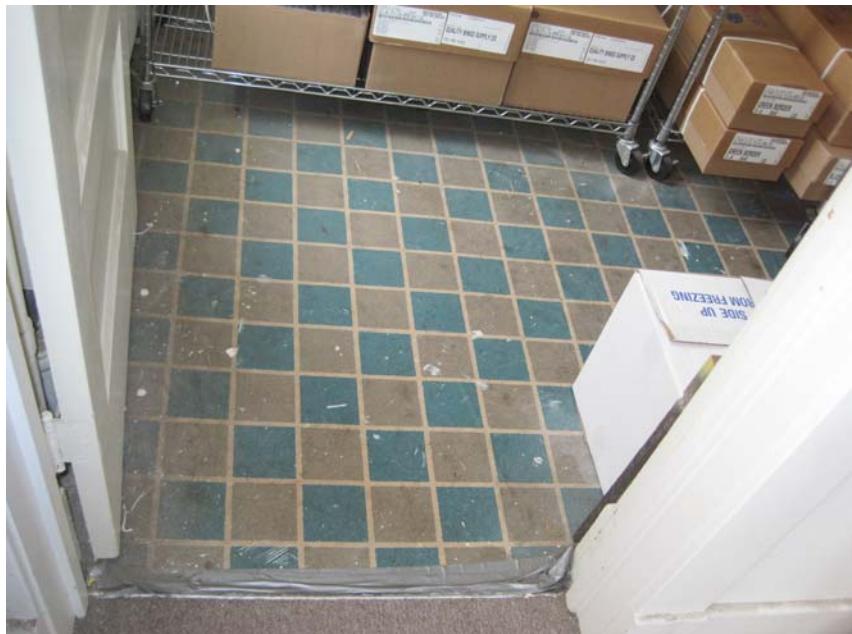
LEL7671 FLOORING IN SECOND FLOOR STORAGE ROOM ADJACENT TO SOUTHWEST CORNER AUXILIARY ROOM

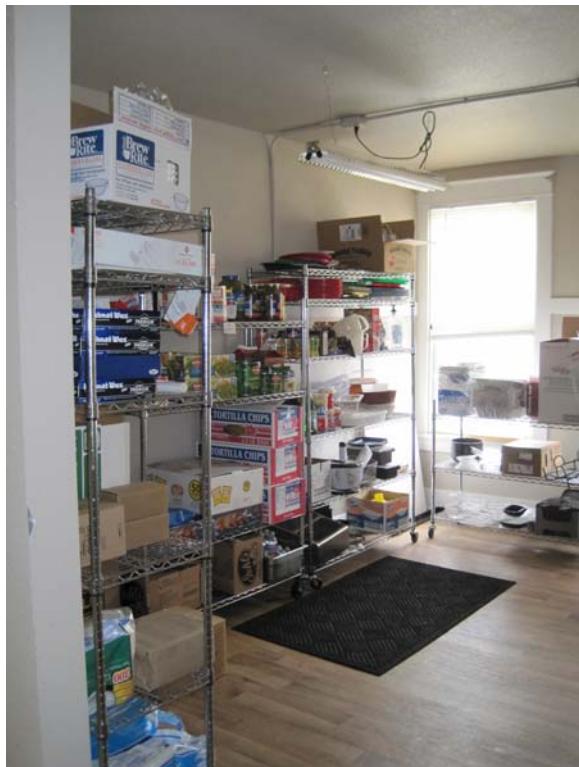
LEL7675 SECOND FLOOR DRY FOOD STORAGE

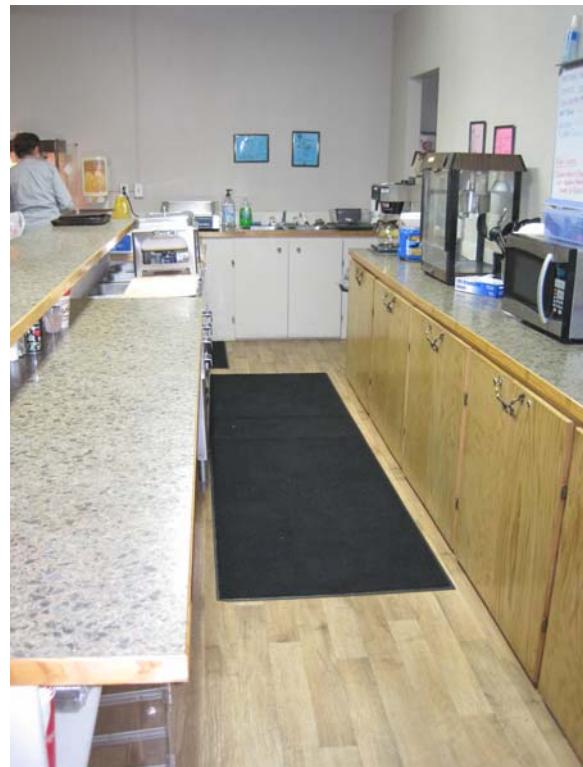
LEL7679 SECOND FLOOR CONCESSIONS ROOM

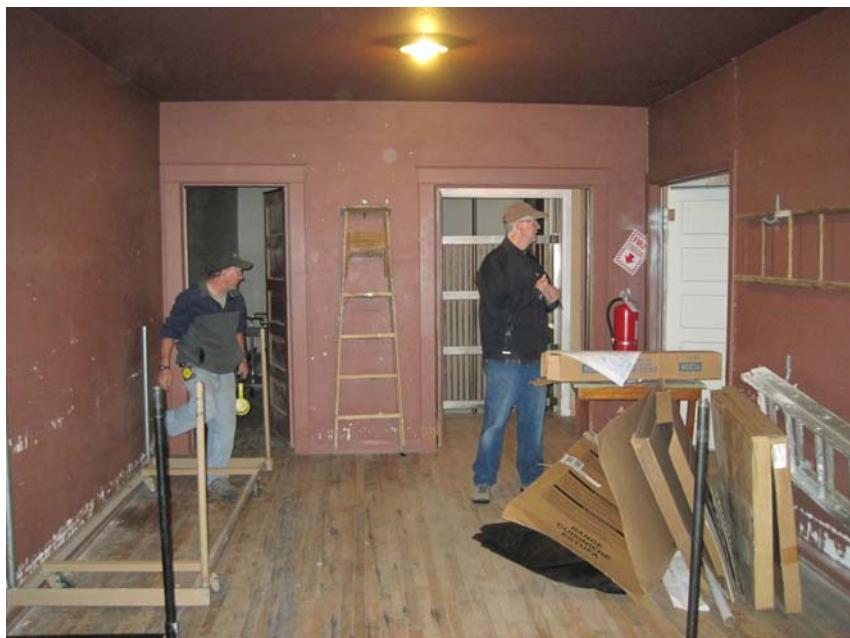
LEL7760 THIRD FLOOR LOBBY, CAMERA FACING EAST

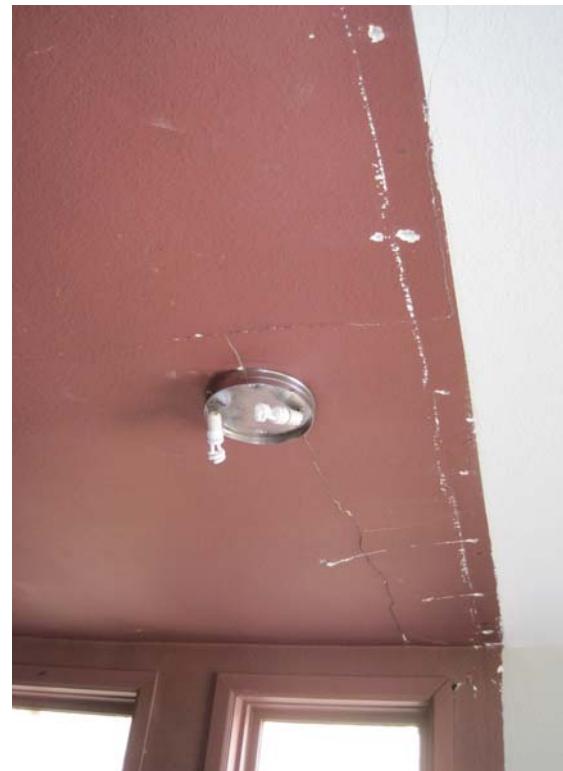
LEL1010 CEILING AT INTERFACE OF THIRD FLOOR LOBBY AND WEST STAIR

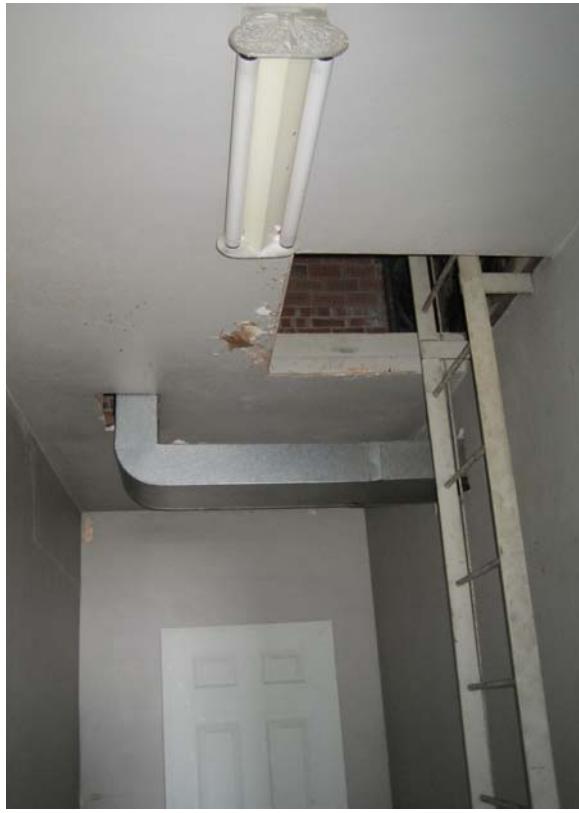
LEL0978 THIRD FLOOR ROOF ACCESS ROOM

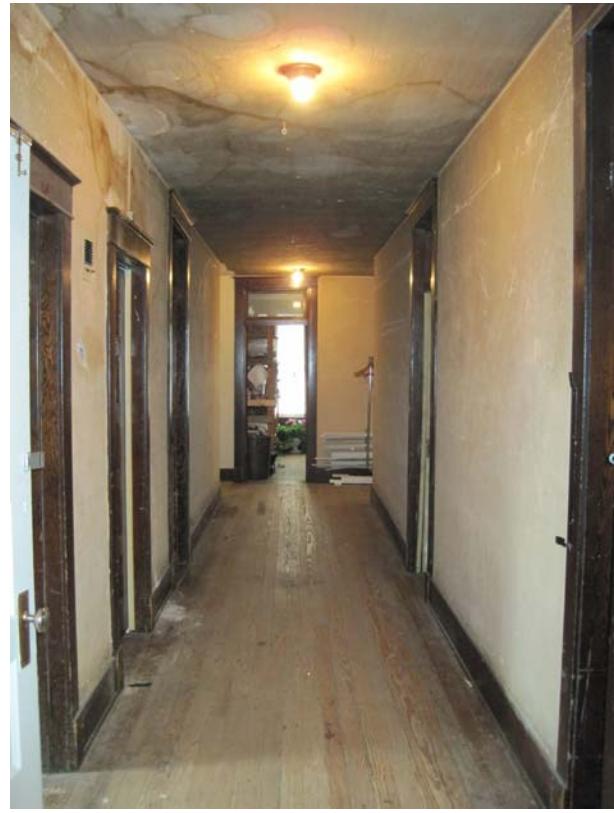
LEL7762 THIRD FLOOR NORTH/SOUTH HALLWAY

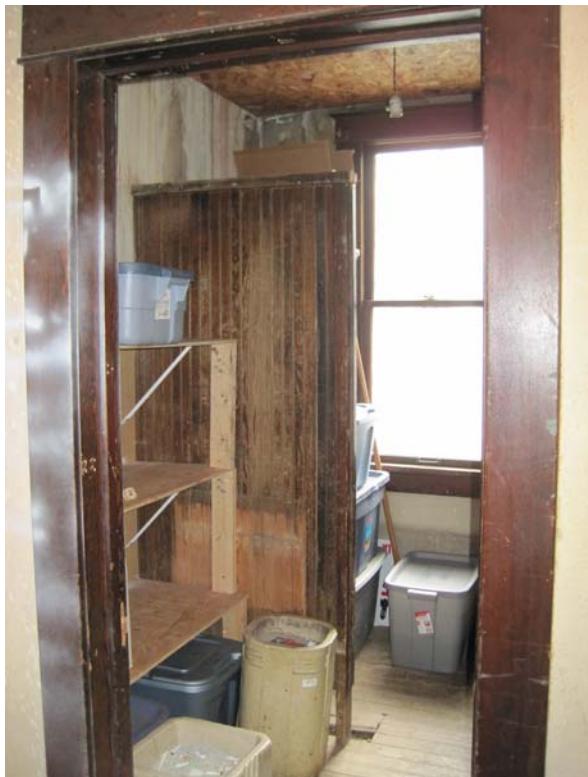
LEL7769 NORTH SECTION OF THIRD FLOOR BATH #1

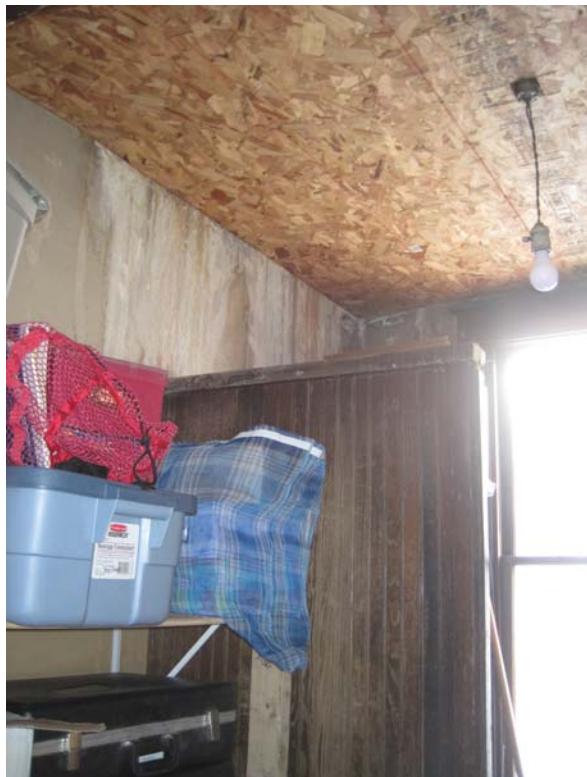
LEL0980 CLOSER VIEW OF BATH #1 FINISHES

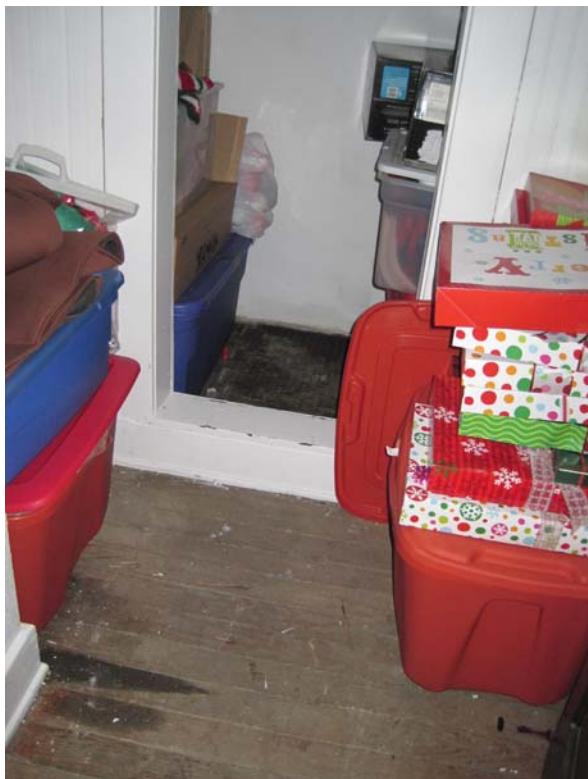
LEL0983 FLOOR OF SOUTH SECTION OF BATH #1

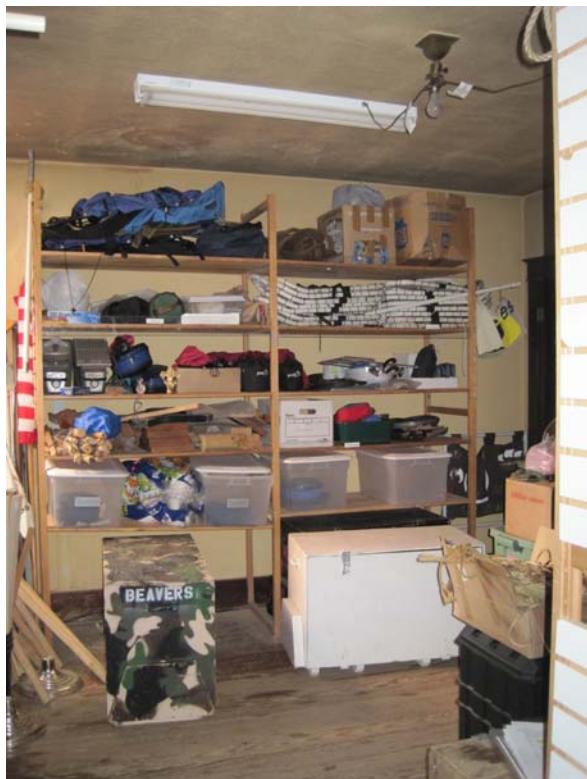
LEL0989 THRID FLOOR BEDROOM #1

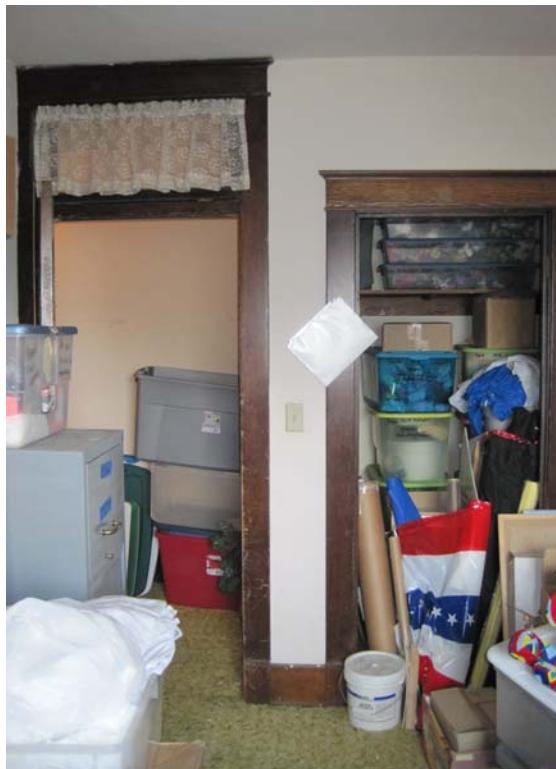
LEL7780 THRID FLOOR BEDROOM #2

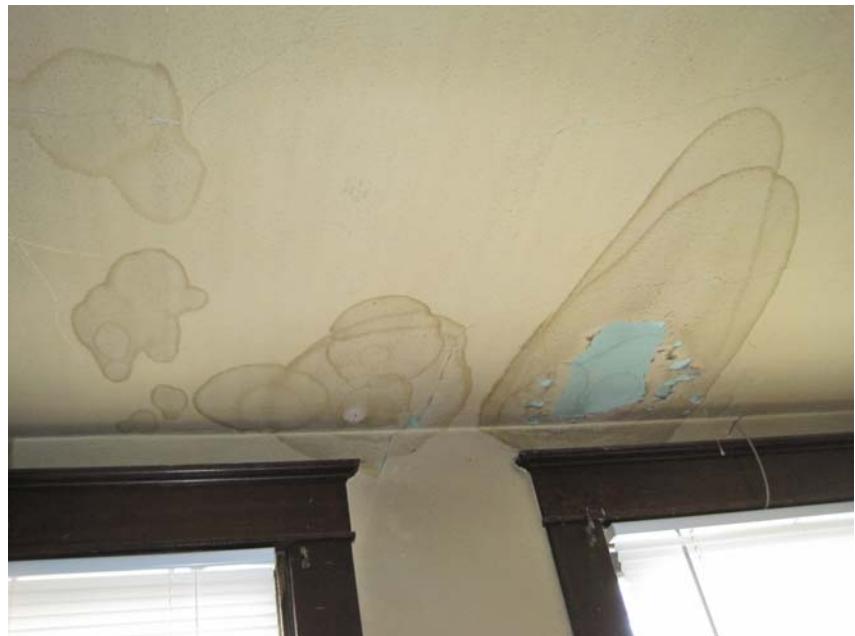
LEL7784 THIRD FLOOR BEDROOM #3 (SIMILAR TO BEDROOM #4)

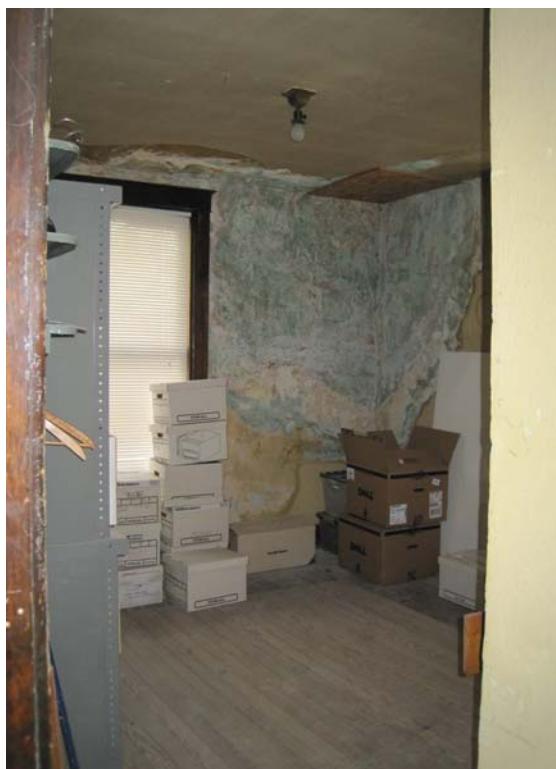
LEL7806 SOUTHWEST CORNER OF THIRD FLOOR BEDROOM #5

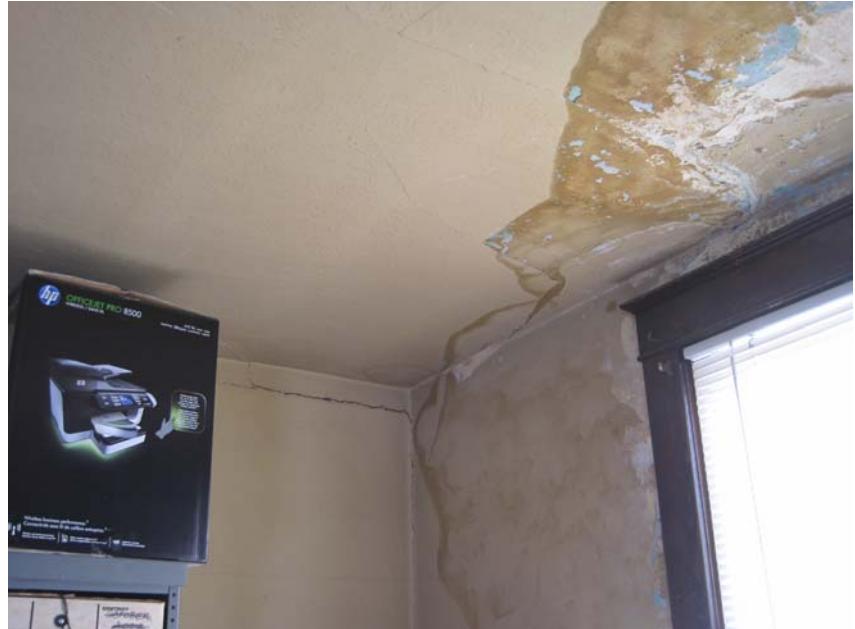
LEL0999 SOUTHEAST CORNER OF BEDROOM #5

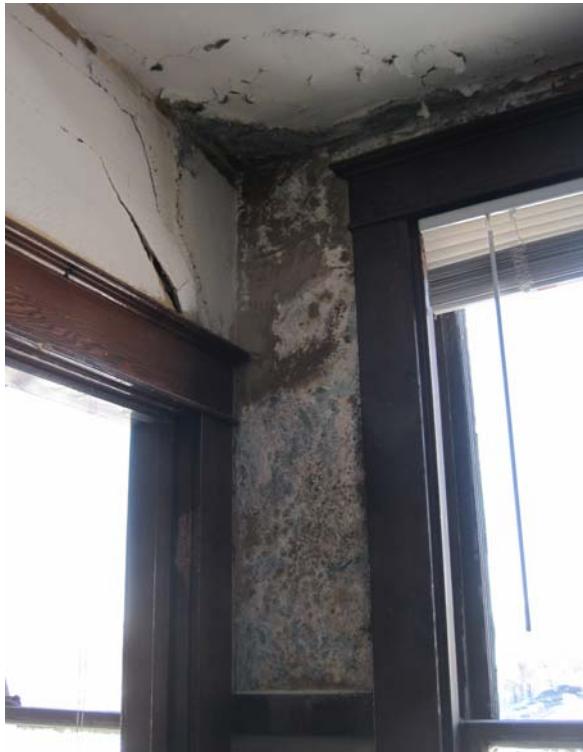
LEL1003 UPPER SOUTHWEST CORNER OF
THIRD FLOOR BATH #3

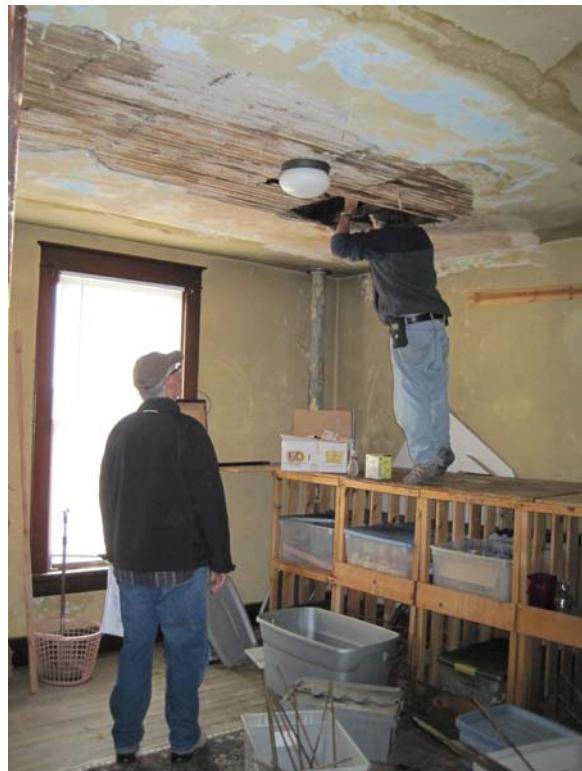
LEL7796 THRID FLOOR BEDROOM #6

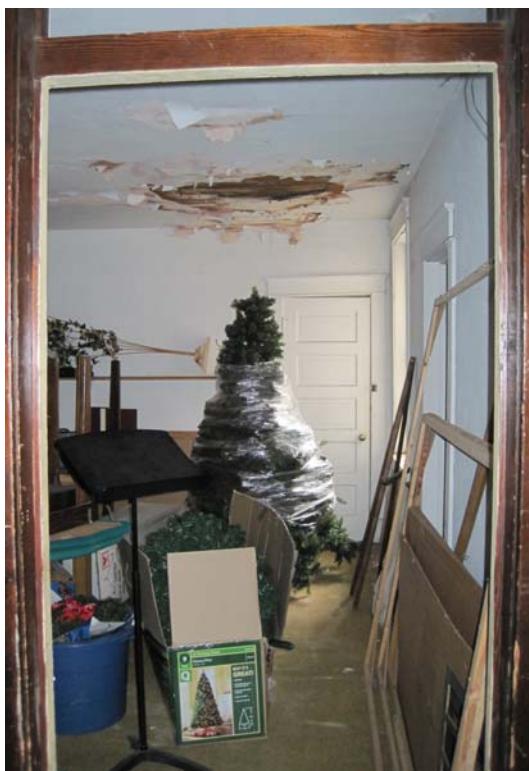
LEL7773 THIRD FLOOR BEDROOM #7

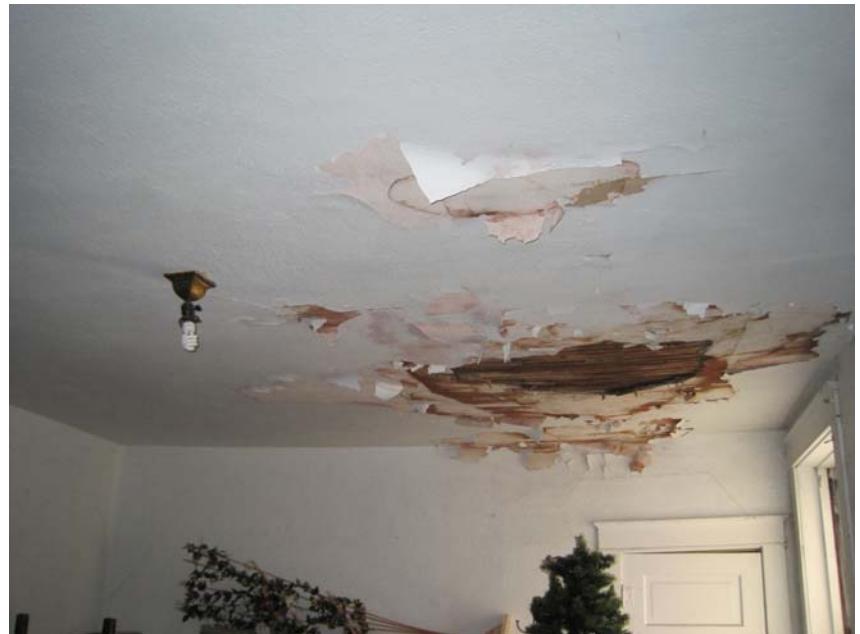
LEL7777 CEILING OF THIRD FLOOR BEDROOM #7
