HISTORIC LOVELAND ELKS LODGE (BPOE #1051) BUILDING

HISTORIC STRUCTURE ASSESSMENT PHOTOS

PAGE NUMBER EC-1	HISTORIC STRUCTURE ASSESSMENT HISTORIC BPOE #1051 BUILDING CHS/SHF #2011-HA-012	EXISTING CONDITIONS PHOTOS PREPARED BY: P. Berglund CHECKED BY: R. S. Beardmore, PE

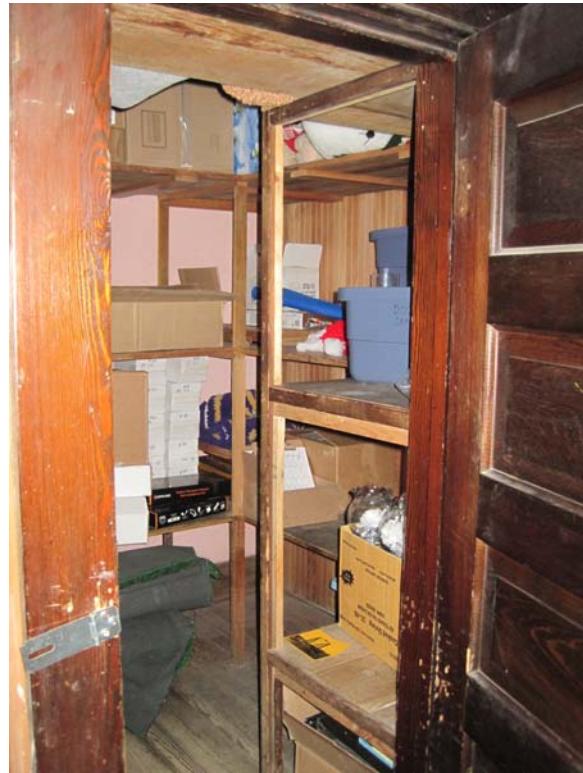
LEL1006 ENCLOSURE AT SOUTH SIDE OF BATH #4

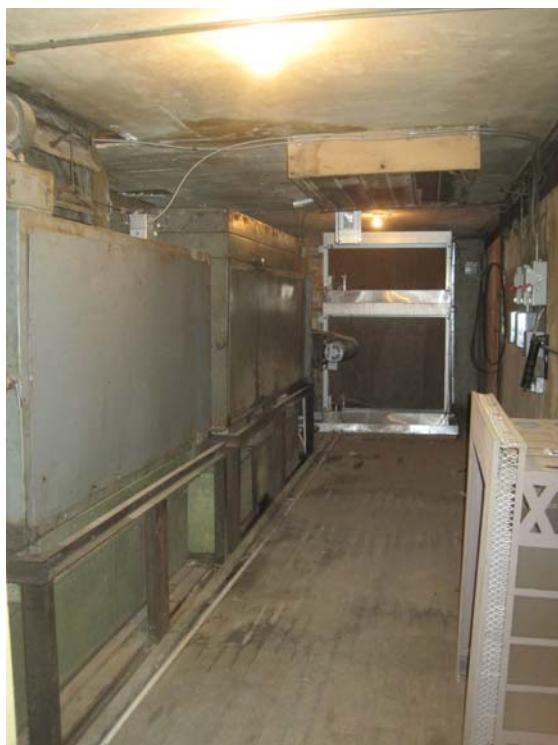
LEL1021 THIRD FLOOR NORTH END MECHANICAL ROOM

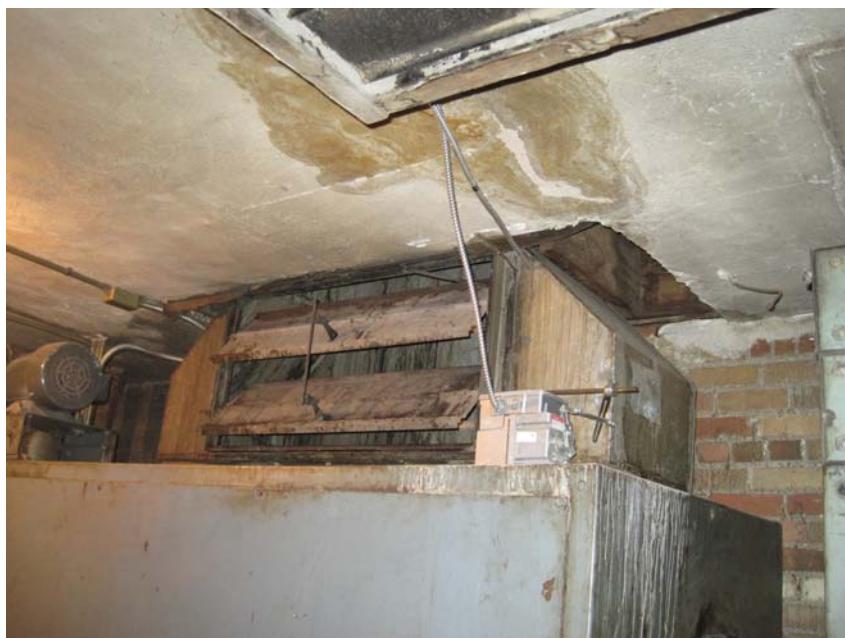
LEL1032 CEILING ABOVE THIRD FLOOR MECHANICAL UNIT

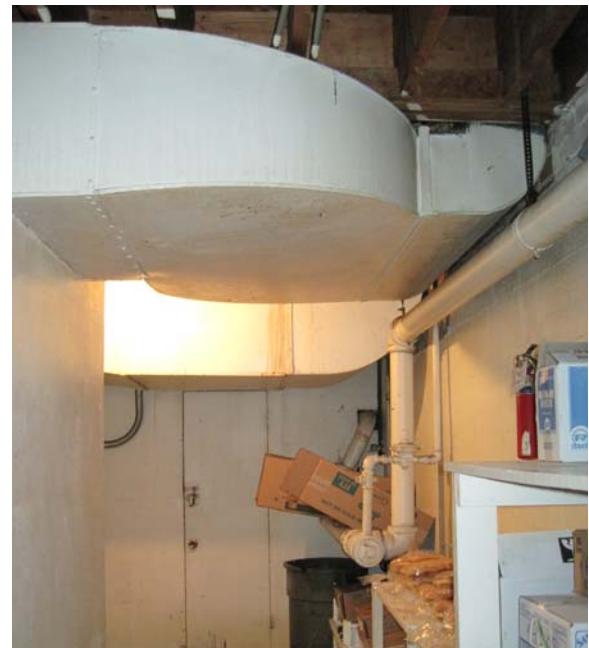
LEL7372 NORTH END BASEMENT DUCTING

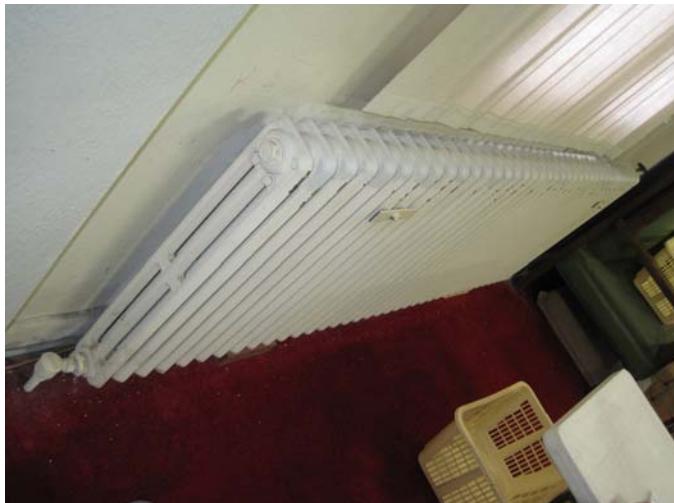
LEL7603 RADIATOR IN SECOND FLOOR LODGE ROOM

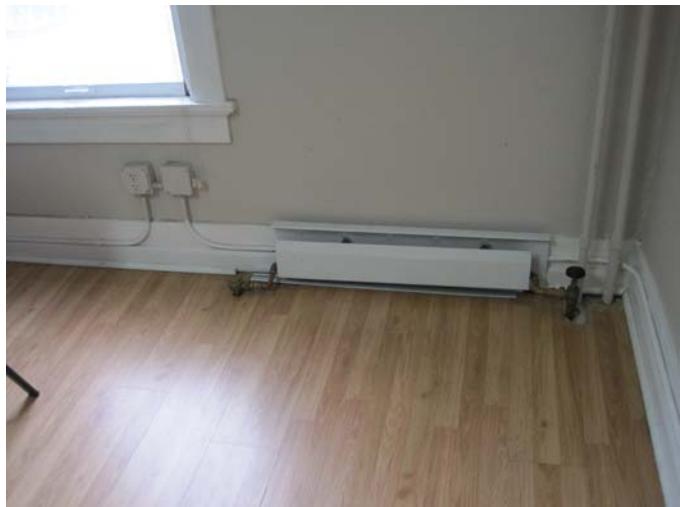
LEL7637 SECOND FLOOR BASEBOARD HEATER

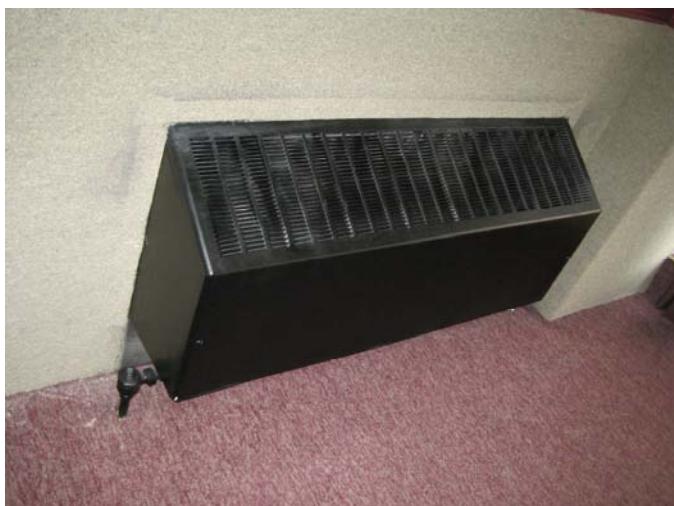
LEL7854 CABINET HEATER IN FIRST FLOOR CONFERENCE ROOM

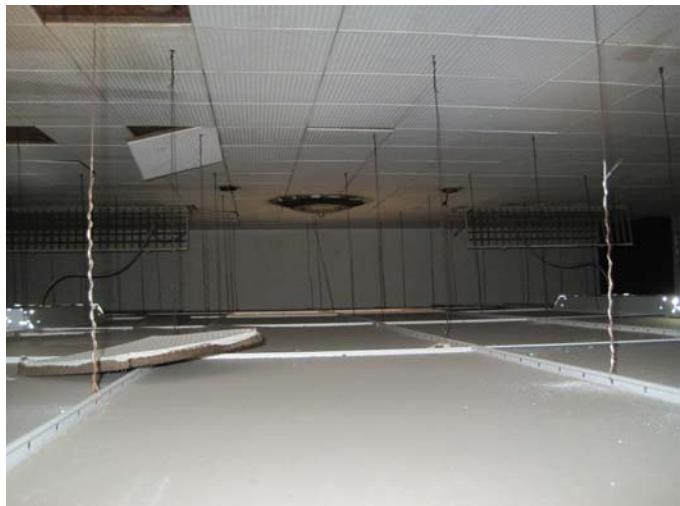
LEL0969 HISTORIC DIFFUSER ABOVE SUSPENDED CEILING IN FIRST FLOOR CONFERENCE ROOM

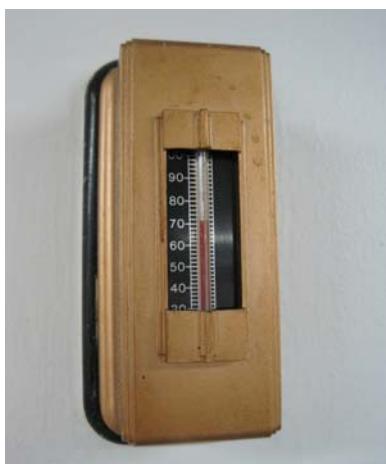
LEL7531 BASEMENT THERMOSTAT

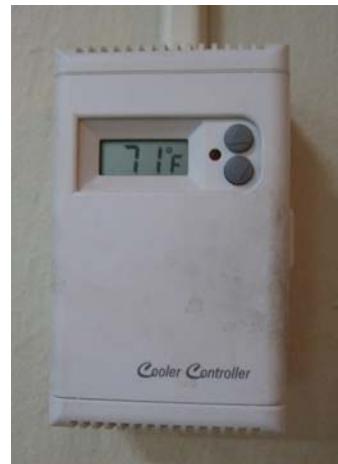
LEL7591 LODGE ROOM THERMOSTAT

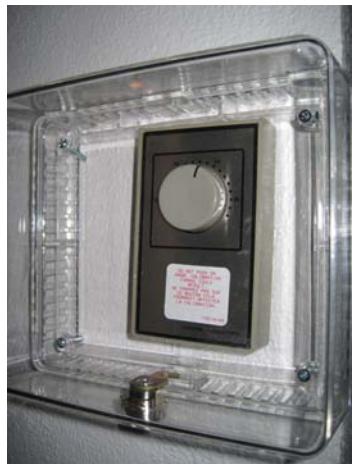
LEL8819 CLUB ROOM THERMOSTAT

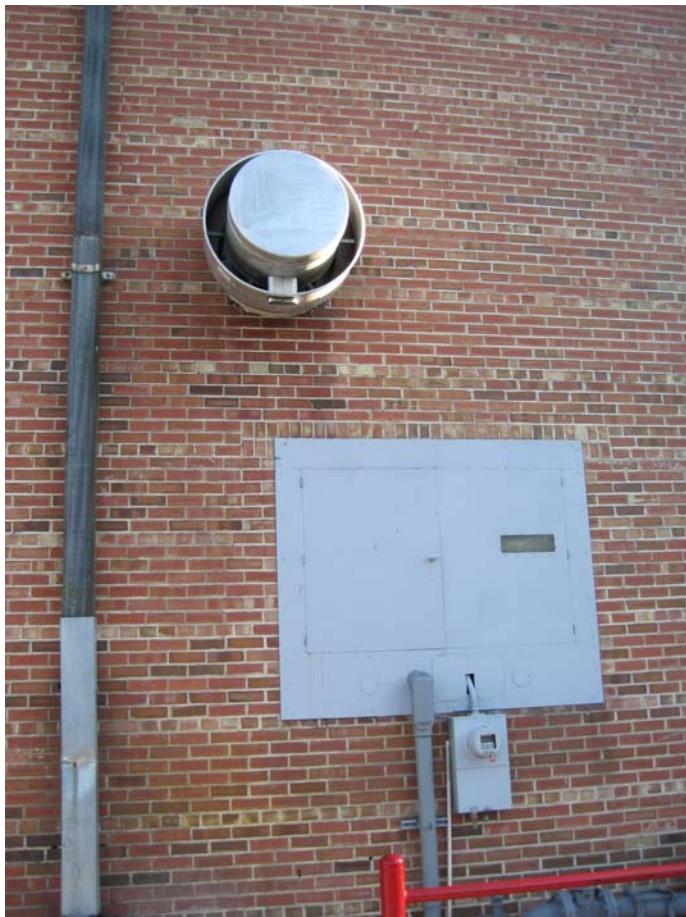
LEL9327 ELECTRICAL SERVICE ENTRANCE AND EXHAUST FAN ON NORTH ELEVATION

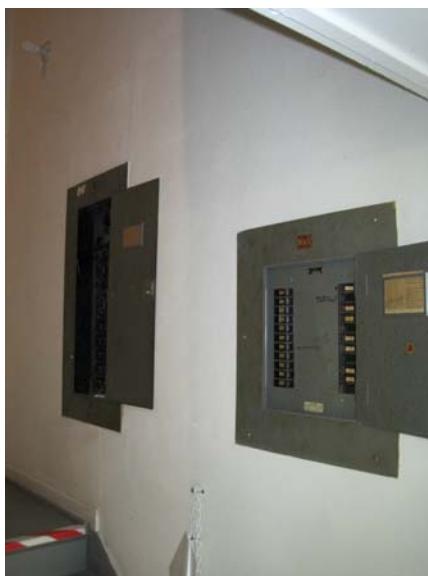
LELE1 VARIOUS ELECTRICAL PANELS

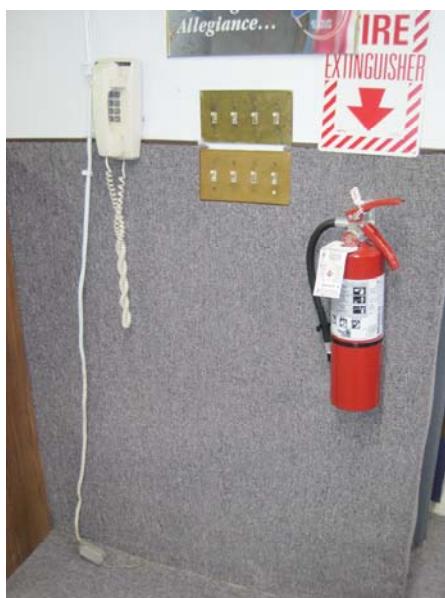
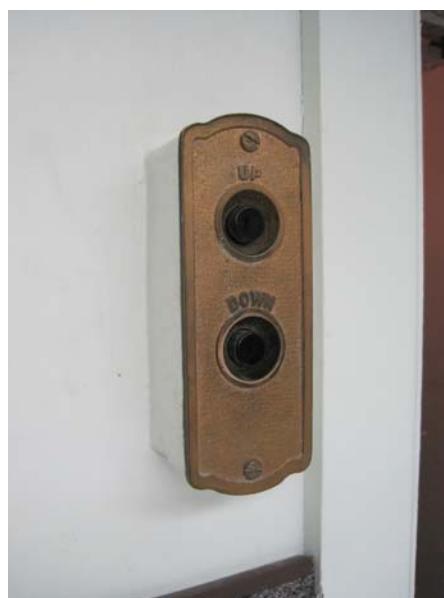
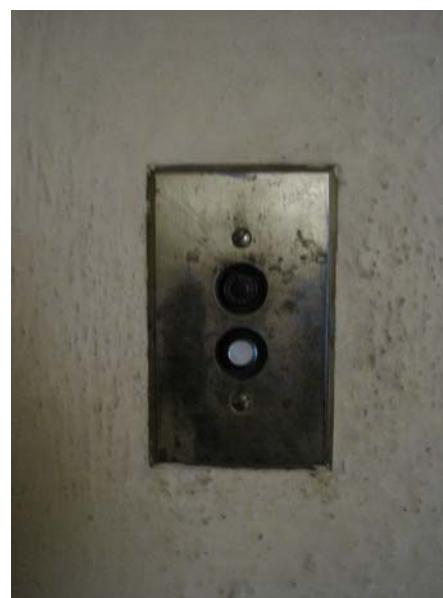
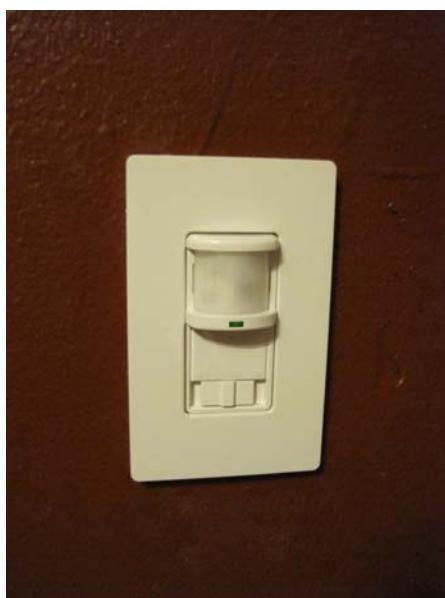
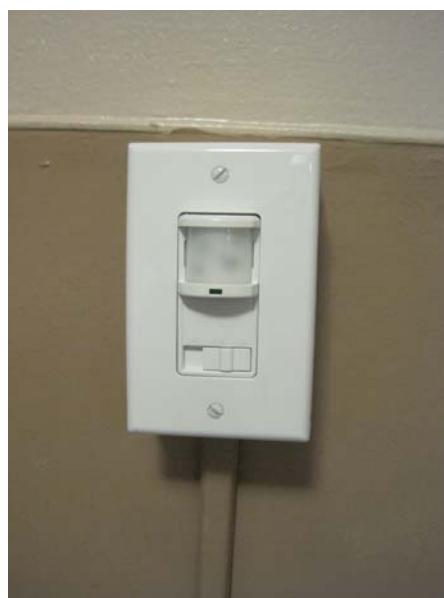
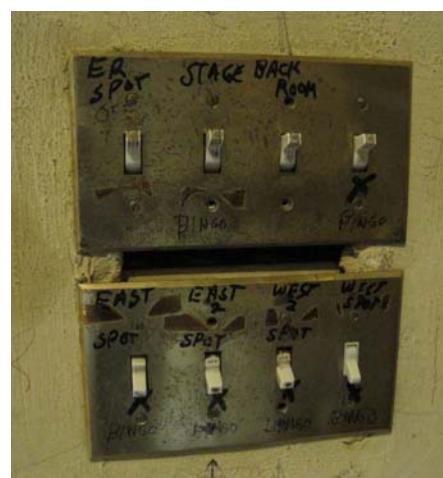
LELE2 HISTORIC AND NON-HISTORIC FLUSH AND SURFACE MOUNTED ELECTRICAL DISTRIBUTION AND SWITCHES

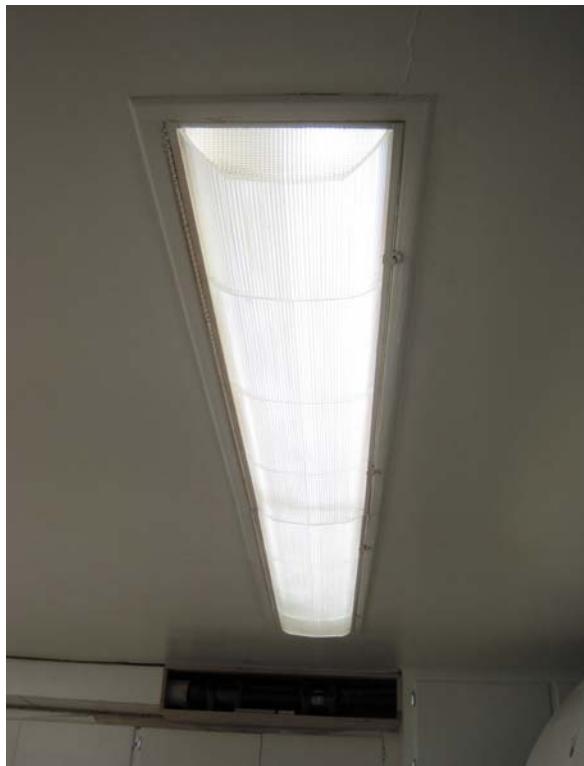
LEL7325 HISTORIC FLUORESCENT LIGHTING
IN BASEMENT KITCHEN

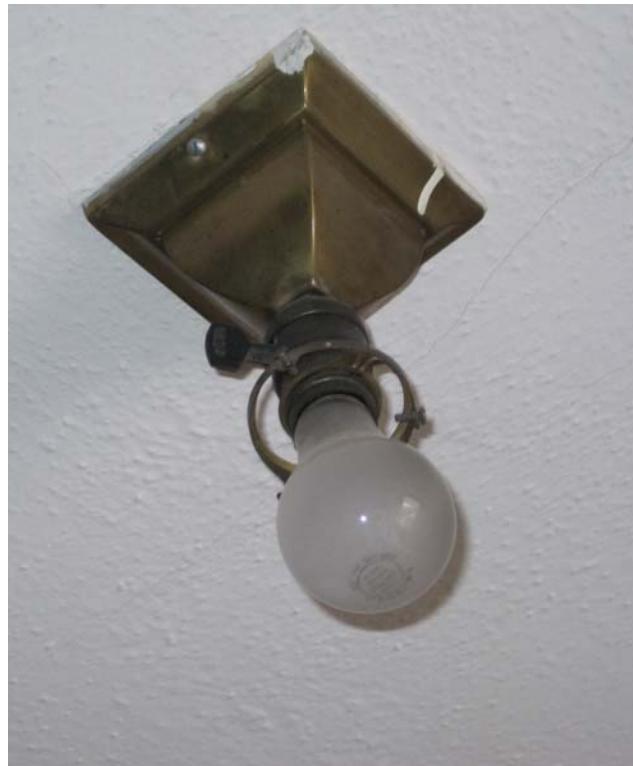
LEL7781 HISTORIC THIRD FLOOR LIGHTING FIXTURE
