Asbestos, LCP and RBM Survey

205 East 6th Street
Loveland, Colorado

January 3, 2018

Terracon Project No. 25177539

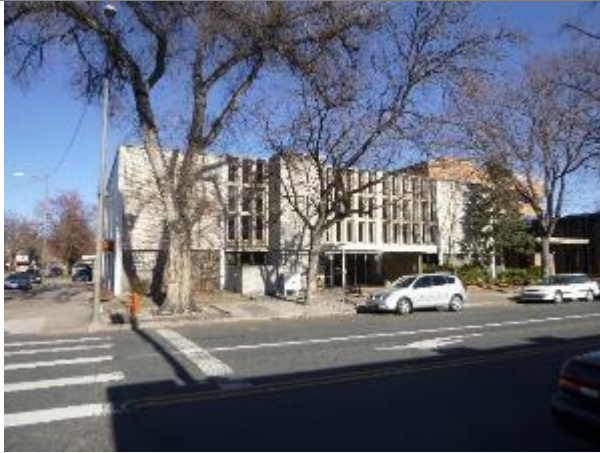
Photo #1 Site building, south exterior.
View is to the north.

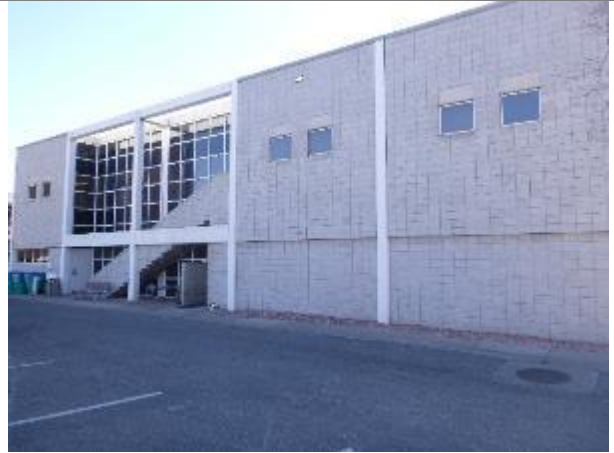
Photo #2 Site building, north exterior.
View is to the southwest.

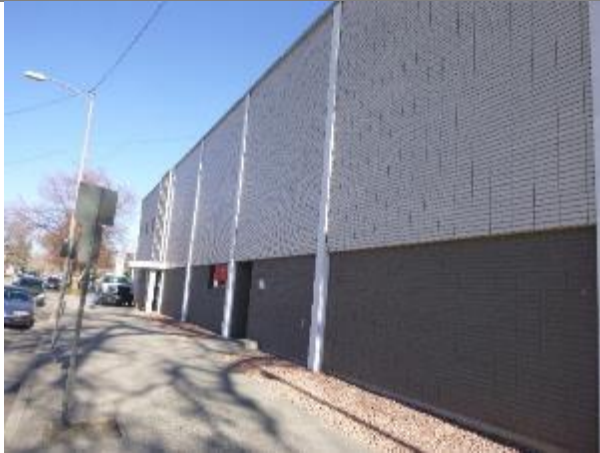
Photo #3 Site building, east exterior.
View is to the north-northwest.

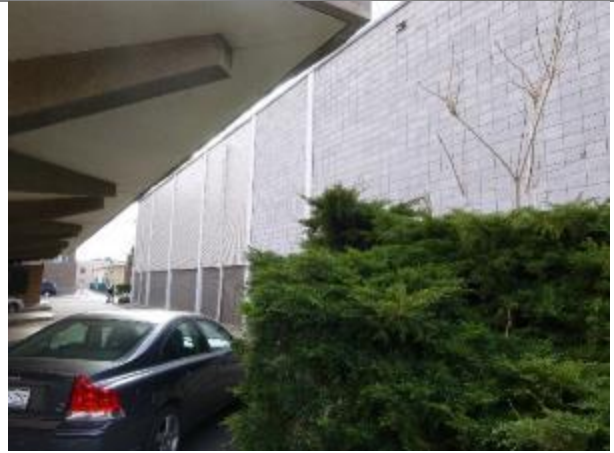
Photo #4 Site building, west exterior.
View is to the southwest.

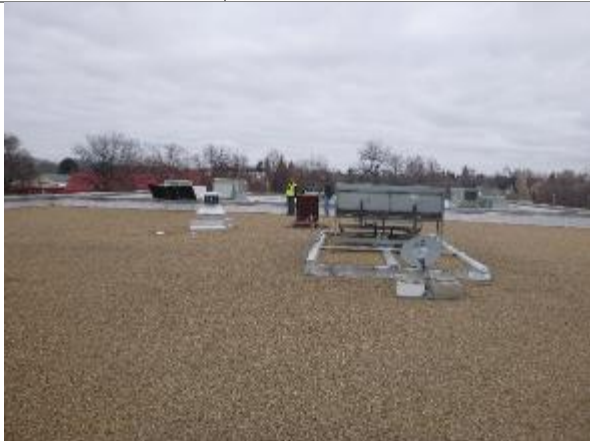
Photo #5 Site building roof. View is to the north.

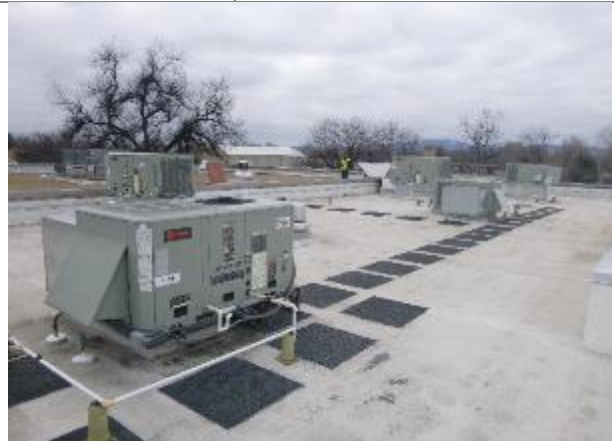
Photo #6 Site building roof. View is to the southwest.

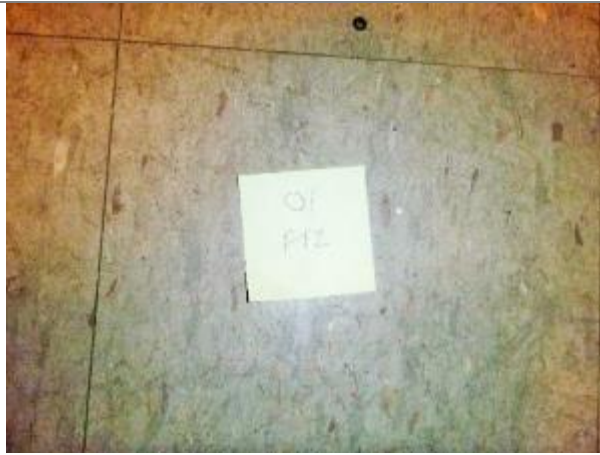
Photo #7 HA-01, 12" x 12" gray mottled floor tile

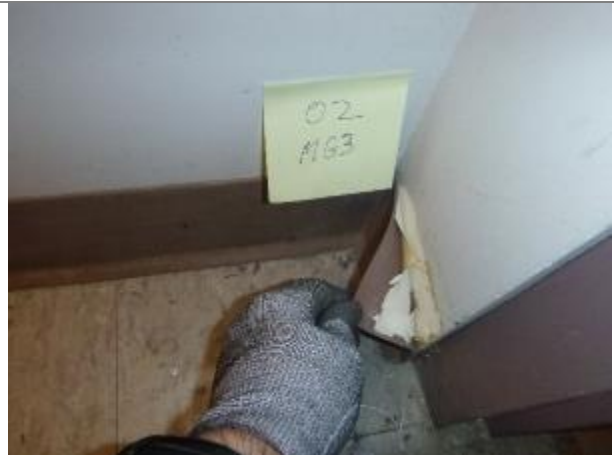
Photo #8 HA-02, tan cove base adhesive

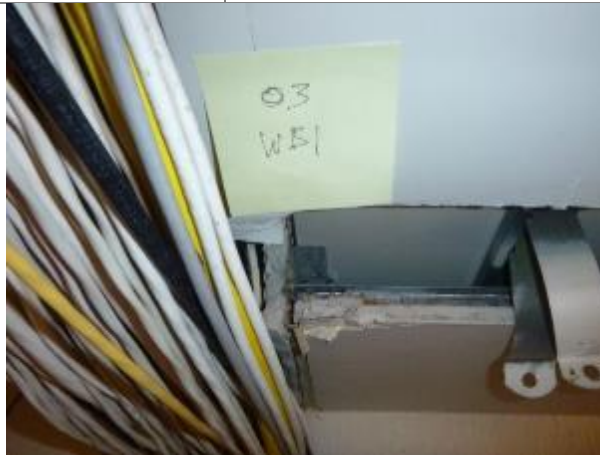
Photo #9 HA-03, light grey gypsum board

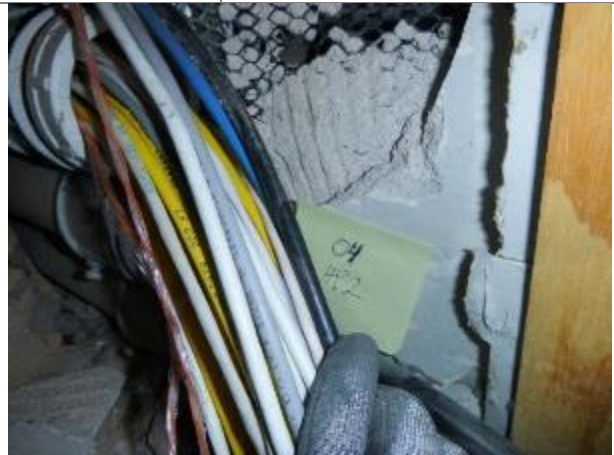
Photo #10 HA-04, tan plaster with white skimcoat

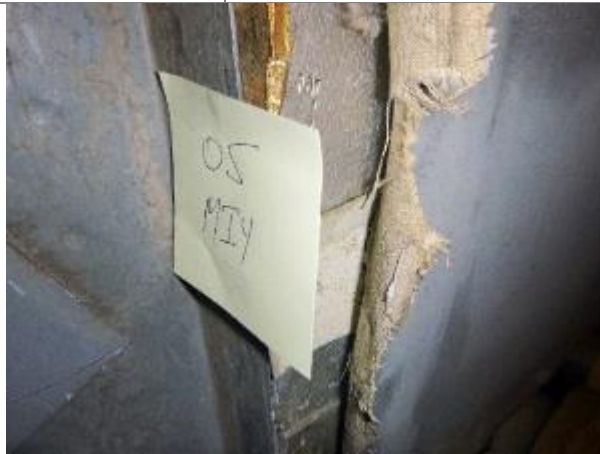
Photo #11 HA-05, gray tape with gray canvass wrap duct insulation

Terracon recommends destructive investigation of inaccessible areas, such as wall or ceiling voids, as well as sampling of the above-mentioned assumed ACM prior to renovation or demolition of the building.

The asbestos-containing duct tape and wrap, mudded joint fittings and assumed ACM duct insulation coating, vermiculite and fuses are considered RACM. The asbestos-containing window glazing and caulking, and assumed ACM ceramic tile mortar and grout, fiberglass reinforced plastic adhesive and mirror mastic are considered Category II non-friable ACM in good condition (except for the damaged caulking on gutters). These materials must be removed by a CDPHE general asbestos abatement contractor (GAC) prior to renovation (if they will be disturbed) or demolition of the building in accordance with applicable federal, state and local regulations.

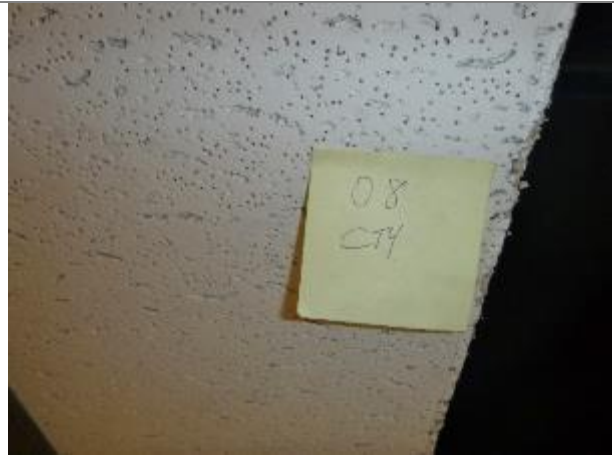
Photo #14 HA-08, 2' x 4' lt gray ceiling tile with horiz. fissures and pinholes

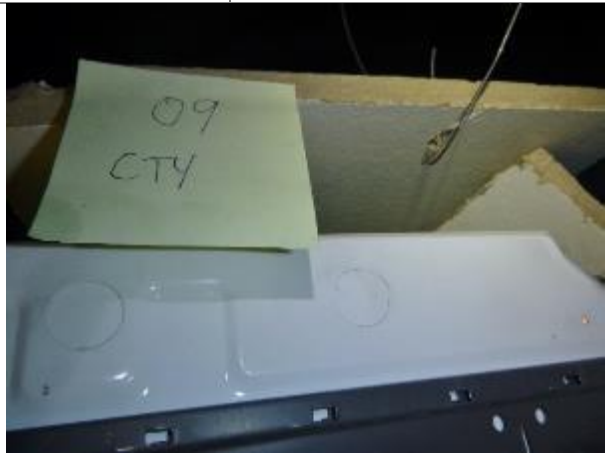
Photo #15 HA-09, 2' x 4' tan ceiling tile with smooth white surface

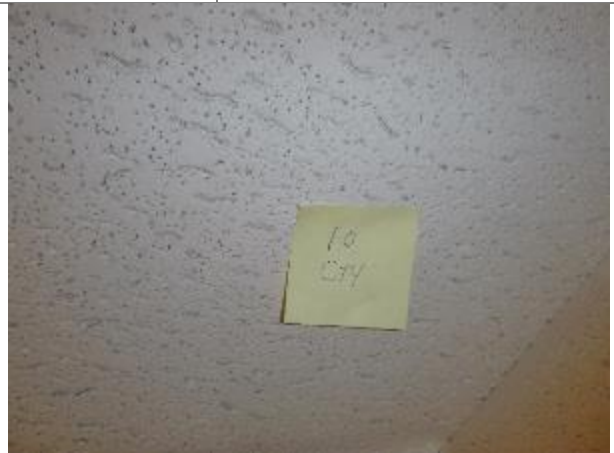
Photo #16 HA-10, 2' x 4' tan ceiling tile with thick horiz. fissures and holes

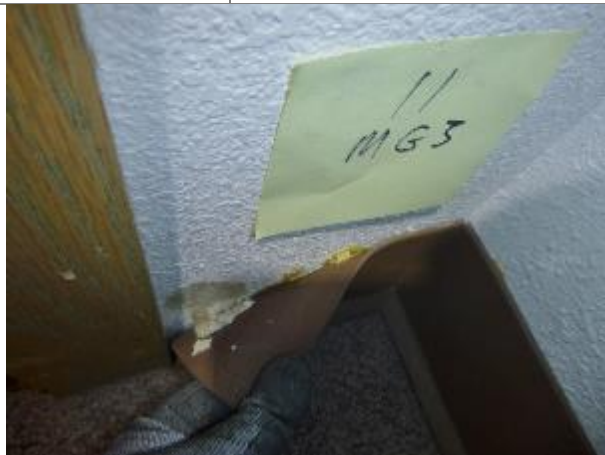
Photo #17 HA-11, tan cove base adhesive

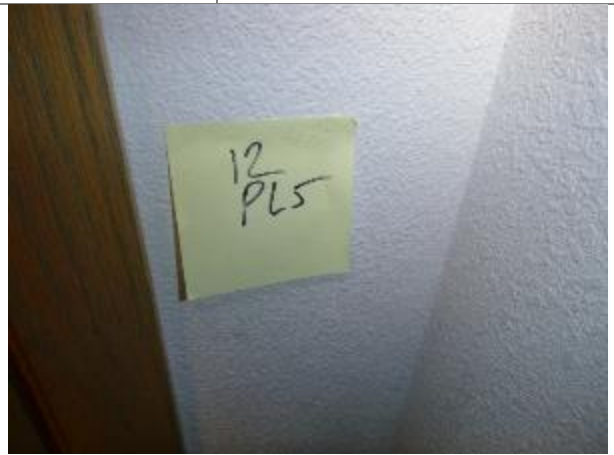
Photo #18 HA-12, white knockdown drywall texture

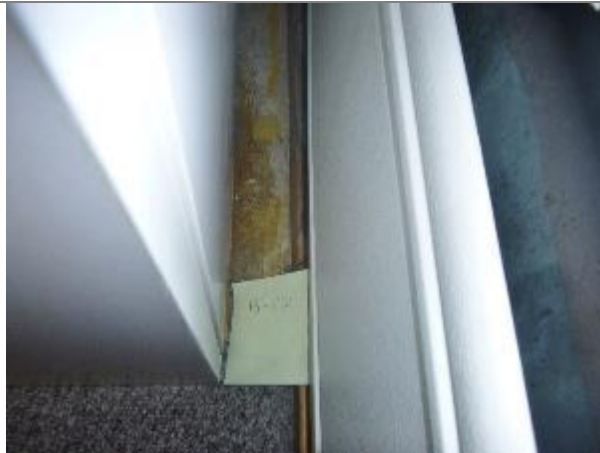
Photo #19 HA-13, yellow carpet adhesive

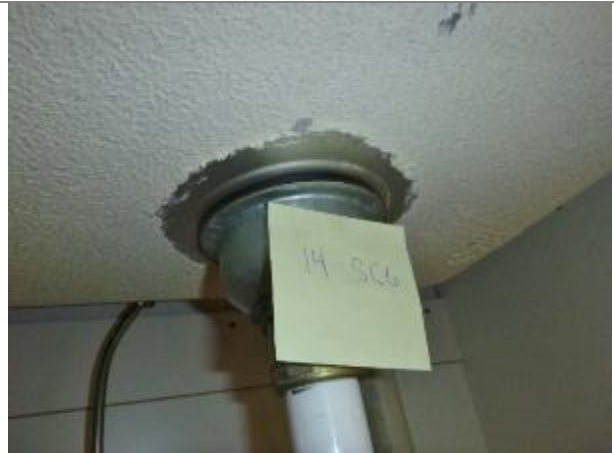
Photo #20 HA-14, light gray sink undercoating

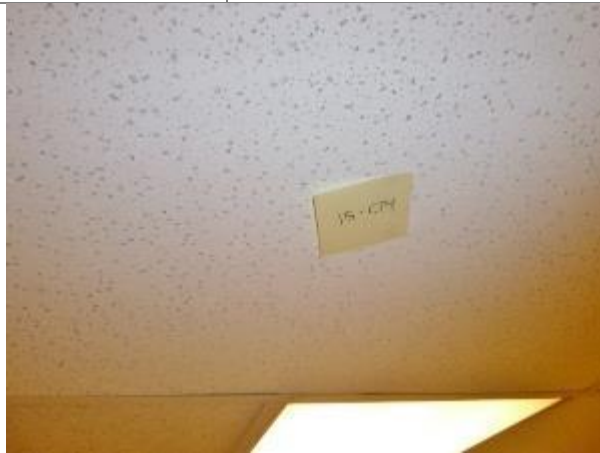
Photo #21 HA-15, 2' x 4' lt gray ceiling tile with small and medium holes

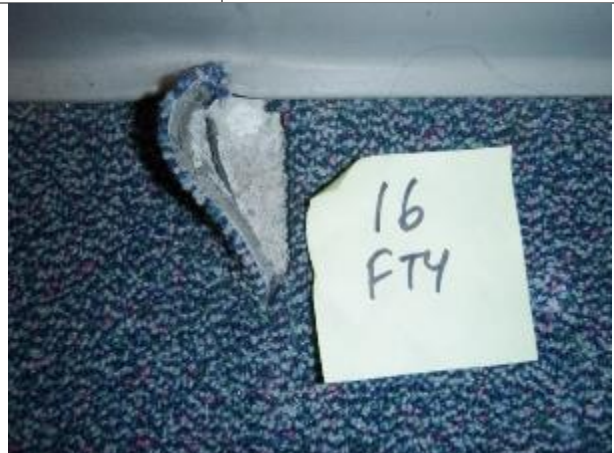
Photo #22 HA-16, tan carpet adhesive

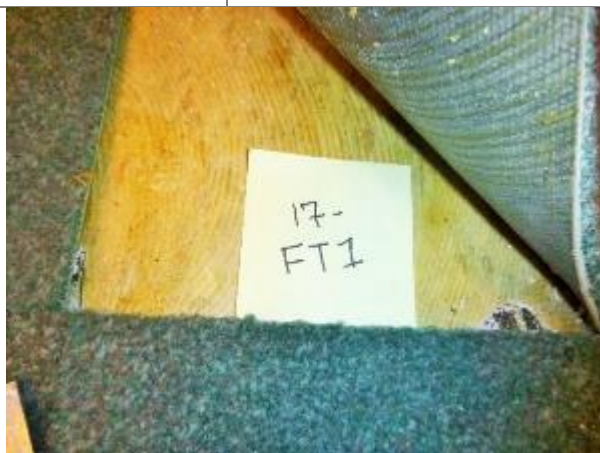
Photo #23 HA-17, 9" x 9" gray floor tile

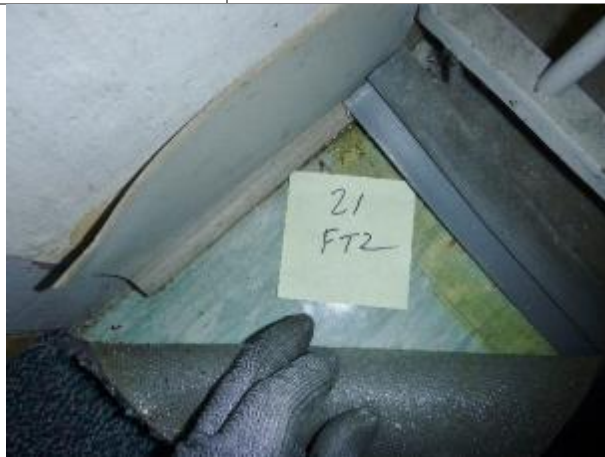
Photo #27 HA-21, 12" x 12" gray/blue mottled floor tile

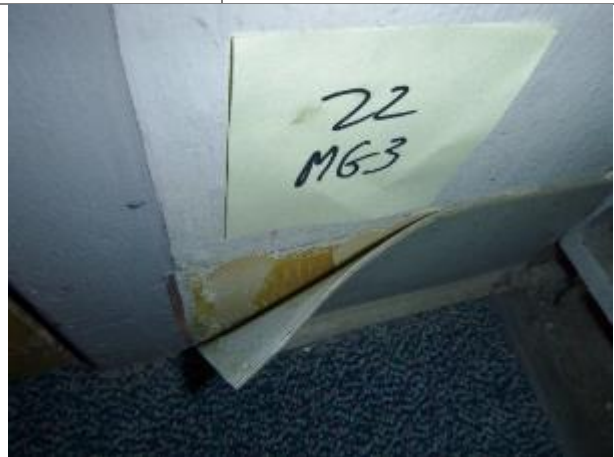
Photo #28 HA-22, tan, light brown and cream cove base adhesive

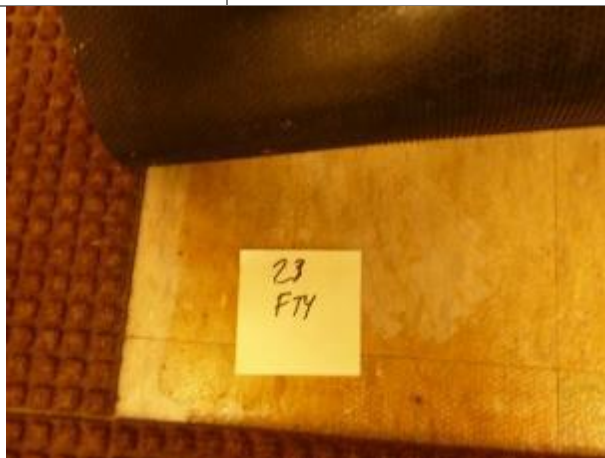
Photo #29 HA-23, yellow/brown carpet adhesive

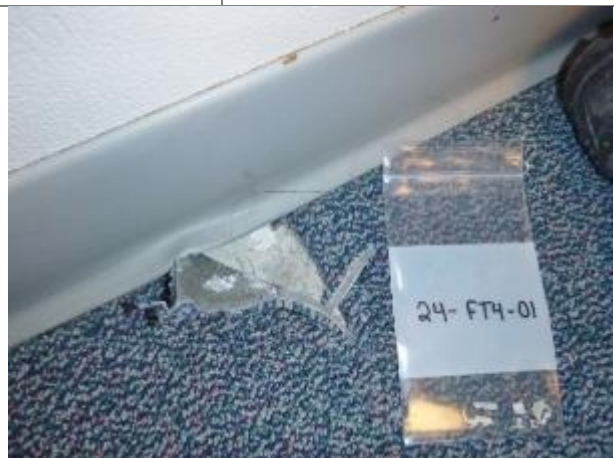
Photo #30 HA-24, gray carpet adhesive

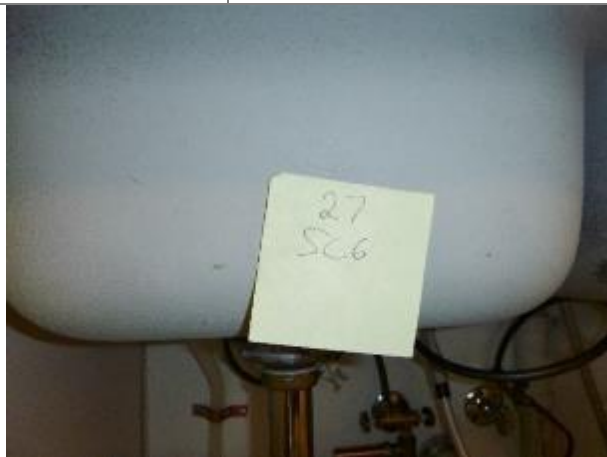
Photo #33 HA-27, gray smooth sink undercoating

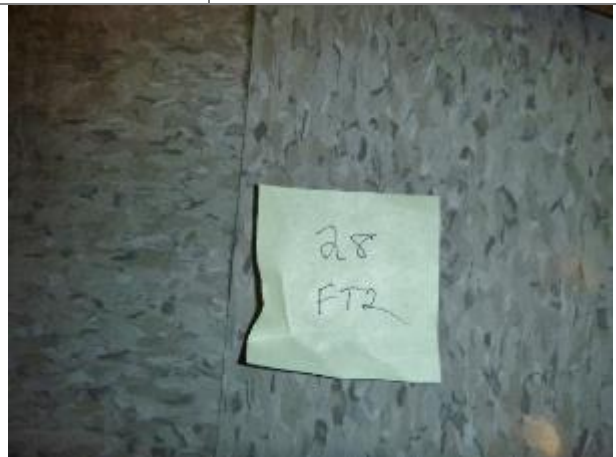
Photo #34 HA-28, 12" x 12" brown mottled floor tile

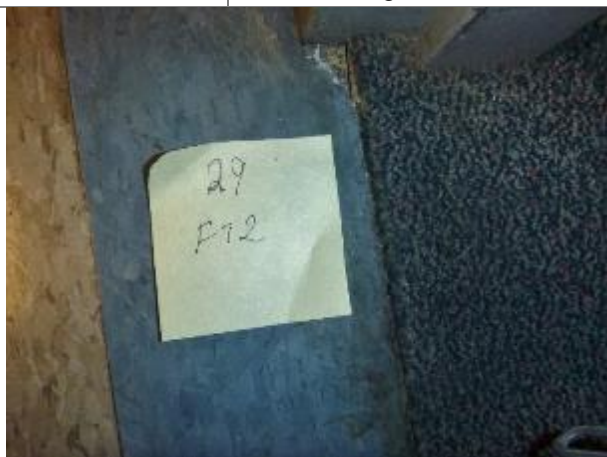
Photo #35 HA-29, 12" x 12" blue mottled floor tile

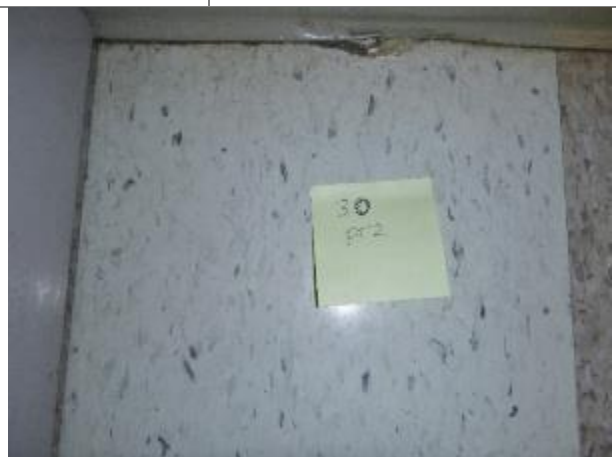
Photo #36 HA-30, 12" x 12" white floor tile with black and gray spots

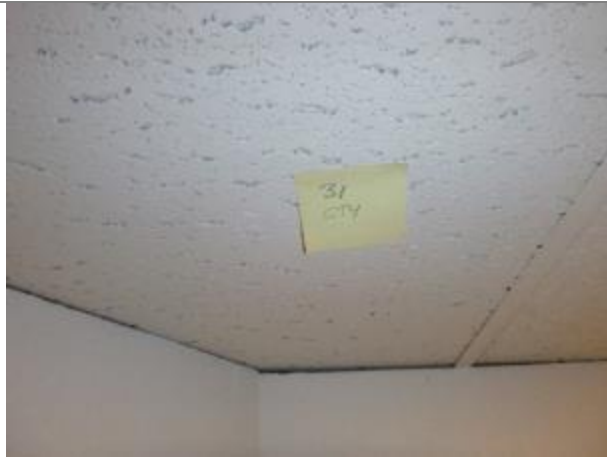
Photo #37 HA-31, 2' x 4' pink ceiling tile with horizontal fissures and wide spaced holes

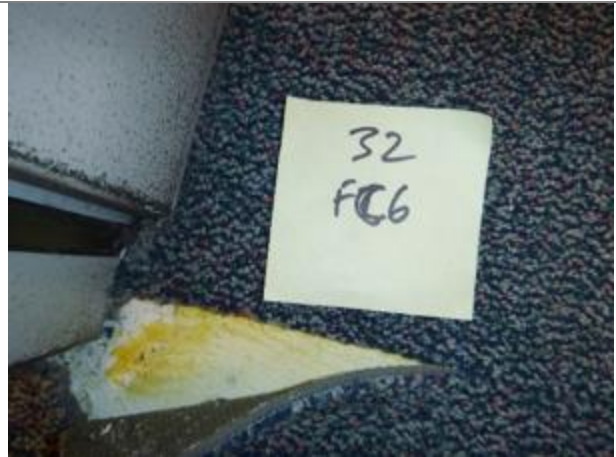
Photo #38 HA-32, gray floor leveling compound

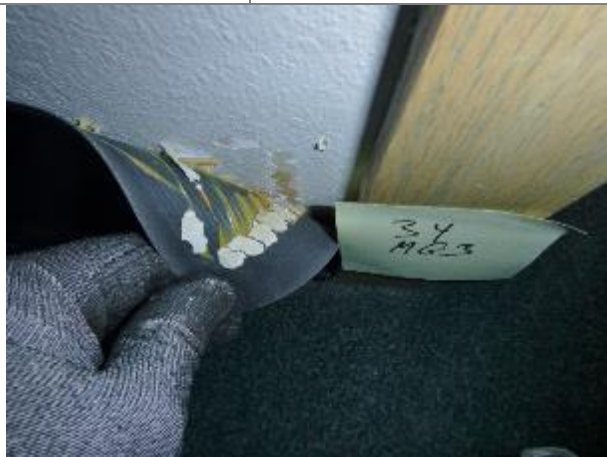
Photo #39 HA-34, yellow cove base adhesive

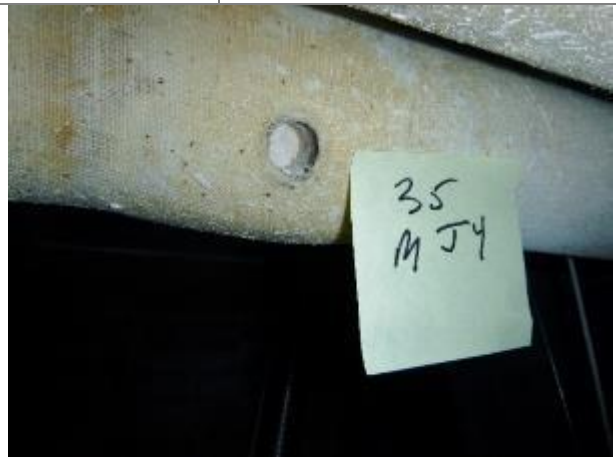
Photo #40 HA-35, white hot and cold water pipe mudded joint fitting

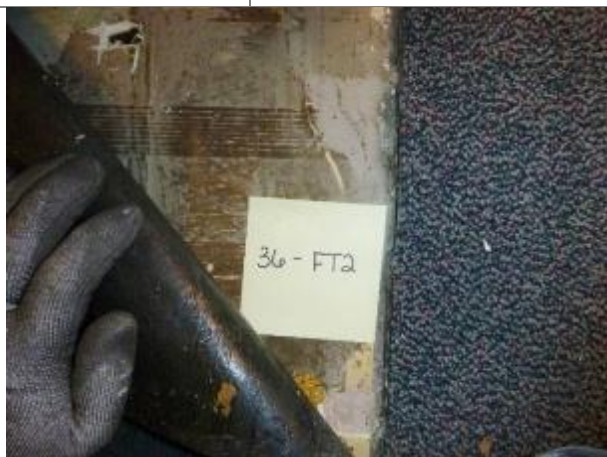
Photo #41 HA-36, 9" x 9" beige/tan floor tile

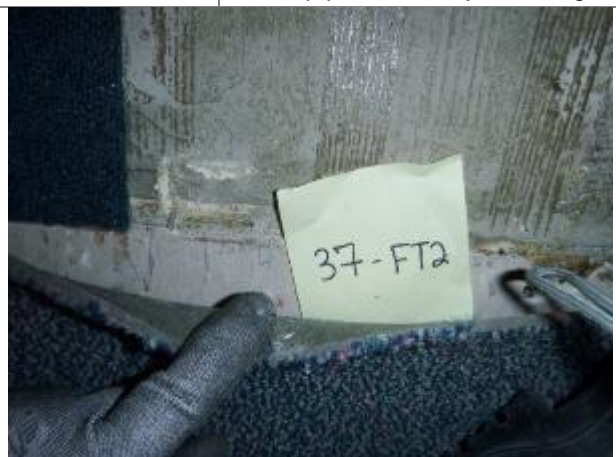
Photo #42 HA-37, 12" x 12" gray floor tile with red, black and white spots

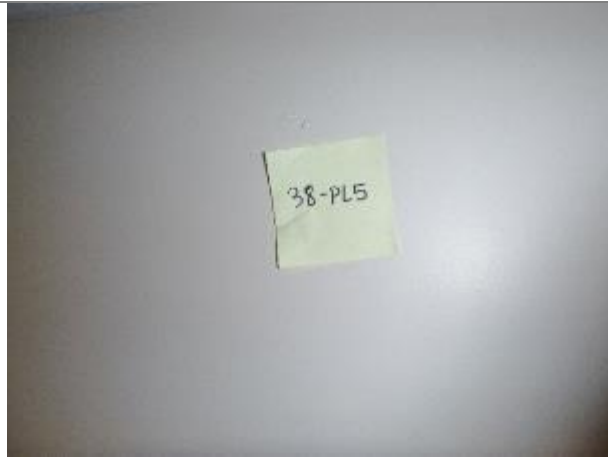
Photo #43 HA-38, white light orange peel drywall texture

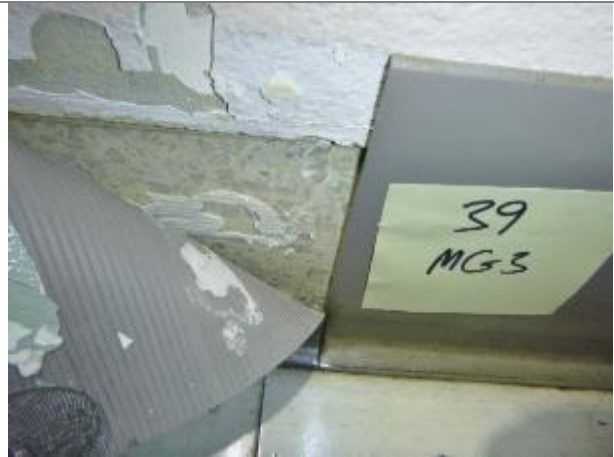
Photo #44 HA-39, white cove base adhesive

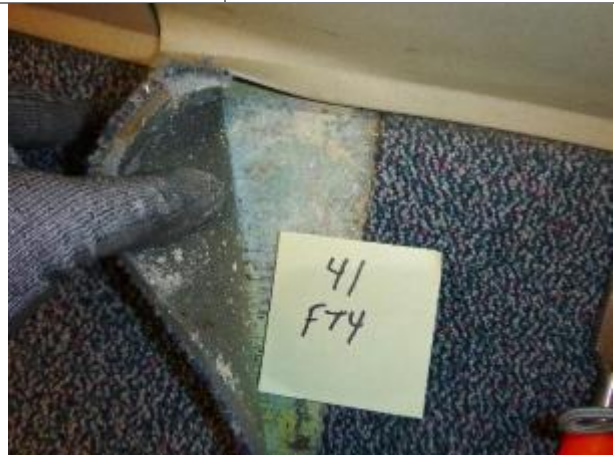
Photo #46 HA-41, gray/blue carpet adhesive

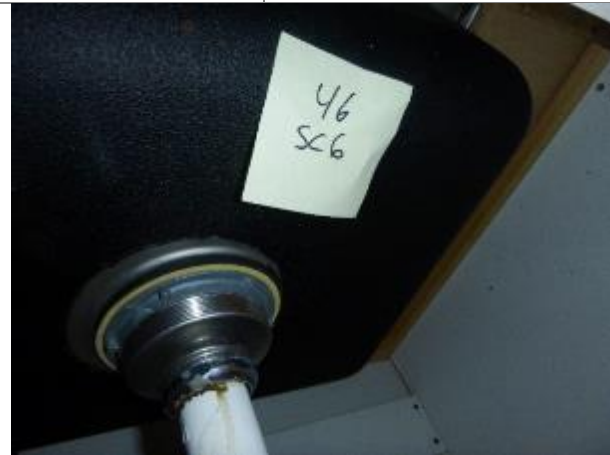
Photo #51 HA-46, black sink undercoating

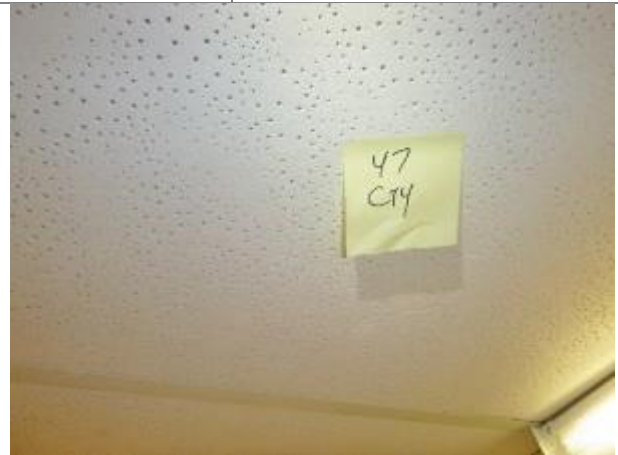
Photo #52 HA-47, 2' x 4' light gray ceiling tile "galaxy" pattern

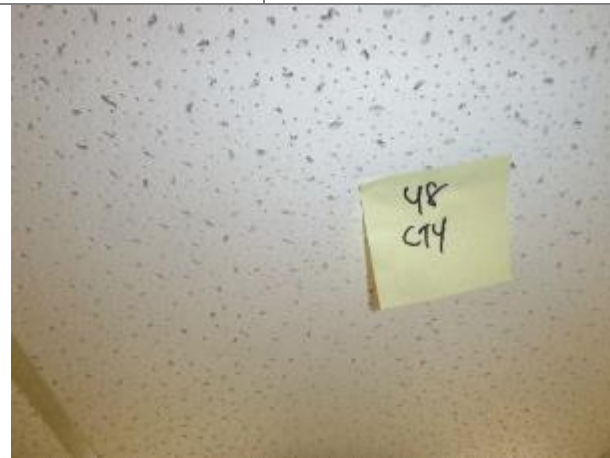
Photo #53 HA-48, 2' x 4' tan ceiling tile with small pinholes and large star pinholes

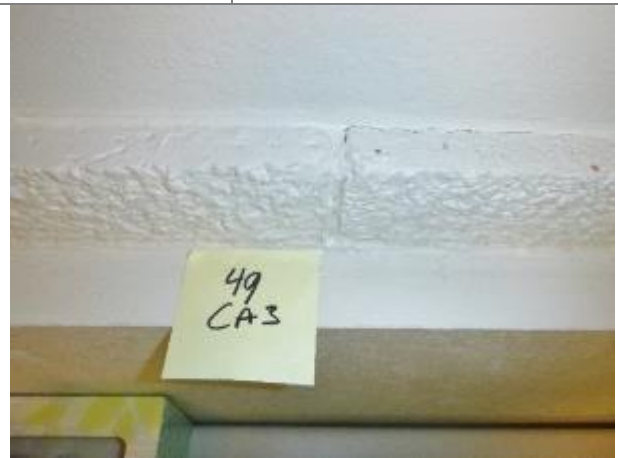
Photo #54 HA-49, white CMU caulking

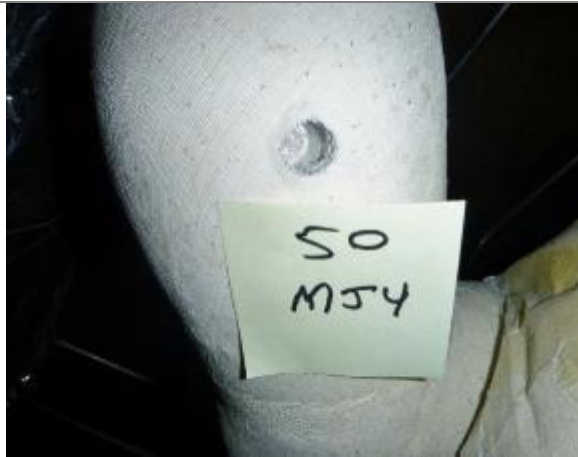
Photo #55 HA-50, white roof drain pipe fitting insulation

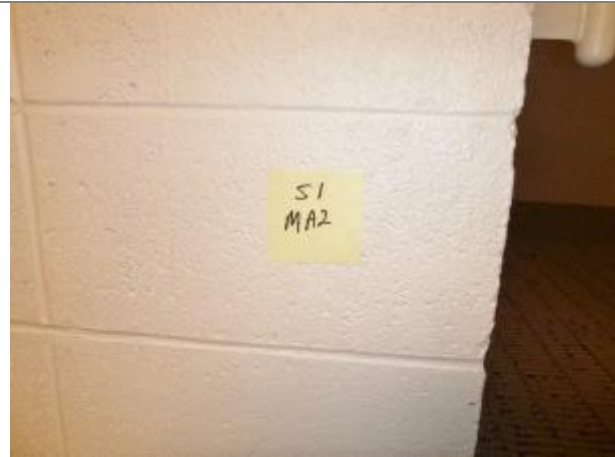
Photo #56 HA-51, white CMU wall sealant

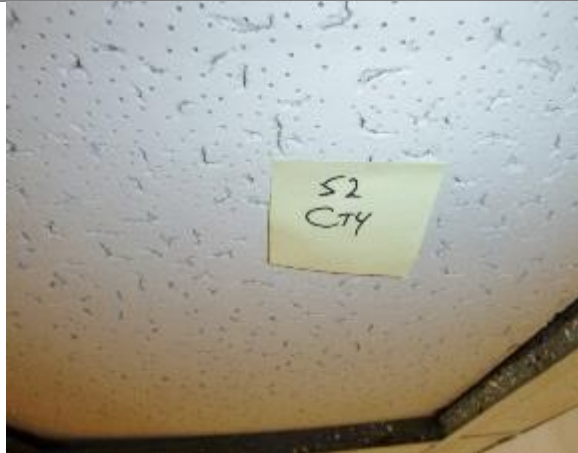
Photo #57 HA-52, 2' x 4' white ceiling tile with chicken feet fissures and pinholes

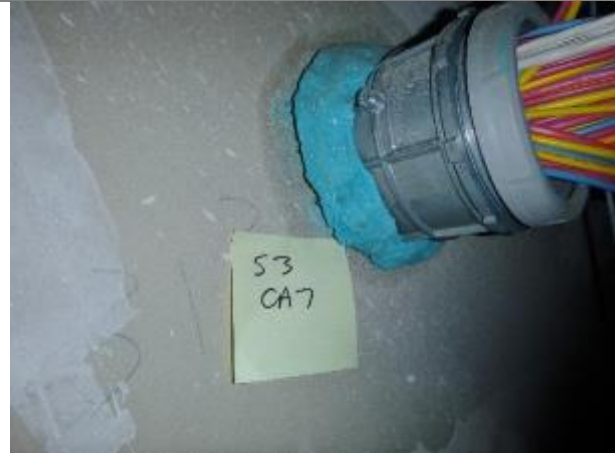
Photo #58 HA-53, green/blue fire stop

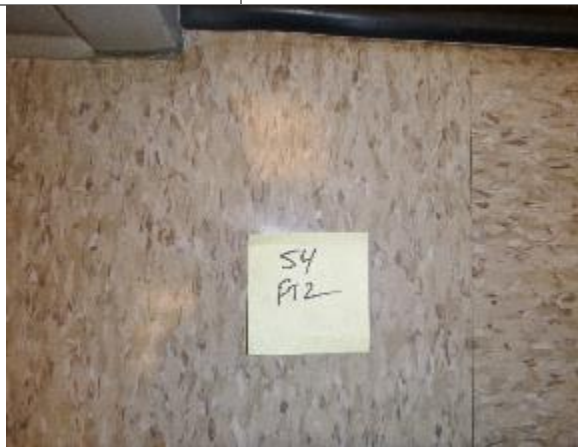
Photo #59 HA-54, 12" x 12" dark tan mottled floor tile

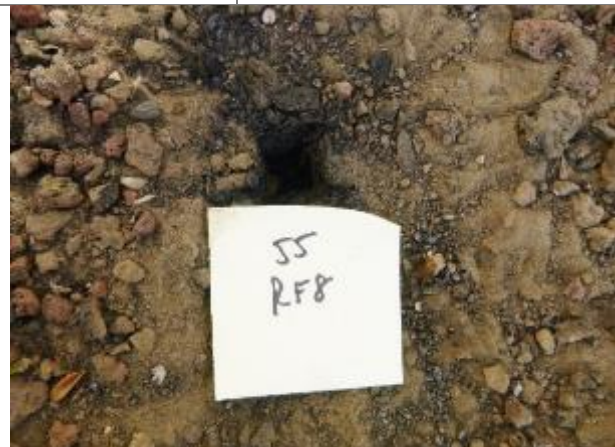
Photo #60 HA-55, black built-up asphaltic roofing with brown insulation

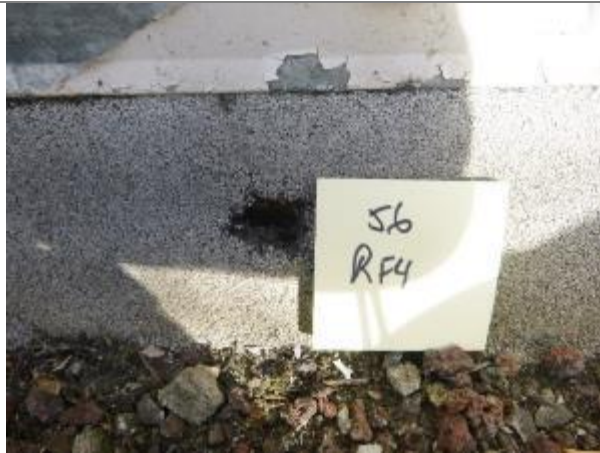
Photo #61 HA-56, gray rolled-on flashing with black tar

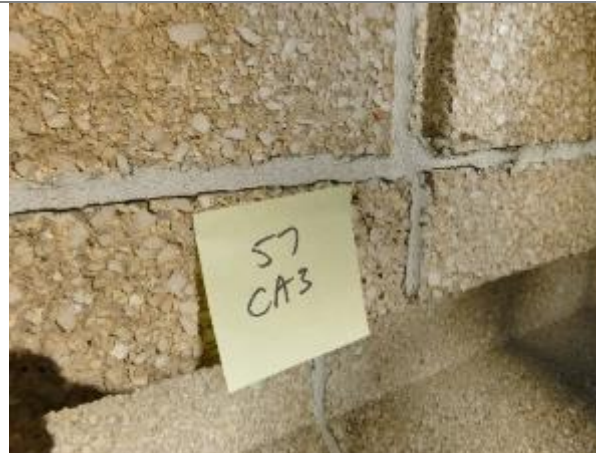
Photo #62 HA-57, gray wall caulking

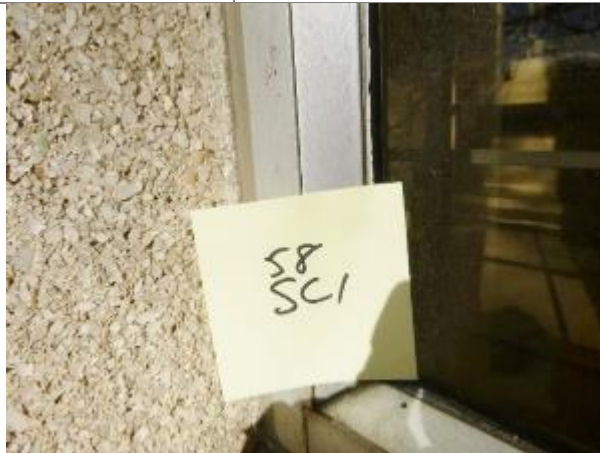
Photo #63 HA-58, white window glazing

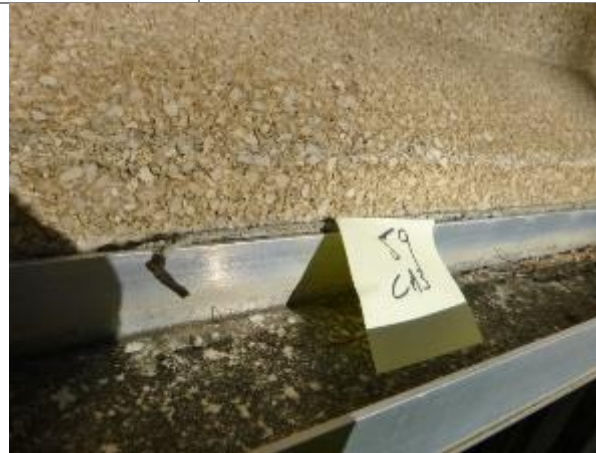
Photo #64 HA-59, dark gray caulking

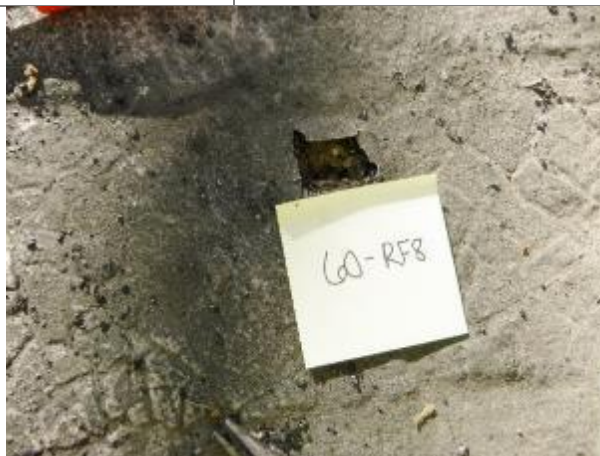
Photo #65 HA-60, white and black built-up roofing with tan insulation

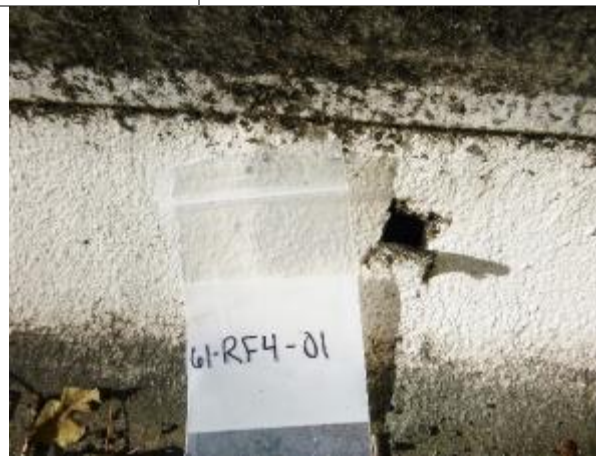
Photo #66 HA-61, white flashing with tan insulation and black tar

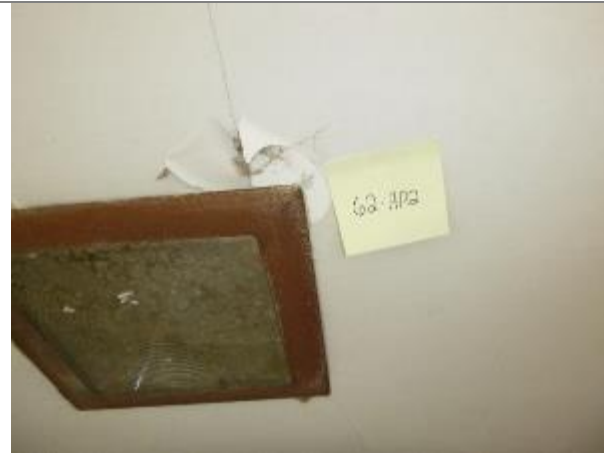
Photo #67 HA-62, white ceiling plaster with white skimcoat

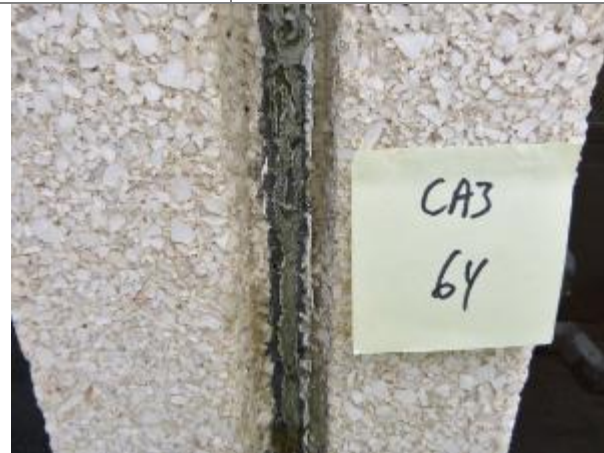
Photo #69 HA-65, gray wall caulking

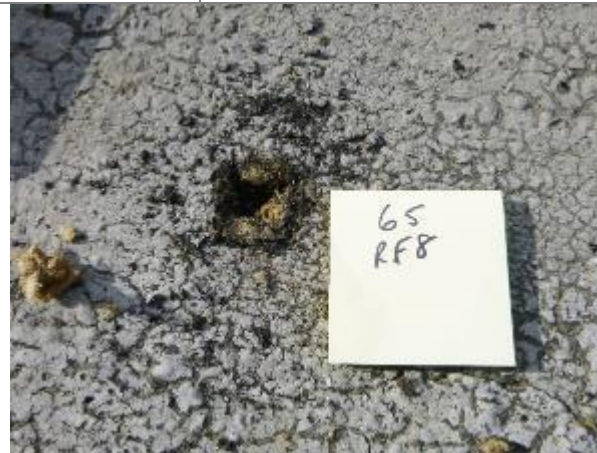
Photo #70 HA-65, silver and black built-up asphaltic roofing

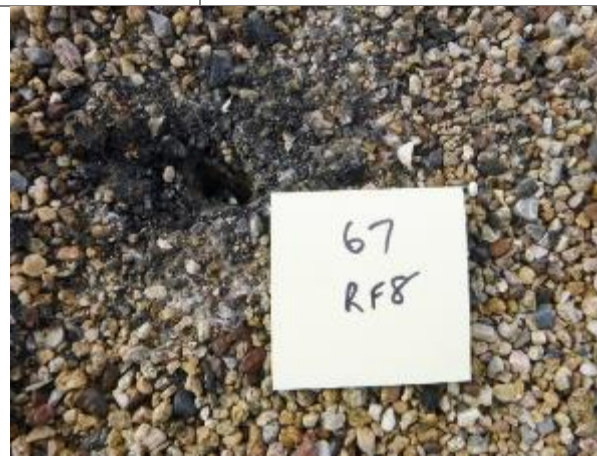
Photo #72 HA-67, brown built-up asphaltic roofing with brown insulation and styrofoam

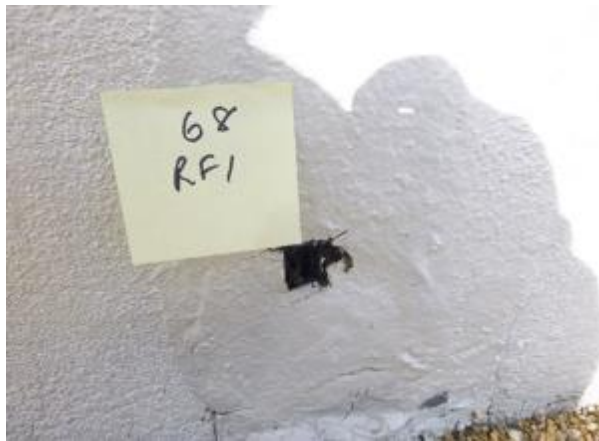
Photo #73 HA-68, silver and black roof flashing

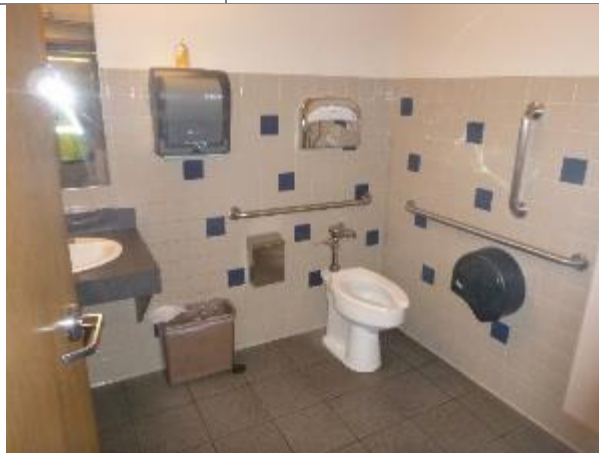
Photo #75 HA-71, Probation Dept. bathrooms, assumed ceramic tile

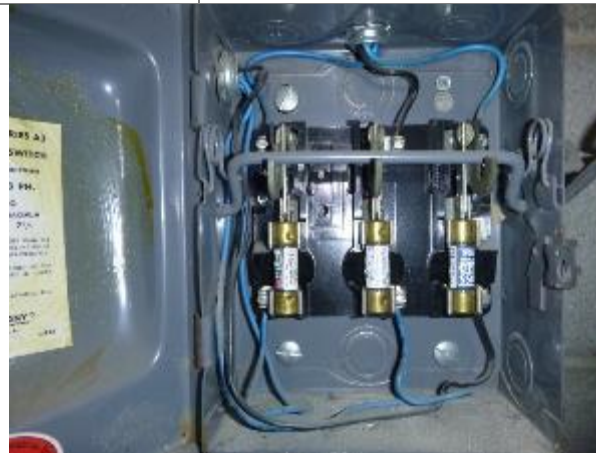
Photo #76 HA-74, Mechanical Room, assumed fuses

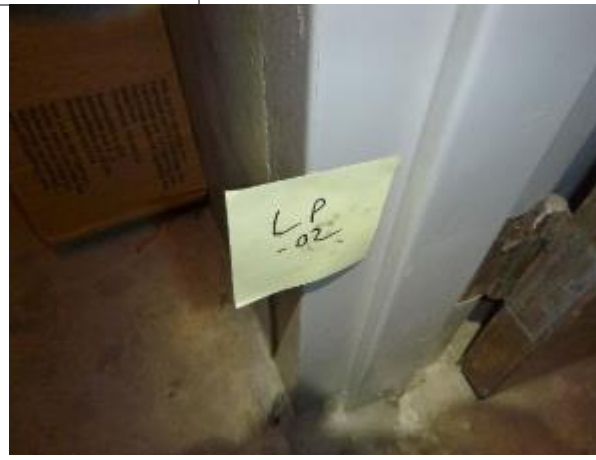
Photo #78 LP-02, metal door frame with gray paint

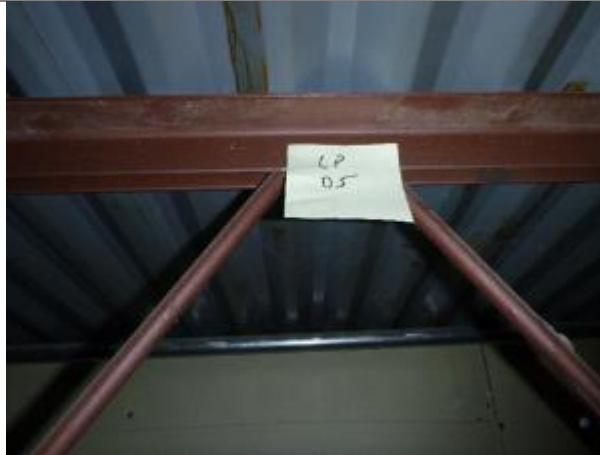
Photo #75 LP-05, metal ceiling joist with red paint

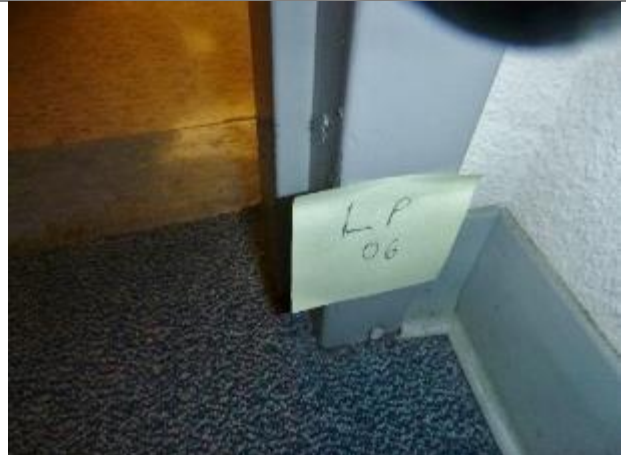
Photo #76 LP-06, metal door frame with gray paint

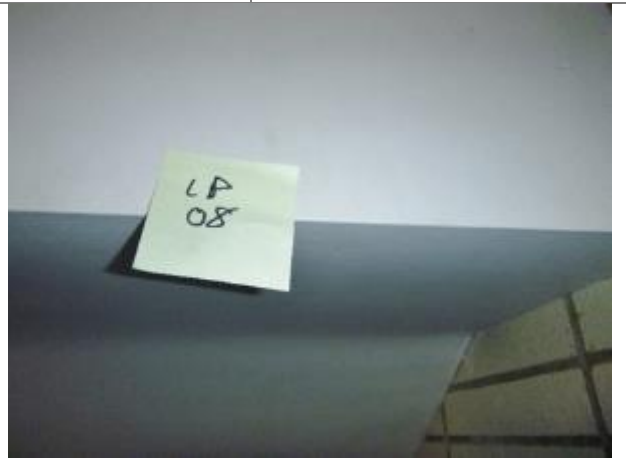
Photo #78 LP-08, plaster ceiling with white paint

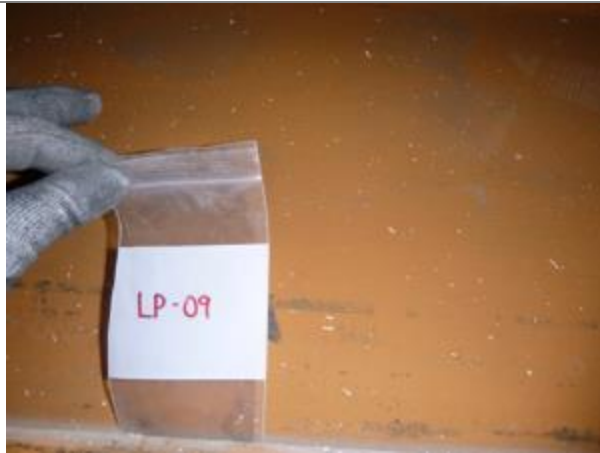
Photo #79 LP-09, metal I-beam with red paint

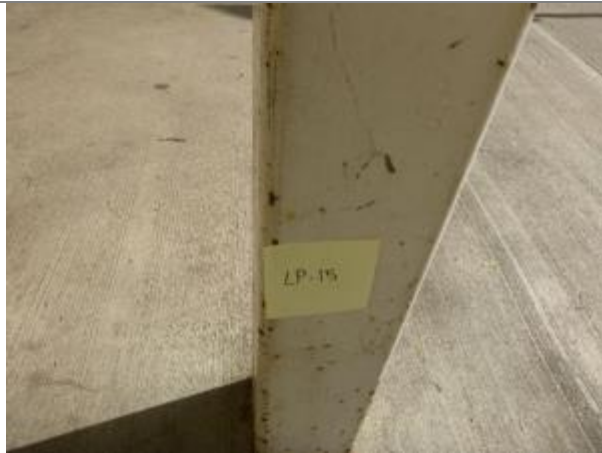
Photo #84 LP-14, metal I-beam with red paint

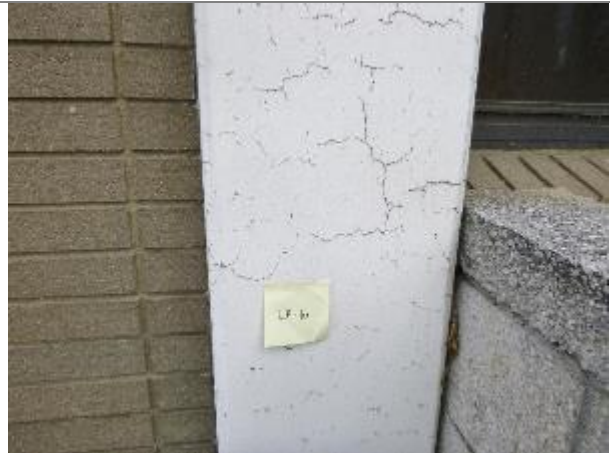
Photo #85 LP-15, metal post with white paint

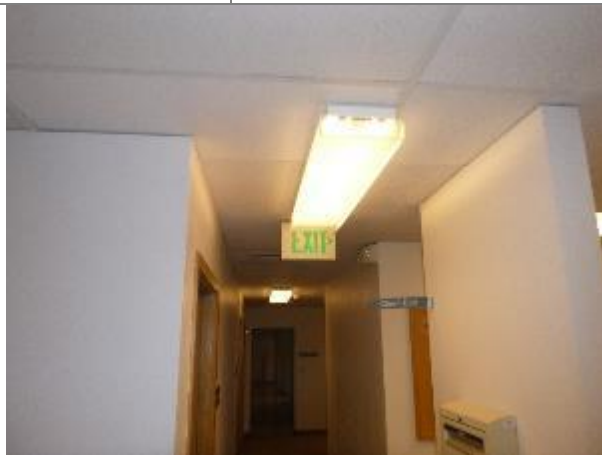
Photo #94 Mechanical Room, fluorescent light bulbs

No mercury in thermostats was observed. Most light bulbs were of the green tip variety and can be deemed non-mercury containing. However, some of the older mercury containing light bulbs were identified. These should be removed and disposed of as universal waste at some point in time.

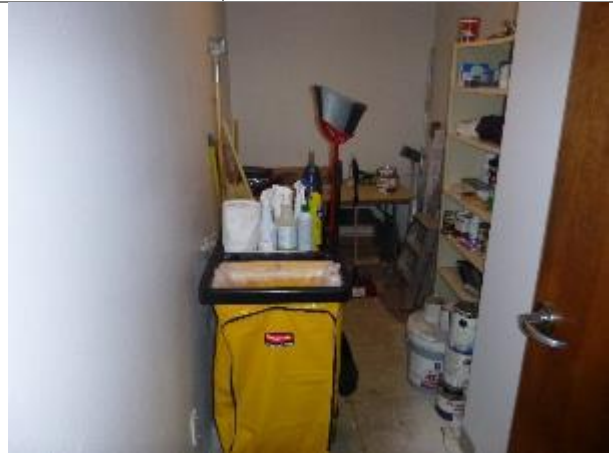
Photo #105 Probation Dept. Waiting Area
Janitor's Closet, cleaning
chemicals.

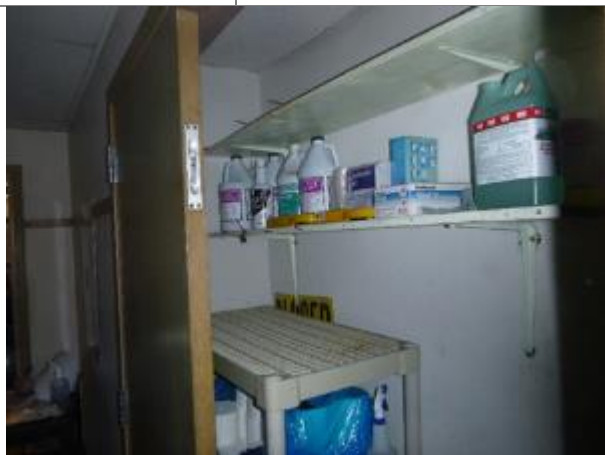
Photo #106 Probation Dept. Janitor's
Closet, cleaning chemicals
and paints.
